*Ventura Countywide  
Stormwater Quality  
Management Program*

Ventura Countywide Stormwater Quality  
Management Program Annual Report

Attachment E - TMDL Reports Volume II

# TOTAL MAXIMUM DAILY LOAD FOR ALGAE, EUTROPHIC CONDITIONS, AND NUTRIENTS IN VENTURA RIVER, INCLUDING THE ESTUARY, AND ITS TRIBUTARIES (VR ALGAE TMDL)

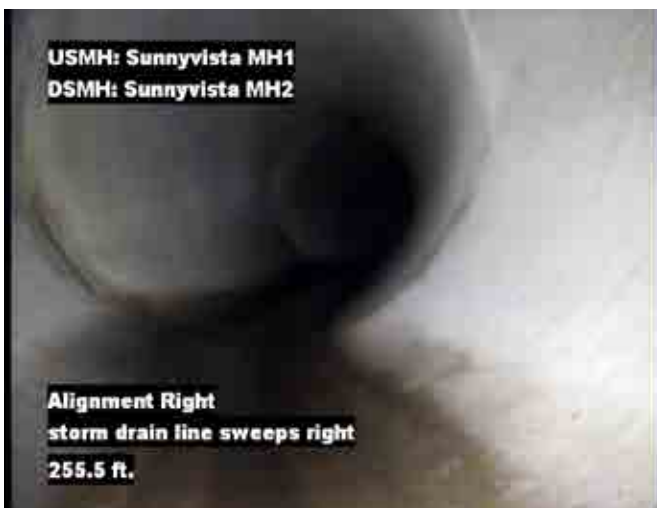
Distance: 255.5 ft.      Grade: 1  
 Condition: Alignment Right  
 Remarks: storm drain line sweeps right

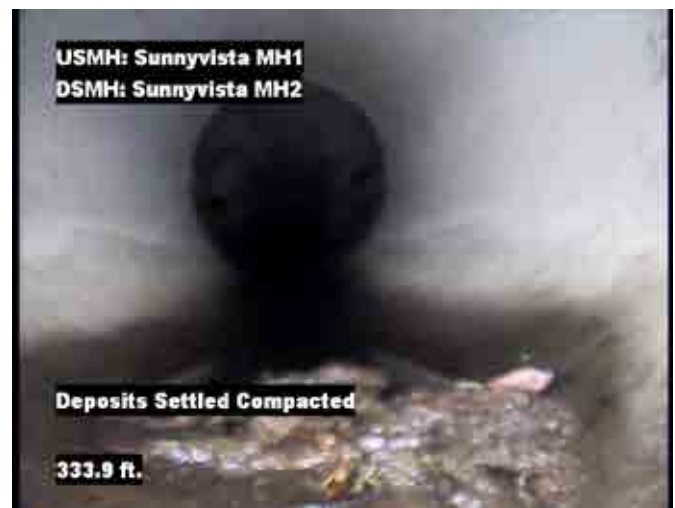
Distance: 333.9 ft.      Grade: 3  
 Condition: Deposits Settled Compacted  
 Remarks: N/A

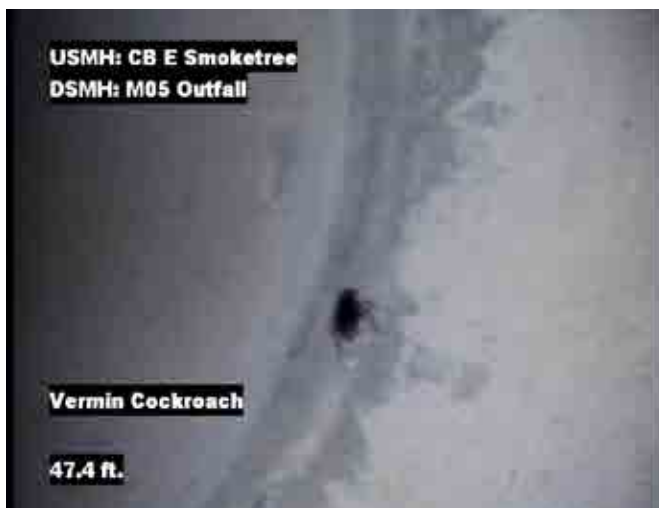
Distance: 47.4 ft.      Grade: 1  
 Condition: Vermin Cockroach  
 Remarks: N/A

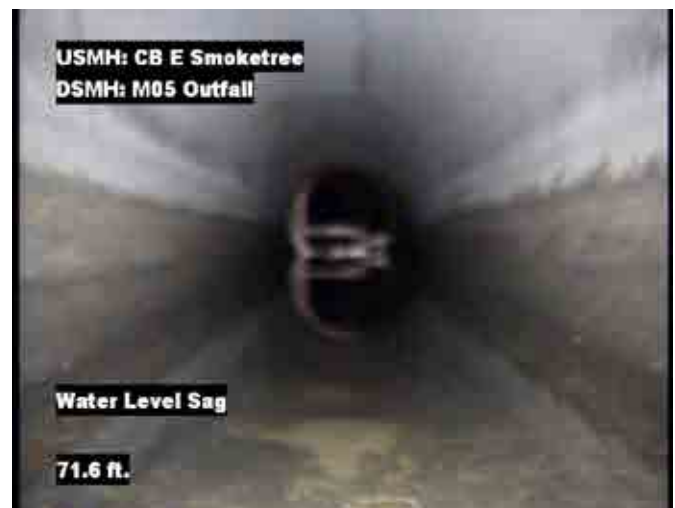
Distance: 71.6 ft.      Grade: 2  
 Condition: Water Level Sag  
 Remarks: N/A

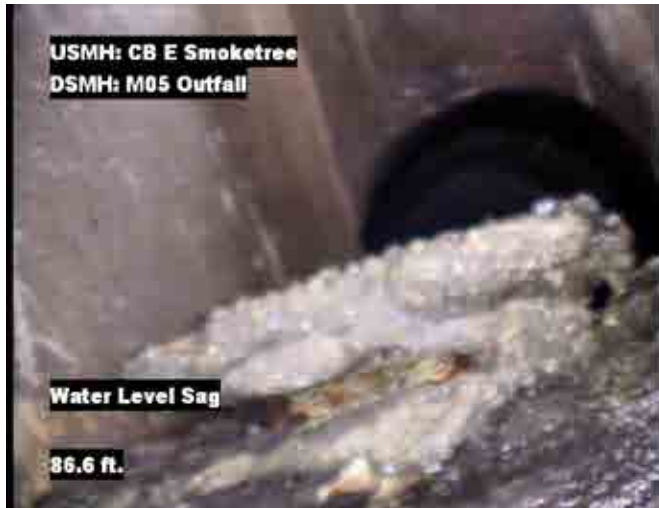
Distance: 86.6 ft.      Grade: 2  
 Condition: Water Level Sag  
 Remarks: N/A

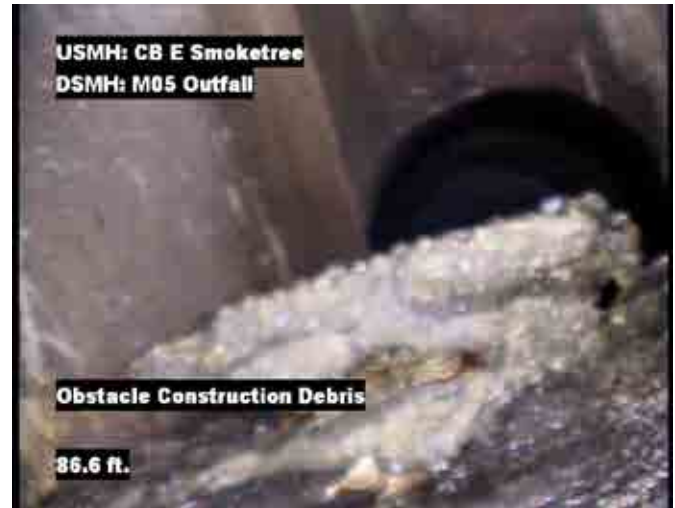
Distance: 86.6 ft.      Grade: 5  
 Condition: Obstacle Construction Debris  
 Remarks: N/A

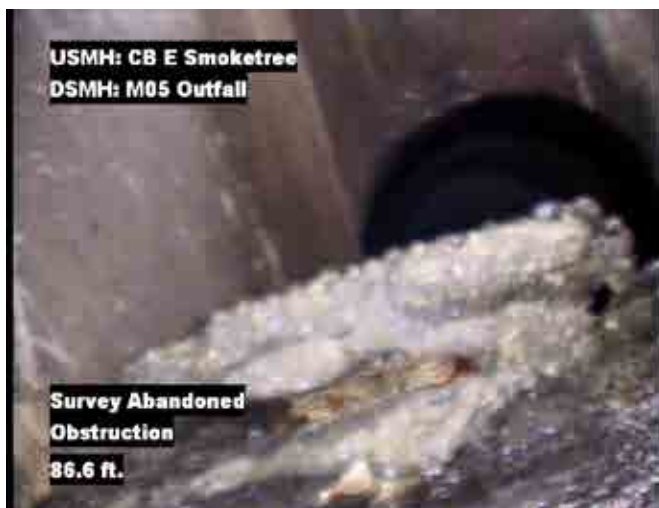
Distance: 86.6 ft.      Grade: 0  
 Condition: Survey Abandoned  
 Remarks: Obstruction

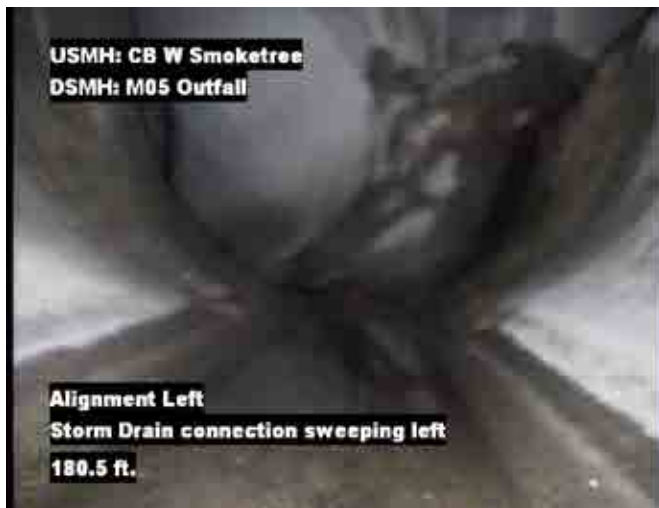
Distance: 180.5 ft. Grade: 4  
 Condition: Alignment Left  
 Remarks: Storm Drain connection sweeping left

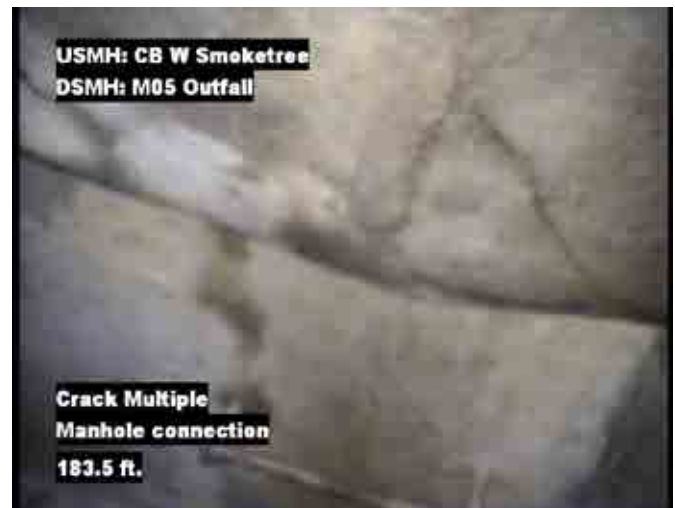
Distance: 183.5 ft. Grade: 3  
 Condition: Crack Multiple  
 Remarks: Manhole connection

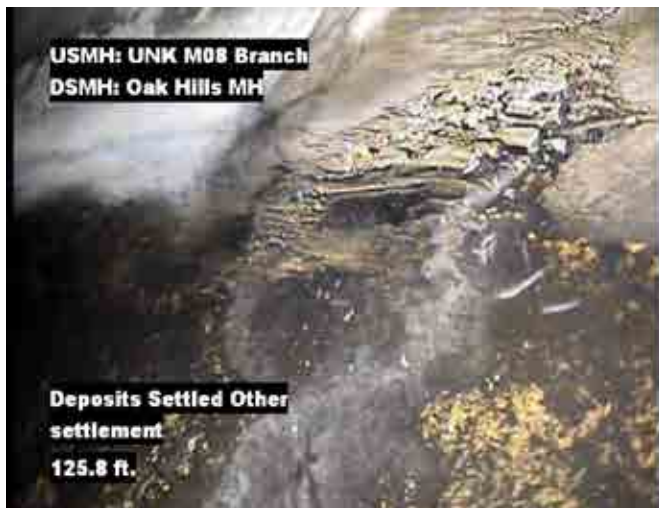
Distance: 125.8 ft. Grade: 2  
Condition: Deposits Settled Other  
Remarks: settlement

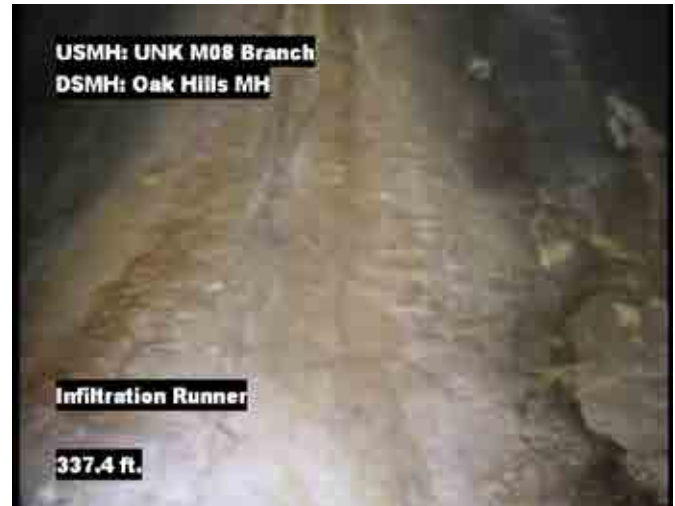
Distance: 337.4 ft.      Grade: 4  
 Condition: Infiltration Runner  
 Remarks: N/A

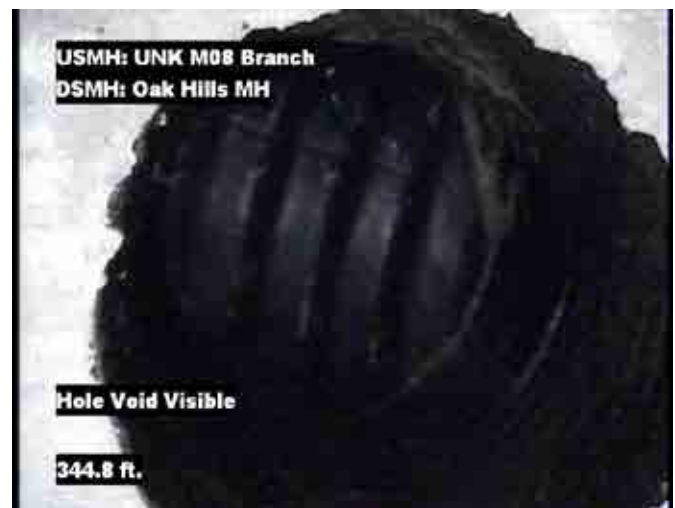
Distance: 344.8 ft.      Grade: 5  
 Condition: Hole Void Visible  
 Remarks: N/A

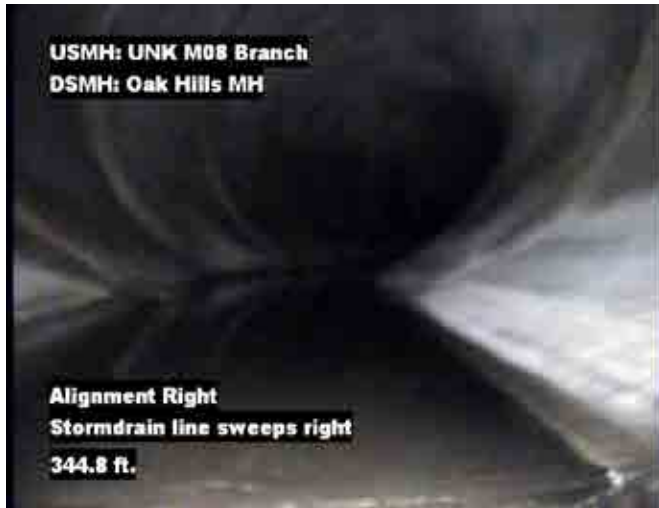
Distance: 344.8 ft.      Grade: 2  
 Condition: Alignment Right  
 Remarks: Stormdrain line sweeps right
