**Ventura Countywide Stormwater
Monitoring Program
Ventura River Watershed
2006 Bioassessment Monitoring Report**

August 2007

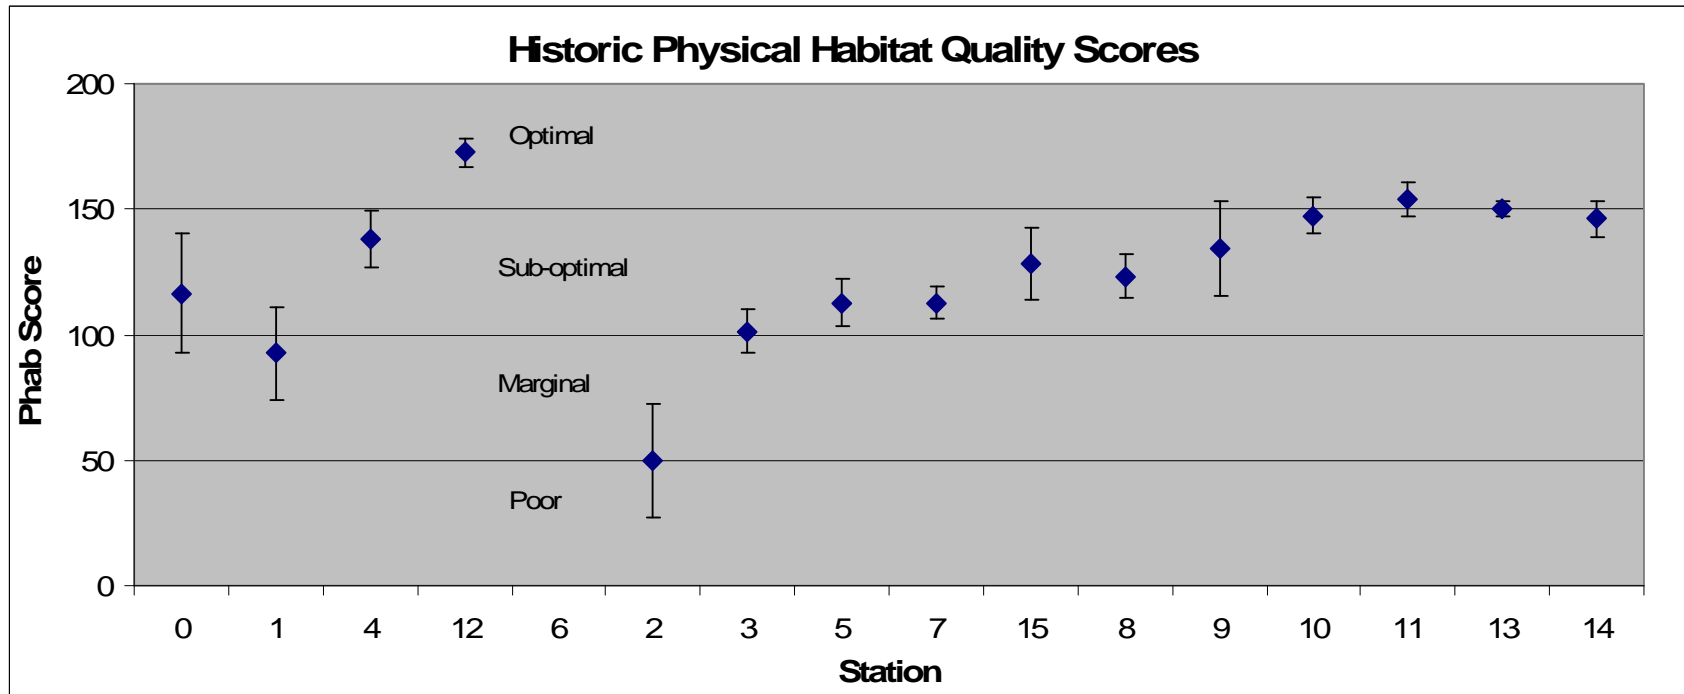
Figure 10. Average physical habitat scores (\pm 95% CI) for sites in the Ventura River Watershed, 2001 to 2006.

The best habitat conditions during the five year period were measured at Station 12 below the Matilija Dam and worst occurred on Canada Larga Creek above its confluence with the main stem of the Ventura River (Figure 10). Physical habitat scores increased as elevation in the watershed increased, becoming progressively greater on the Ventura River main stem from Station 0 near the ocean to Station 12 below Matilija Dam and from Canada Larga Creek (Stations 2 and 3) to the North Fork of the Matilija Creek (Stations 10 to 14). The greatest variation in physical/habitat scores during the five year period were found at Stations 0 and 2. Station 0 is located just above the confluence of the Ventura River with the ocean and Station 2 is located just above the confluence of Canada Larga Creek with

The best habitat conditions during the five year period were measured at Station 12 below the Matilija Dam and worst occurred on Canada Larga Creek (Station 2) above its confluence with the main stem of the Ventura River (Figure 10). Physical habitat scores increased as elevation in the watershed increased, becoming progressively greater on the Ventura River main stem from Station 0 near the ocean to Station 12 below Matilija Dam and from Canada Larga Creek (Stations 2 and 3) to the North Fork of the Matilija Creek (Stations 10 to 14). The greatest variation in physical/habitat scores during the five year period were found at Stations 0, 2 and 9. Station 0 is located just above the confluence of the Ventura River with the ocean and Station 2 is located just above the confluence of Canada Larga Creek with the Ventura River in the lower watershed. Station 9 is located on San Antonio Creek. The habitats at each of these sites were strongly influenced by the severity of the storm seasons preceding sampling. During the large storms of 2005 the stream beds and banks were scoured of vegetation and up stream sediments were deposited, decreasing the amount of instream cover that was present for BMI's. During relatively mild storm seasons the vegetative and instream cover at these sites remains unchanged. In contrast, the upper watershed (Station 12, 10, 11, 12 and 13) are characterized as much more stable owing to a streambed composed mostly of boulder, cobble and gravel, with banks that are, for the most part, covered with dense stands of vegetation.

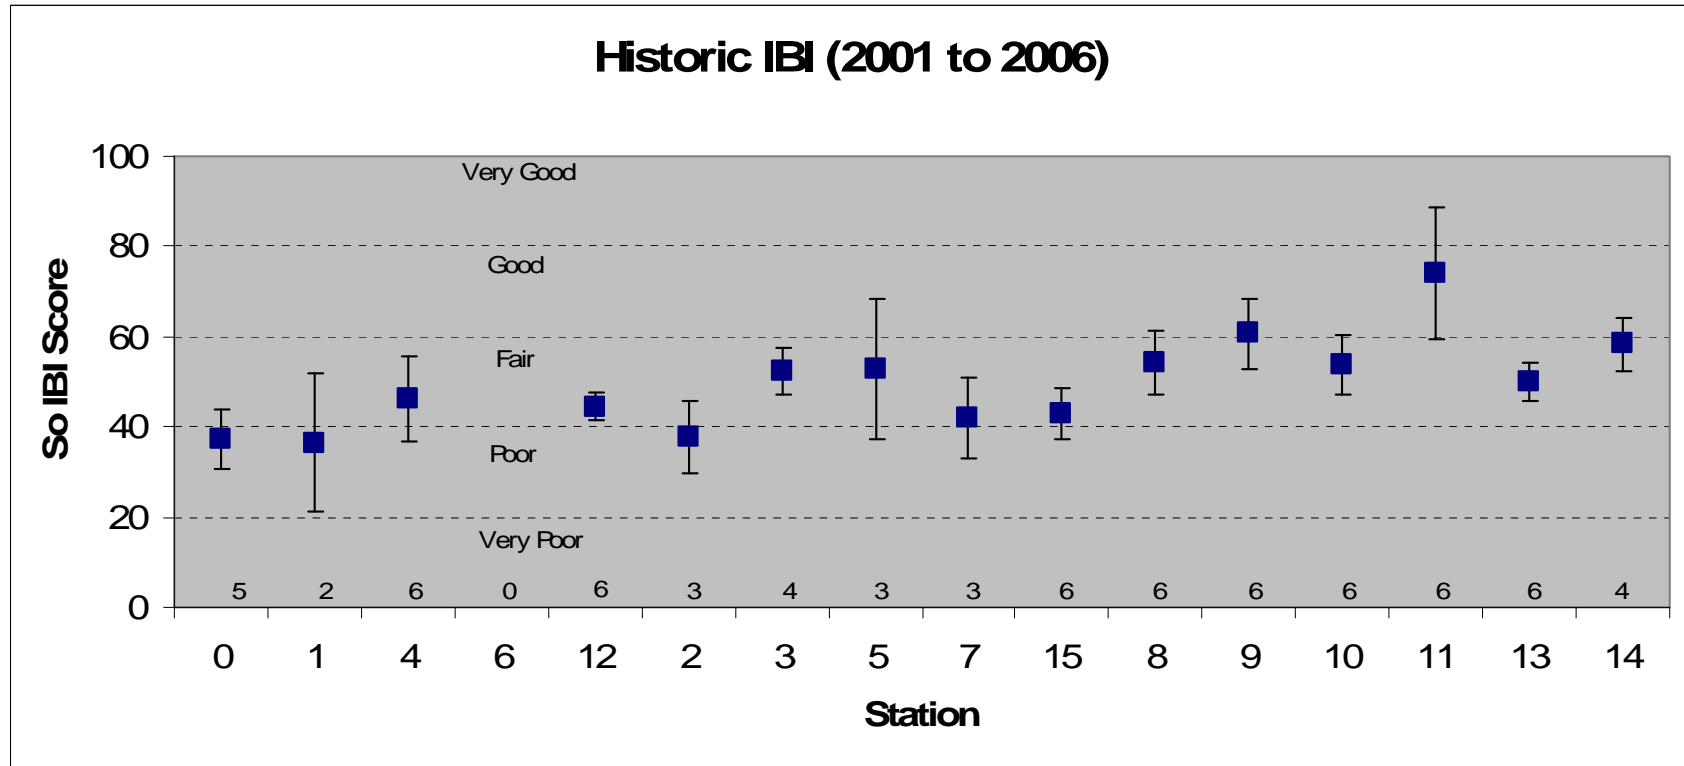
Figure 11. Average (\pm 95% CI) So CA IBI scores for sites in the Ventura River Watershed, 2001 to 2006. Number of years included in average (n) appears above station label.

During the six year period from 2001 to 2006 the average IBI scores for all sites, except Stations 0, 1 and 2, were in the fair or good range. The average scores for Stations 0, 1 (above the Main Street Bridge) and 2 (Canada Larga Creek), were slightly below the impairment threshold (39). IBI scores increased with elevation on the Ventura River, Canada Larga Creek (Stations 2 and 3) and San Antonio Creek (Stations 7, 15, 8 and 9). The greatest average IBI score during the five year period was at Station 11 on the North Fork of the Matilija.

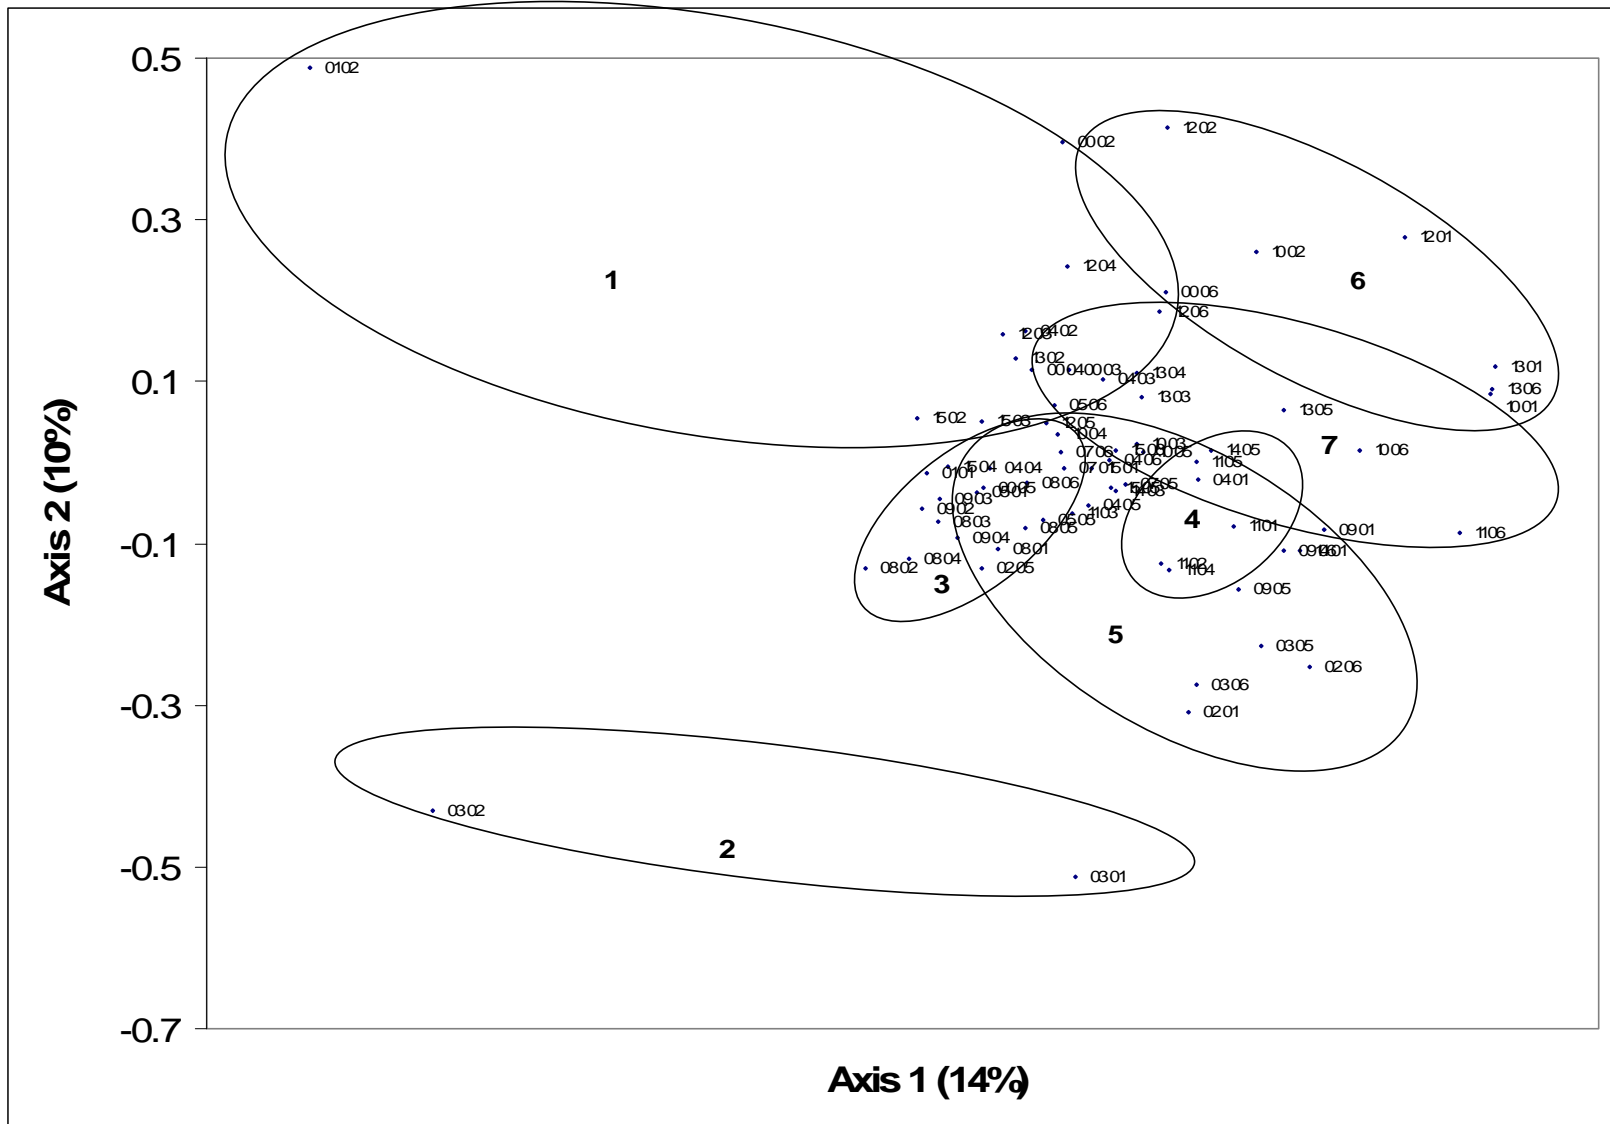
Figure 13. Ordination space plots for axis 1 vs axis 2, with cluster groups circled and stations identified.

Axis 1 explained 14% of the variation in community structure and seemed to separate stations by geographical location in the watershed (Figure 13). Station 1, located near the ocean (moved to current location at Station 0 in 2002) was composed of the most different assemblage during the six year period. Each of the other station groups aligned along axis 1 lower to upper watershed. Axis 2 explained 10% of the environmental variation and separated Station group 2 from the other groups probably due to the high relative abundance of the stonefly, *Malkena sp.*, which was only found in very low numbers at upper watershed sites.
