*Ventura Countywide
Stormwater Quality
Management Program*

Ventura Countywide Stormwater Quality
Management Program Annual Report

Attachment E – TMDL Reports (2/3)

Revolon Slough/Beardsley Wash Trash TMDL TMRP/MFAC 2017-2018 Annual Report

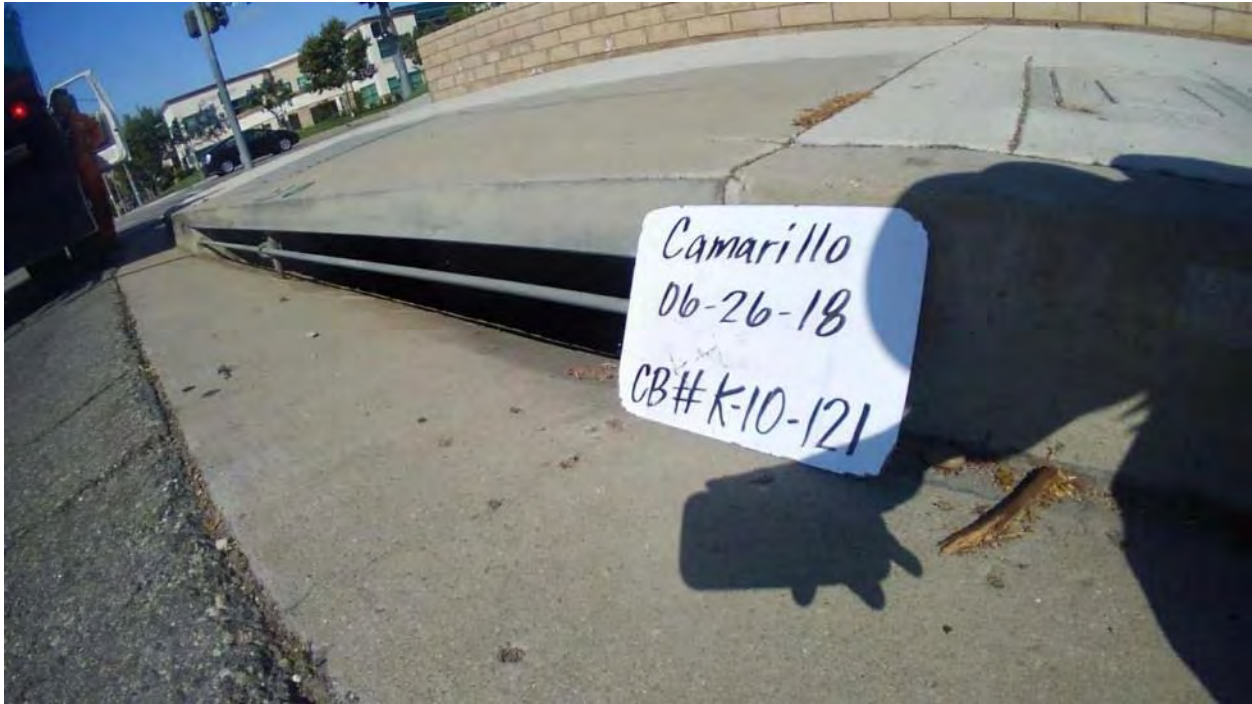
Figure 1. Catch Basin # K-10-121 view from street in June, 2018

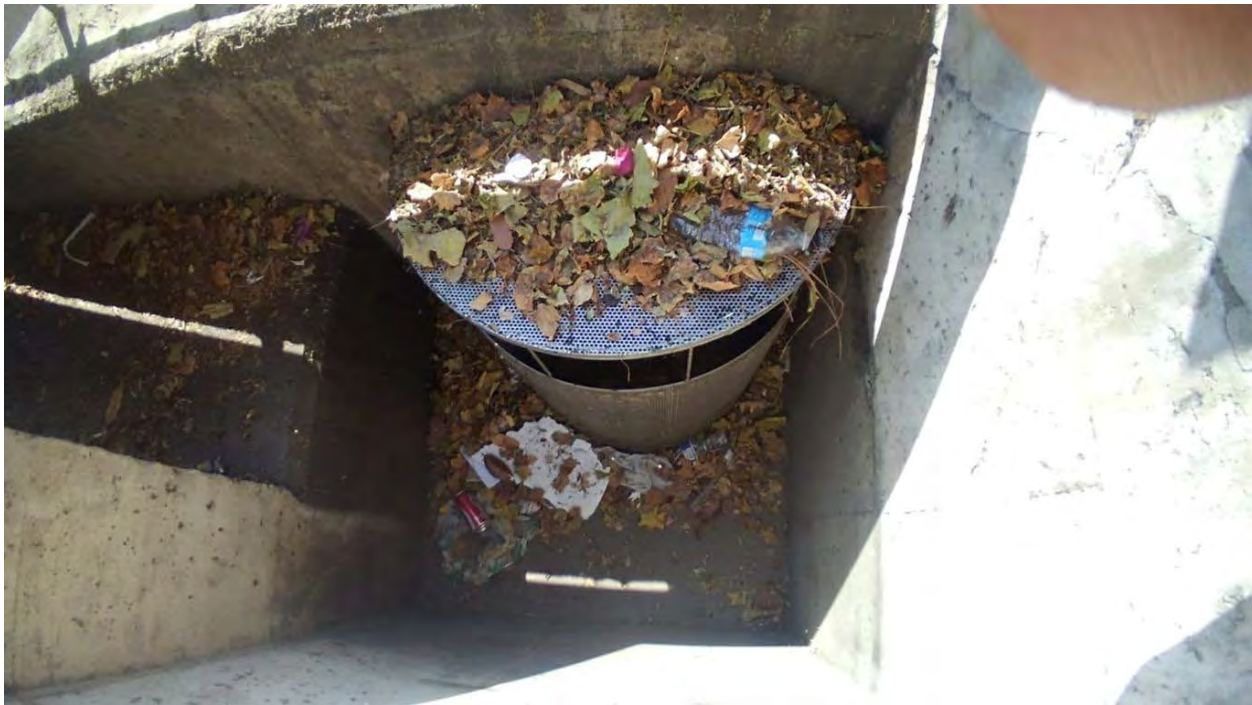
Figure 2. Full capture device before cleaning in June, 2018

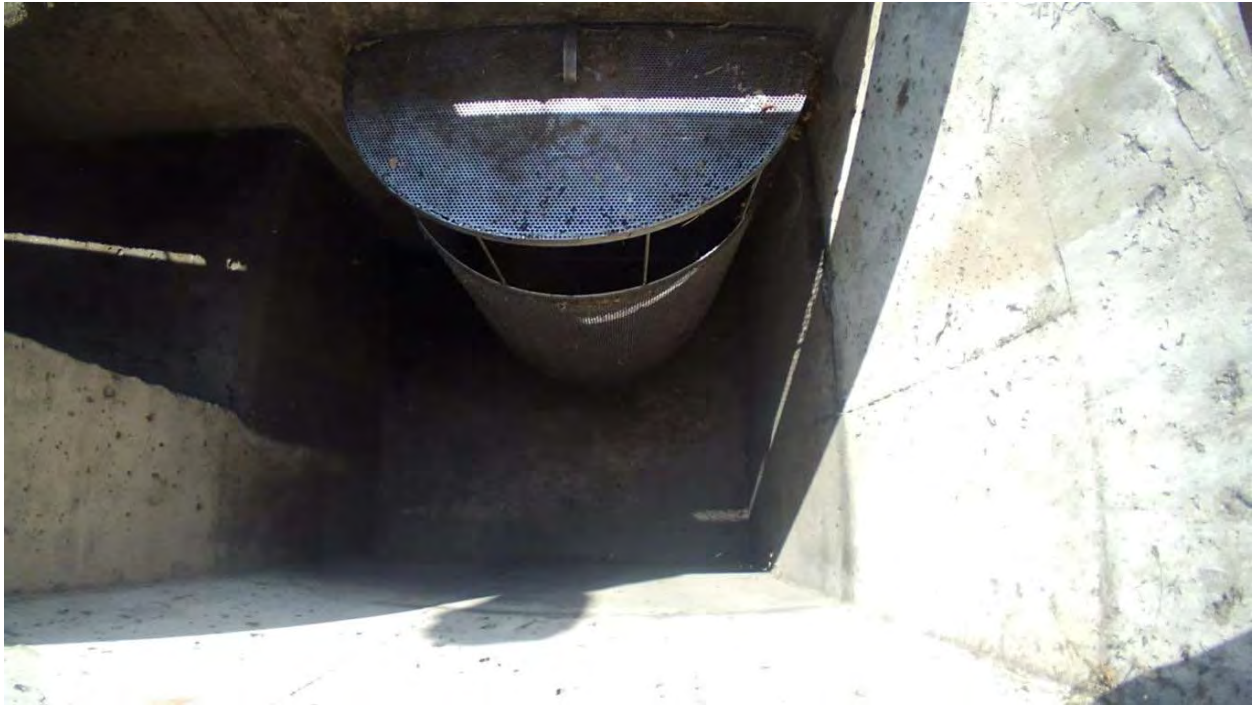
Figure 3. Full capture device after cleaning in June, 2018

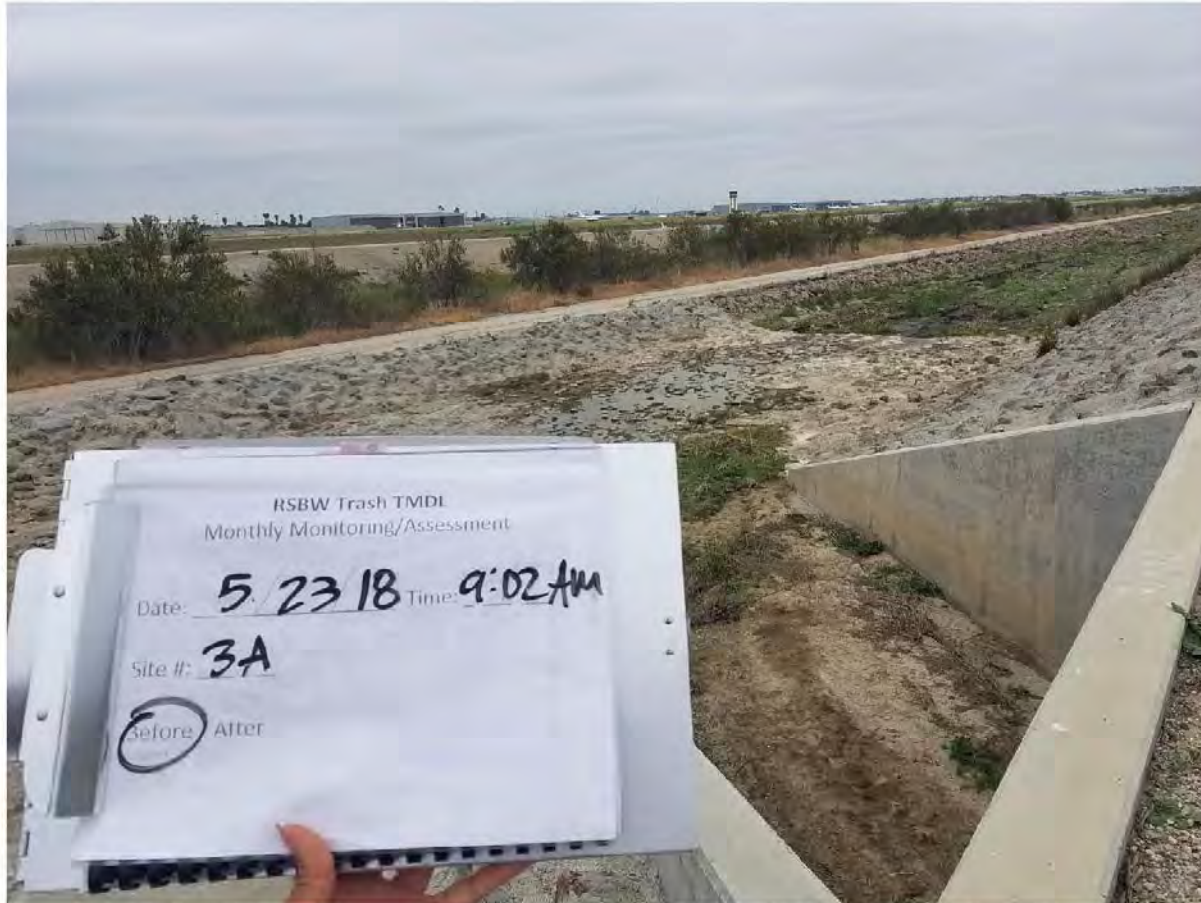
Minimal debris present – Category 1 (less than 10 pieces)

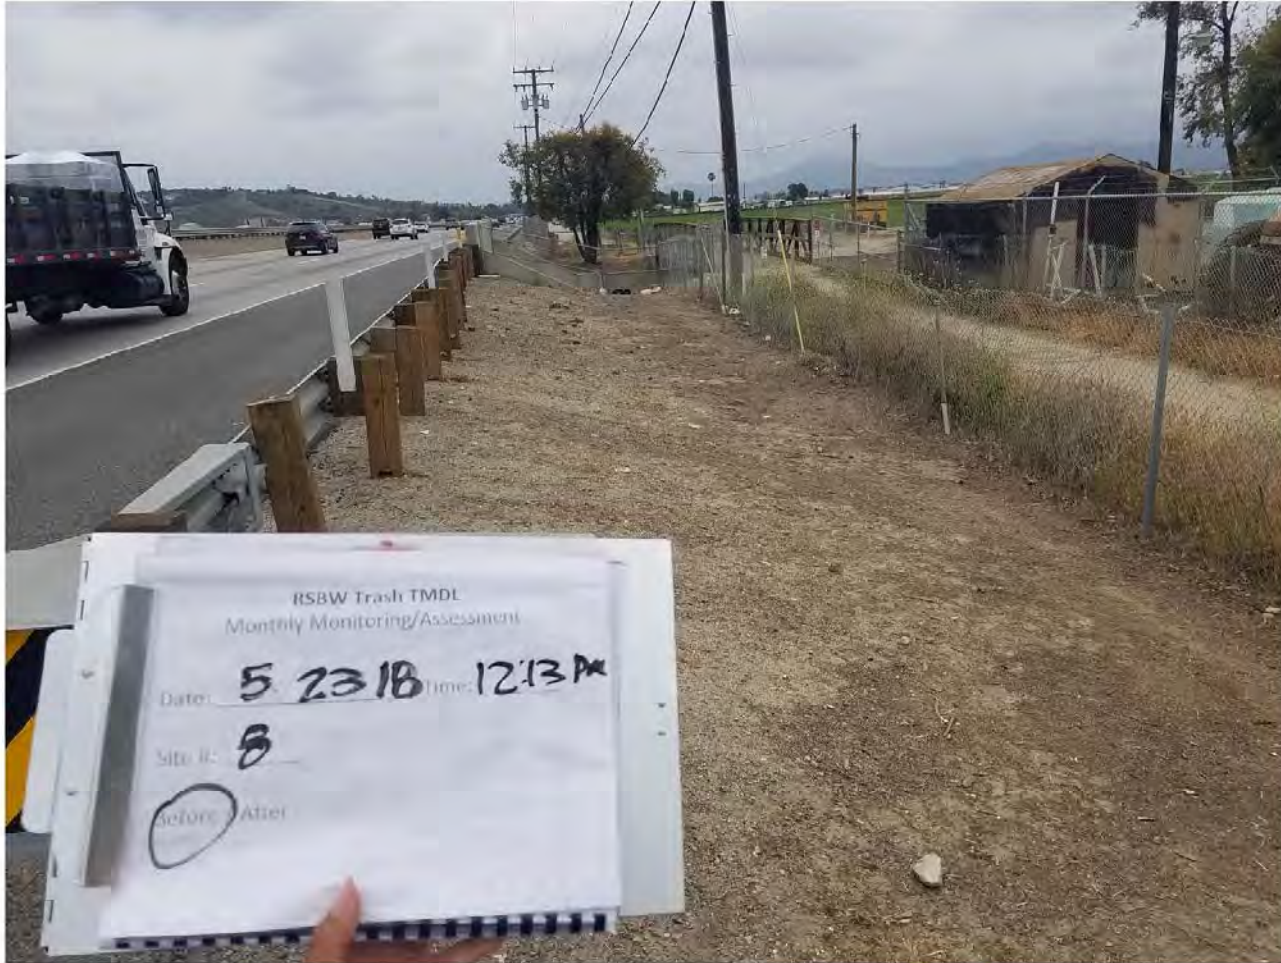
Minimal debris (Category 1 less than 10 pieces)

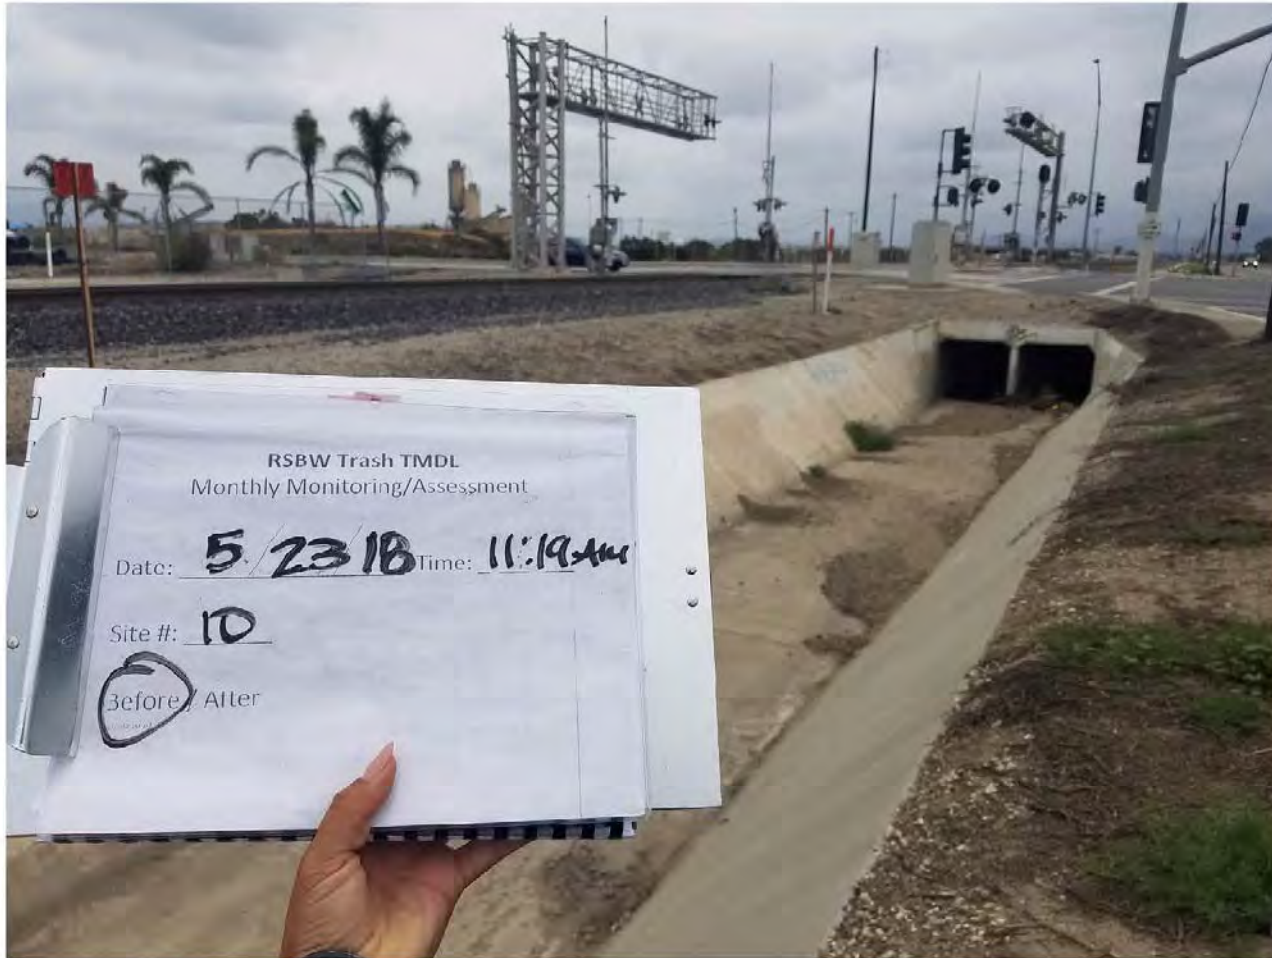
Minimal debris (Category 1 less than 10 pieces)

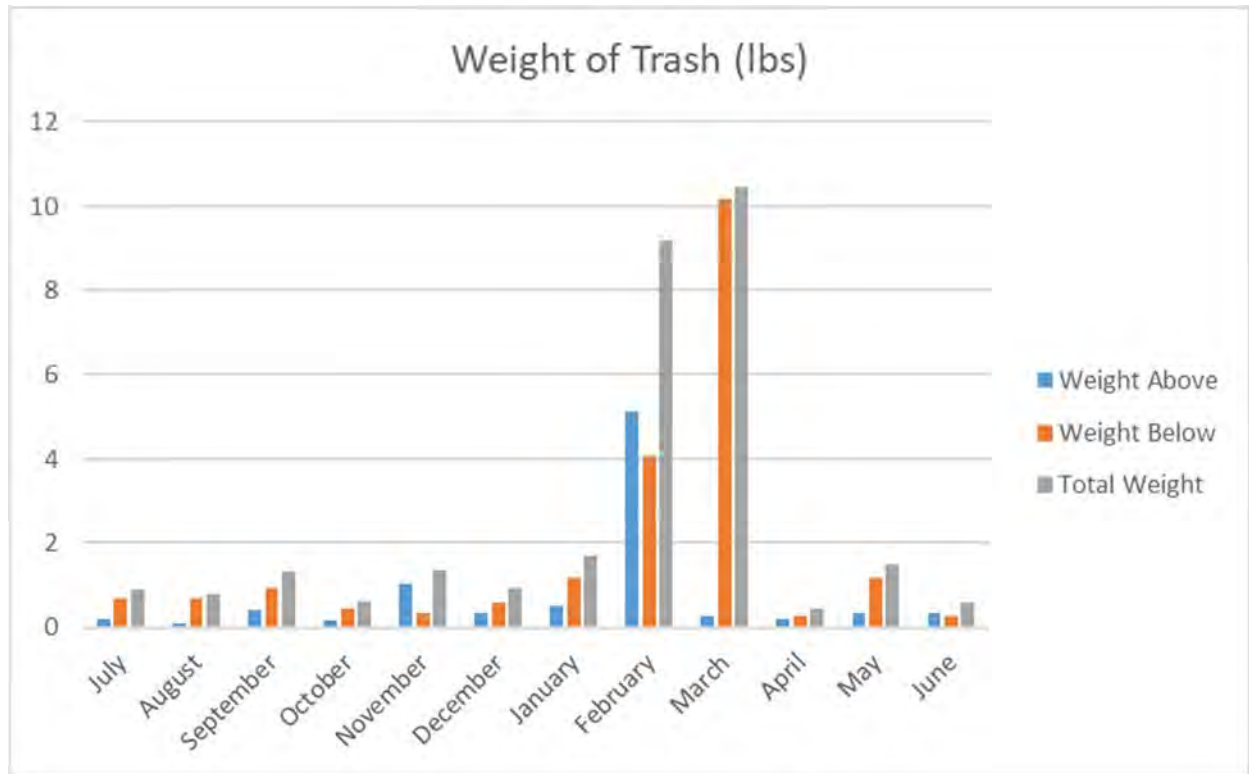
Figure 3. Weight of Trash Collected at MC1

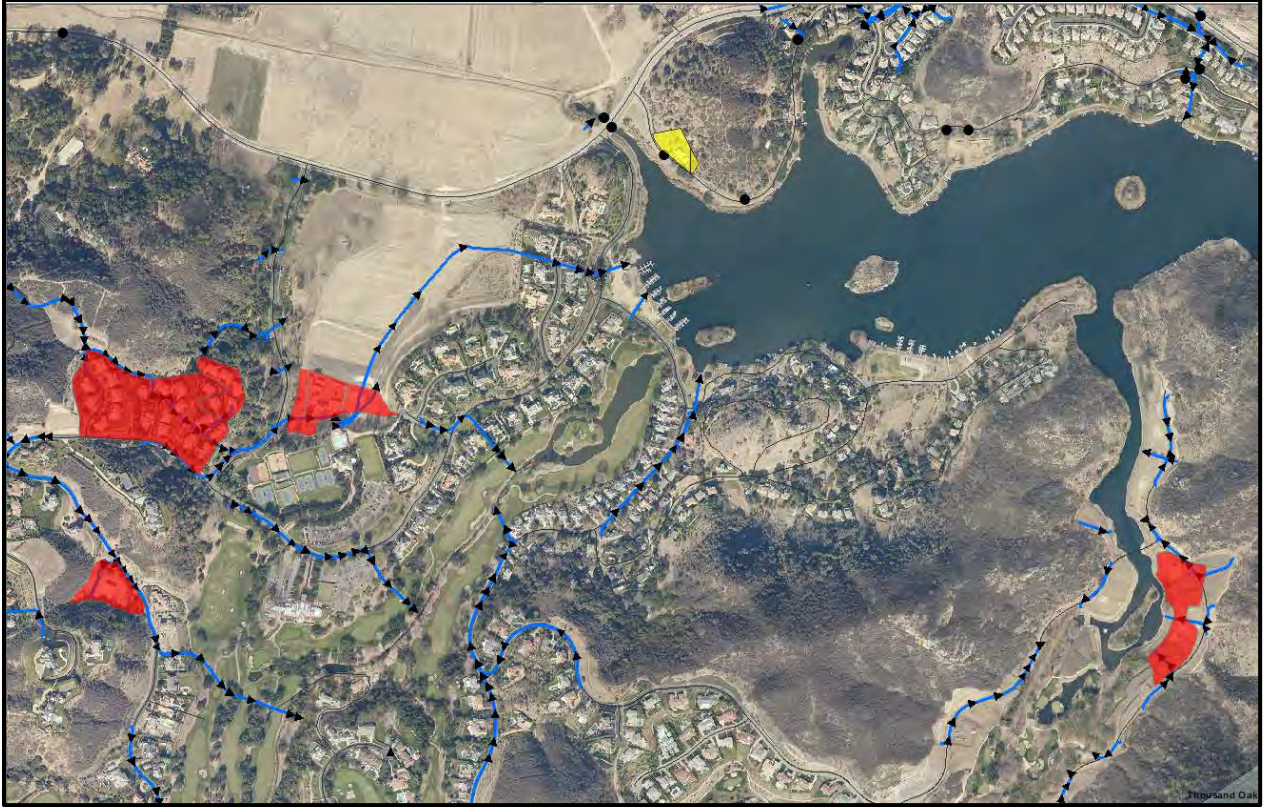
Outside of the Oak Park urban area, the only other priority land uses identified from the SCAG 2005 data were mostly private areas within the Lake Sherwood subwatershed, identified as either Commercial, Industrial, or High Density land uses. These red highlighted areas depicted in **Figure 3** include a private service yard, residential duplexes, a storage yard, and low rise office buildings under Lake Sherwood Homeowners Association’s jurisdiction with no discharge into County storm drain system, but direct discharge into Lake Sherwood. The yellow highlighted area indicates County’s Fire Station, which as discussed above, is not a Commercial land use and does not generate high volumes of trash.

Figure 3- Priority Land Use Areas Outside of Oak Park Urban Area

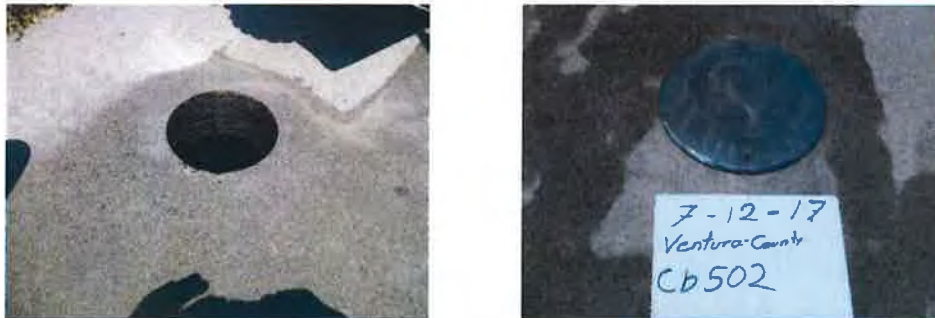
vandal proof screws that covers each maintenance access port. The transportation roads O&M District 1 & 2 representatives have been provided with extra screws as well as customized bits for operating them.

Figure 2 - Maintenance Access Port & Lid

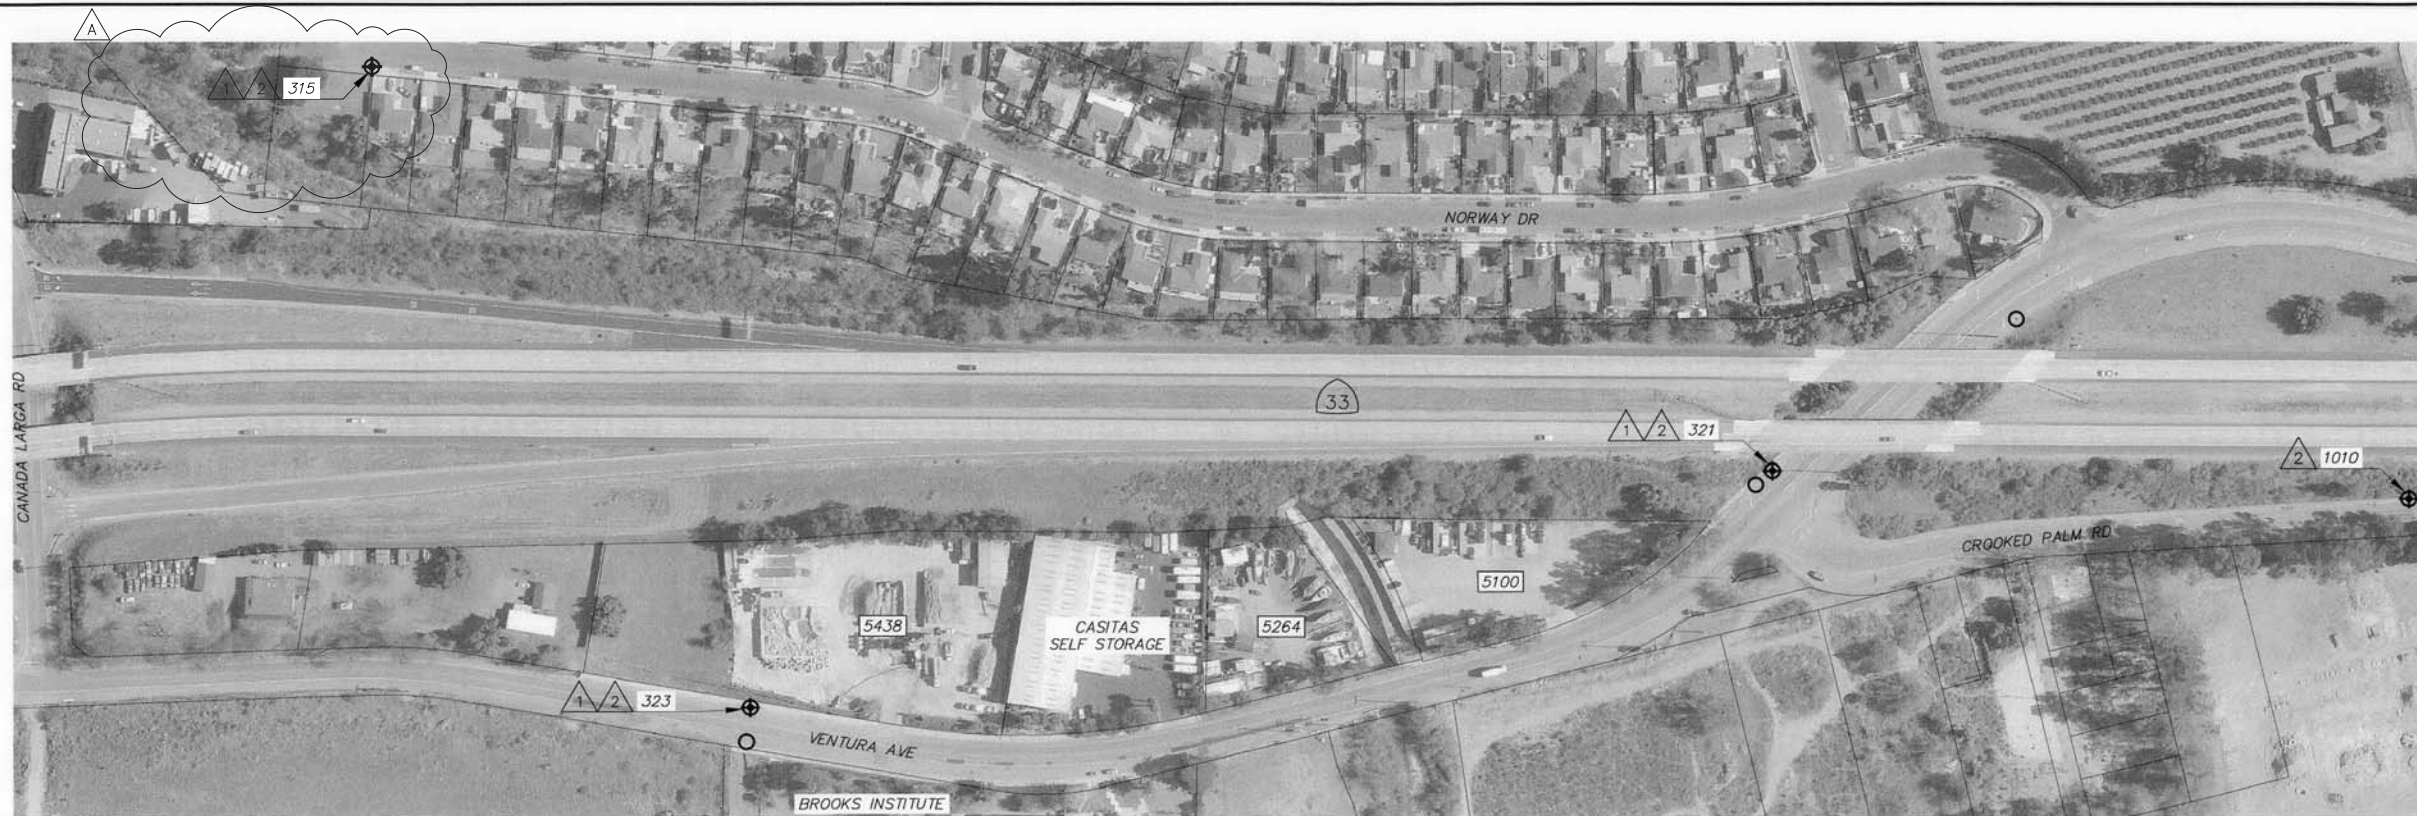
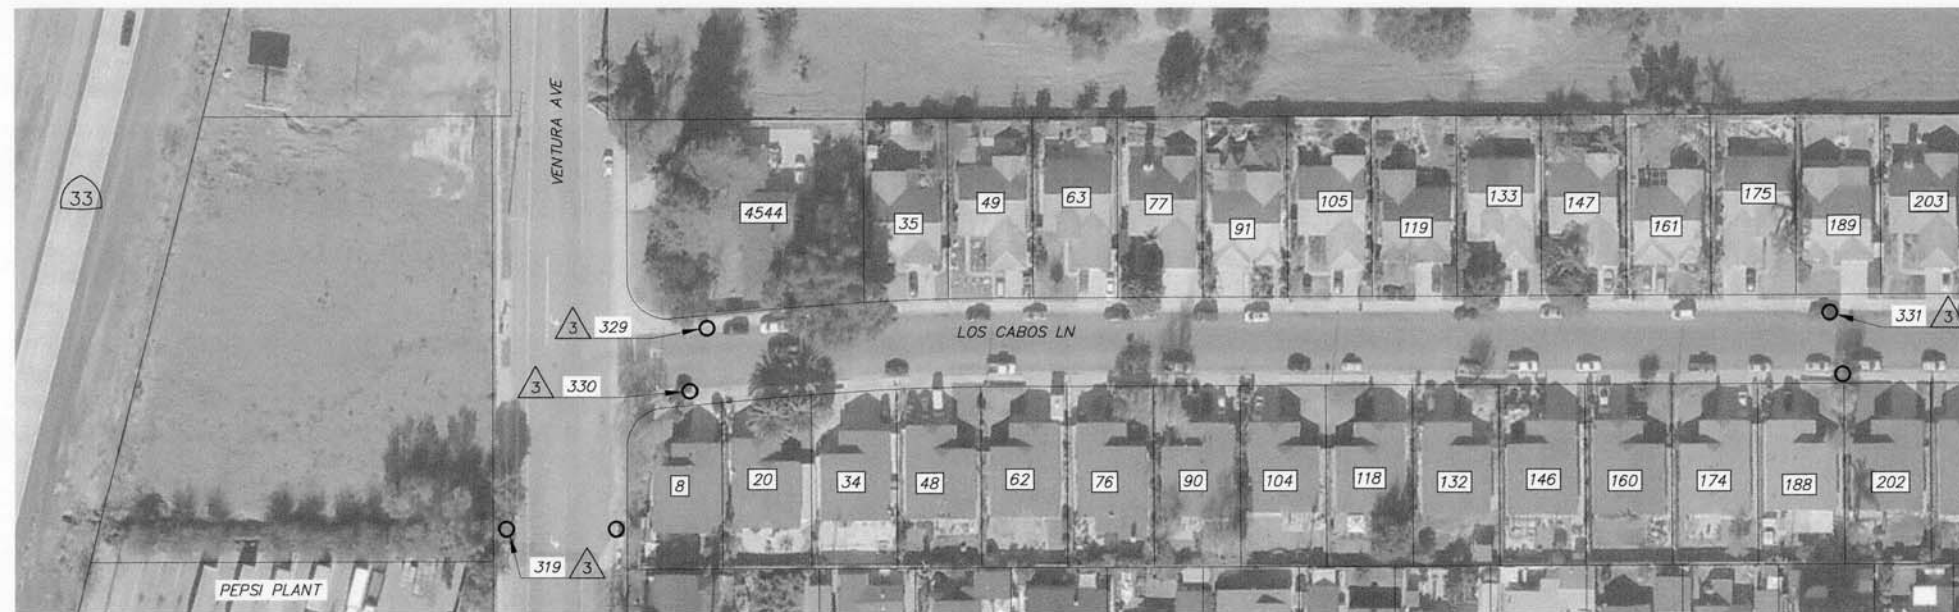
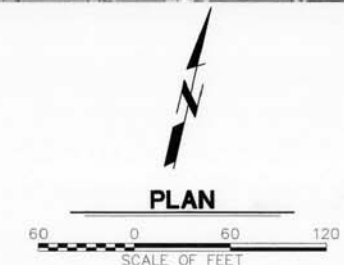
SHEET 1
OF 5
DRAWING NO.
Y-4-092

1. REMOVE AND DISPOSE OF EXISTING DAMAGED SEMI-CIRCULAR FULL CAPTURE TRASH DEVICE. (3)
2. CONSTRUCT FULL CAPTURE TRASH DEVICE FOR THE OUTLET PIPE WITHIN THE EXISTING CATCH BASIN. CATCH BASIN INFORMATION ON SHEET 5 TO BE VERIFIED BY CONTRACTOR IN FIELD. (3)
3. CONSTRUCT NEW CATCH BASIN MAINTENANCE ACCESS PORT PER. (A/5) (4)

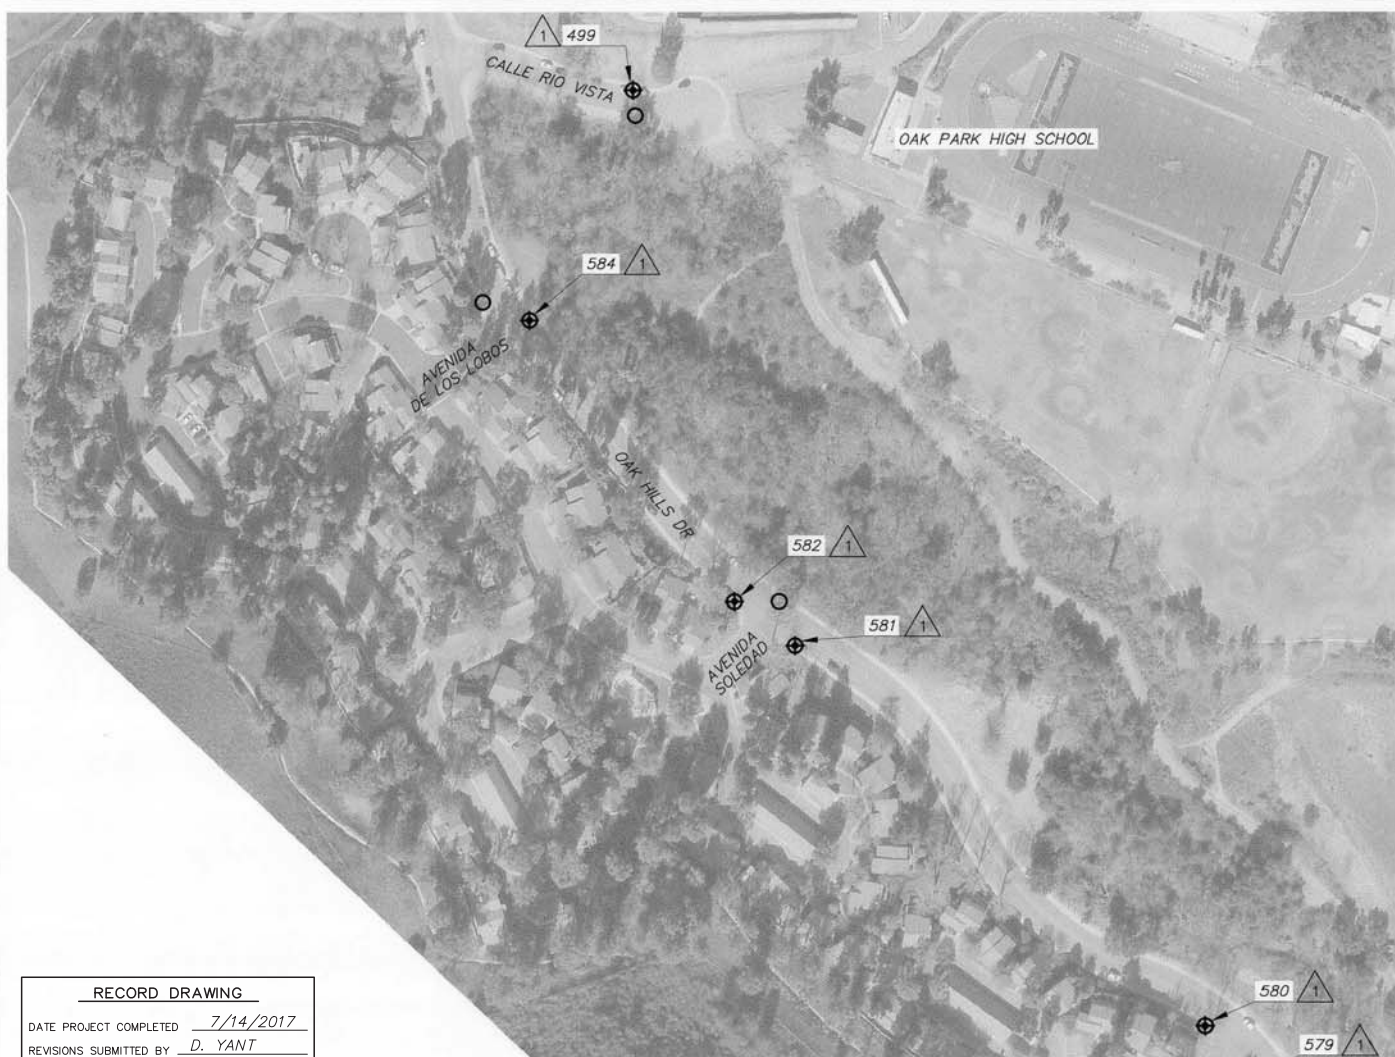
SHEET 2
OF 5
DRAWING NO.
Y-4-093

- NOTES:**
- CONSTRUCT FULL CAPTURE TRASH DEVICE FOR THE OUTLET PIPE WITHIN THE EXISTING CATCH BASIN. CATCH BASIN INFORMATION ON SHEET 5 TO BE VERIFIED BY CONTRACTOR IN FIELD. (3)
 - CONSTRUCT NEW CATCH BASIN MAINTENANCE ACCESS PORT PER: (A/5/4)
