*Ventura Countywide  
Stormwater Quality  
Management Program*

Ventura Countywide Stormwater Quality  
Management Program Annual Report  
**Attachment E: TMDL Annual Reports**  
**Part 1 of 2**

## **Attachment E: Total Maximum Daily Load Data and Reports Part 1 of 2**

**Revlon Slough and Beardsley Wash Trash TMDL  
City of Oxnard 2013 Annual Report**

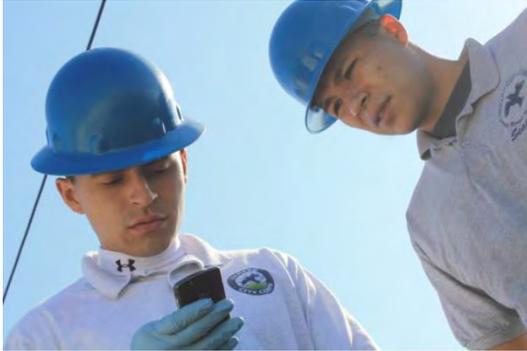
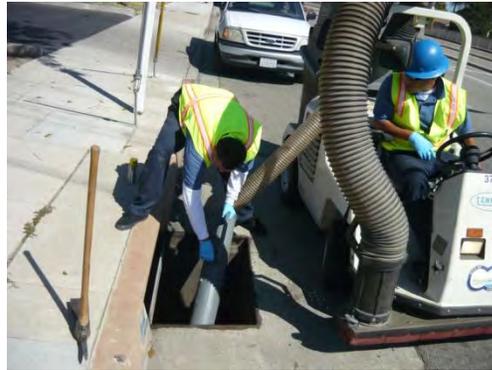
These monitoring methodologies were moved upstream of the open channels this year when City Corps crews were engaged to perform the catch basin surveys and cleanings. Again, crews took GPS points for the catch basins, and a drop-down menu allowed them to quickly categorize percent trash, leaves, and sediment in the catch basin prior to maintenance.

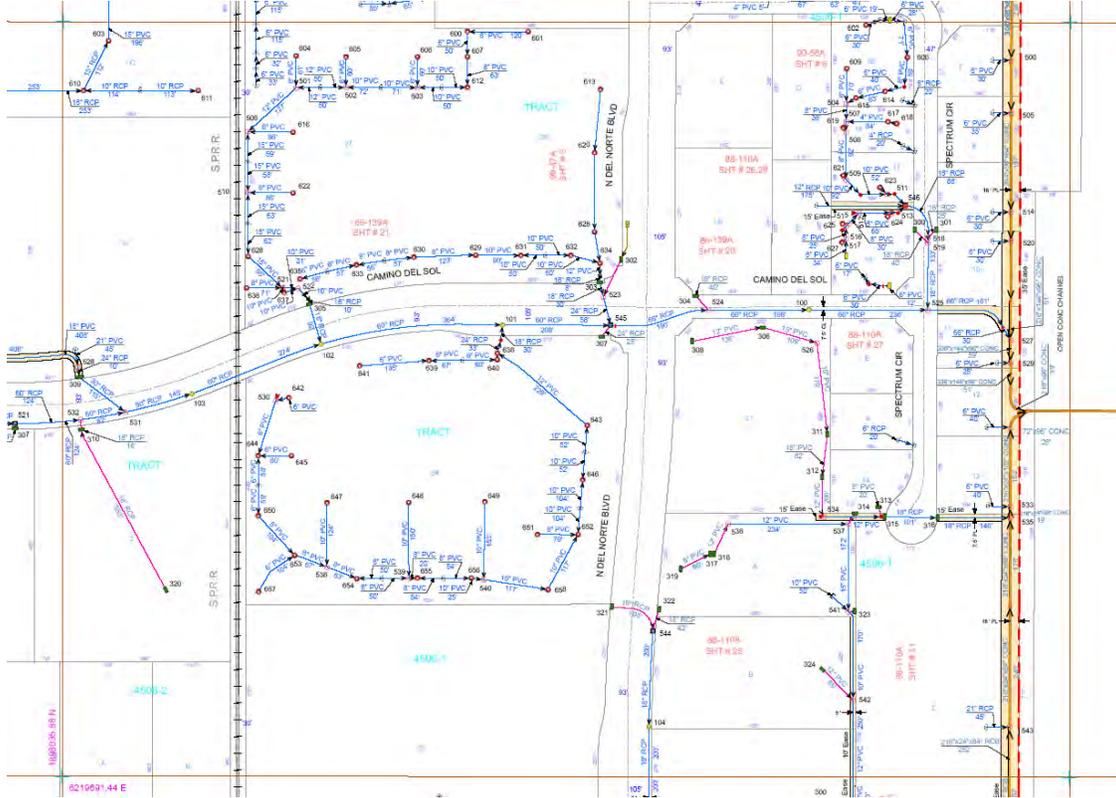
Sturgis Drain receives mixed flows from commercial / industrial and agricultural areas. The drainage area is shown below:

None of these catch basins are currently Priority A.

The proposed FreshCreek device would have captured the joined north/south flows of the channel as they transition to the east, and to Revolon Slough. The sub-drainage area is now proposed for catch basin inserts (see Section 3.1 above).

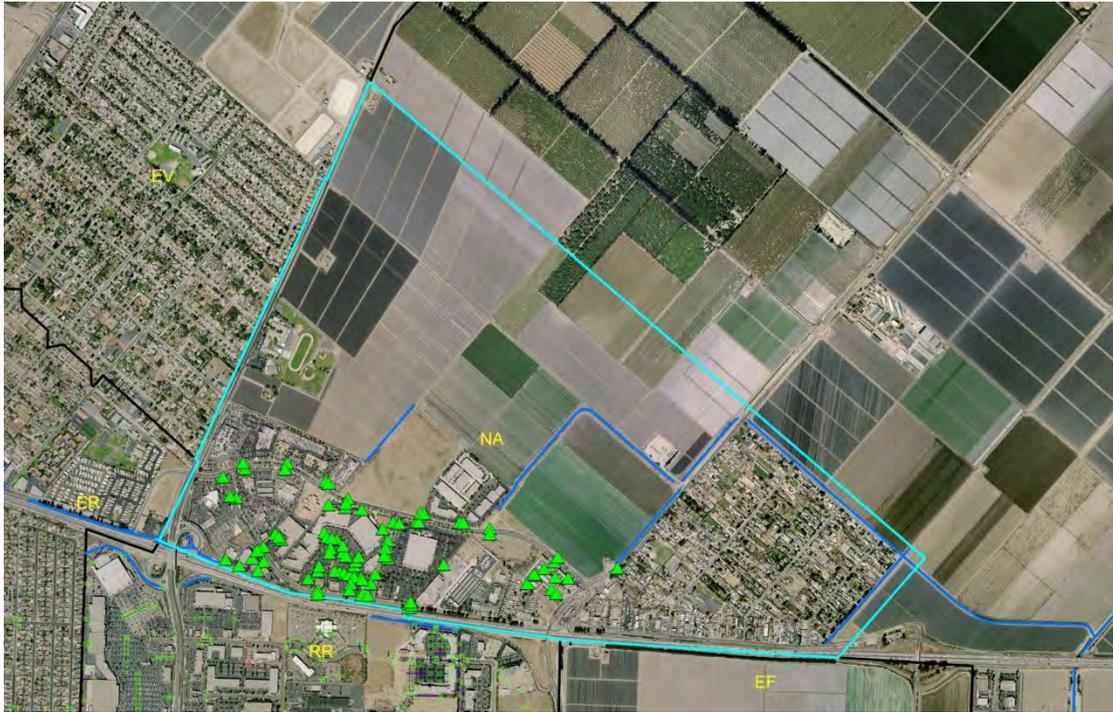
The Nyeland Drain receives commercial / industrial flows before entering agricultural drainage areas. The Nyeland drainage area is shown below:

The proposed FreshCreek device would have captured the joined north-bound flows as they daylight. Catch basin inserts are now proposed, as noted in the map above

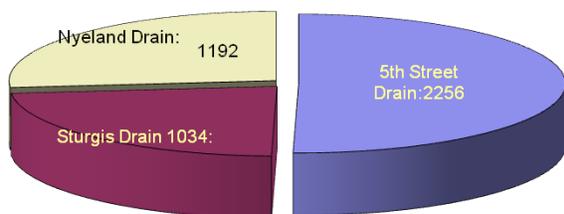
**Total Trash Found  
2009-2013**

From 2009-2013 the largest numbers of trash were found in the 5<sup>th</sup> Street Drain. This is probably due to the large amount of vehicular traffic. 5<sup>th</sup> Street Drain had the closest percentages between plastic/Styrofoam and paper classes of trash, which may also indicate trash thrown or blown from vehicles. Below is a comparison between long-term trash numbers and 2013 trash collection numbers for the three channels.

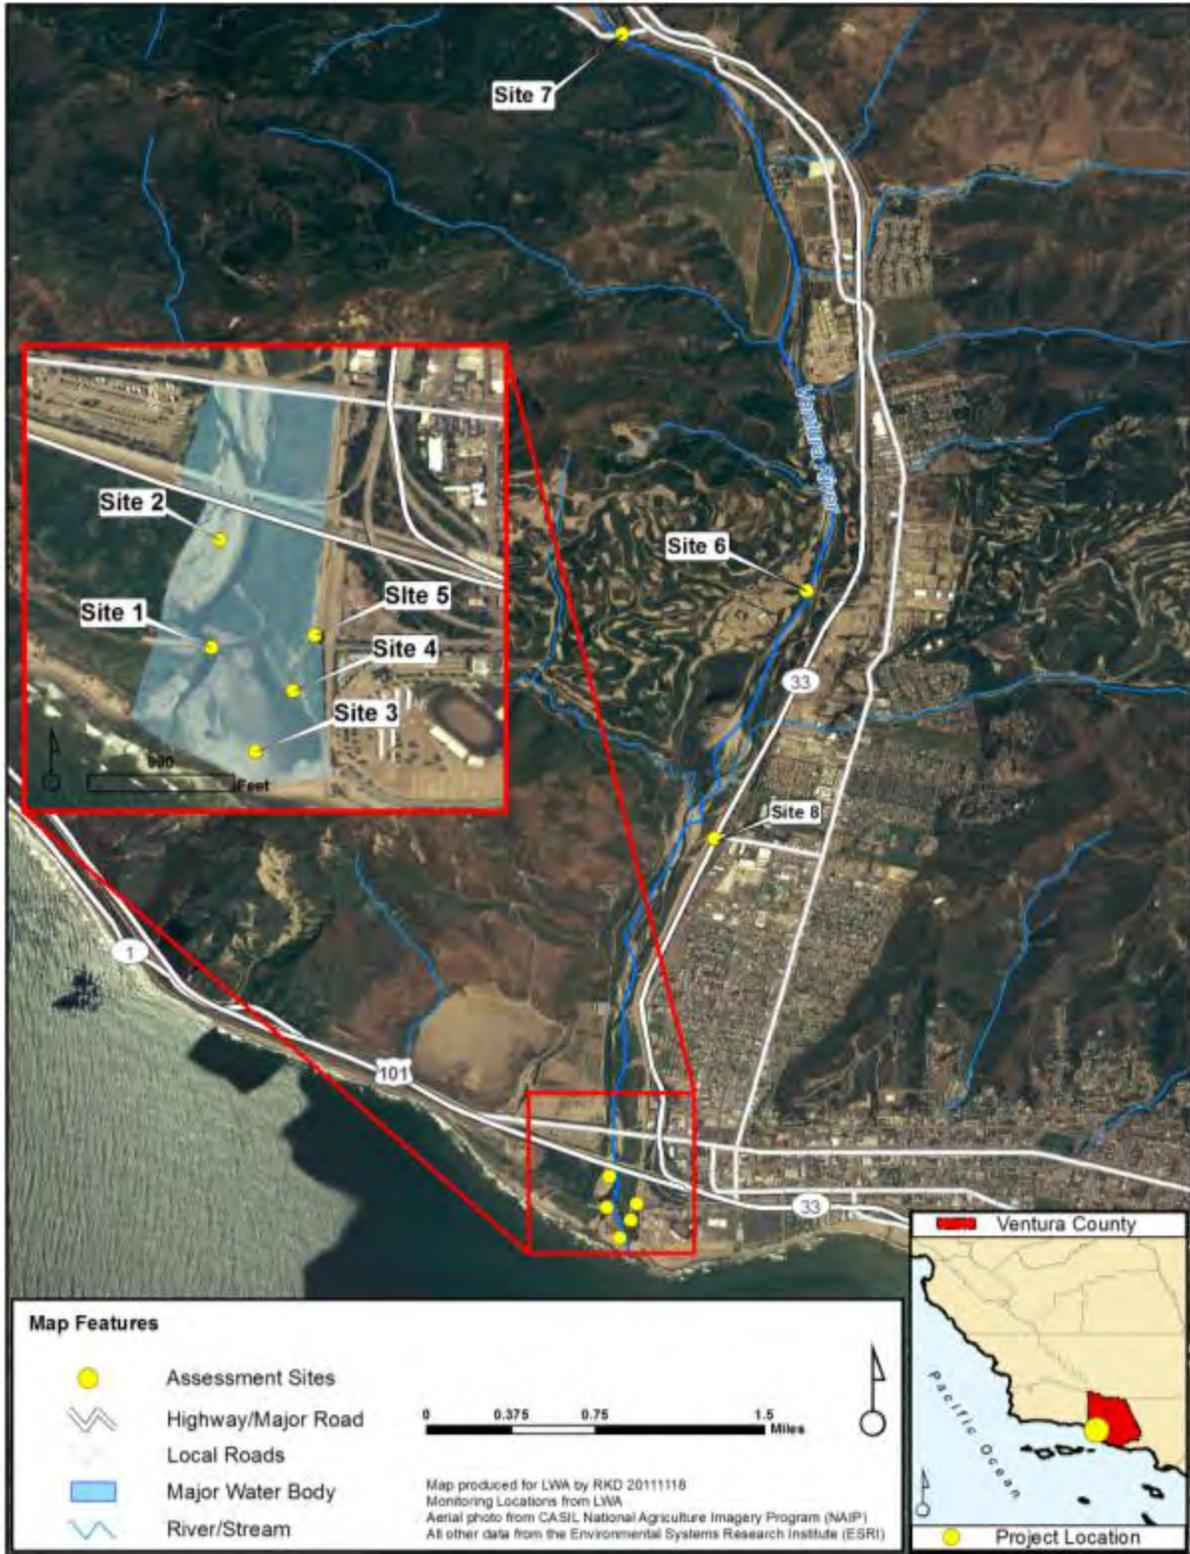
Figure 1. TMRP MFAC Assessment Site Locations

- Site 1: Lower Ventura River Estuary Below U.S. 101 Freeway (MFAC)
- Site 2: Upper Ventura River Estuary Below U.S. 101 Freeway (MFAC)
- Site 3: Sandy beach area between the estuary and the ocean and along the bike path (MFAC)
- Site 4: Ventura County Fairgrounds: defined as the area where water is discharged from the catch basin to the estuary (MFAC)
- Site 5: Front Street Storm drain (MFAC)
- Site 6: Ventura River at State Freeway 33 and Shell Road
- Site 7: Ventura River near State Freeway 33 at Casitas Vista Road (above City of Ventura)
- Site 8: Caltrans site on State Freeway 33 near Stanley Avenue on-ramp

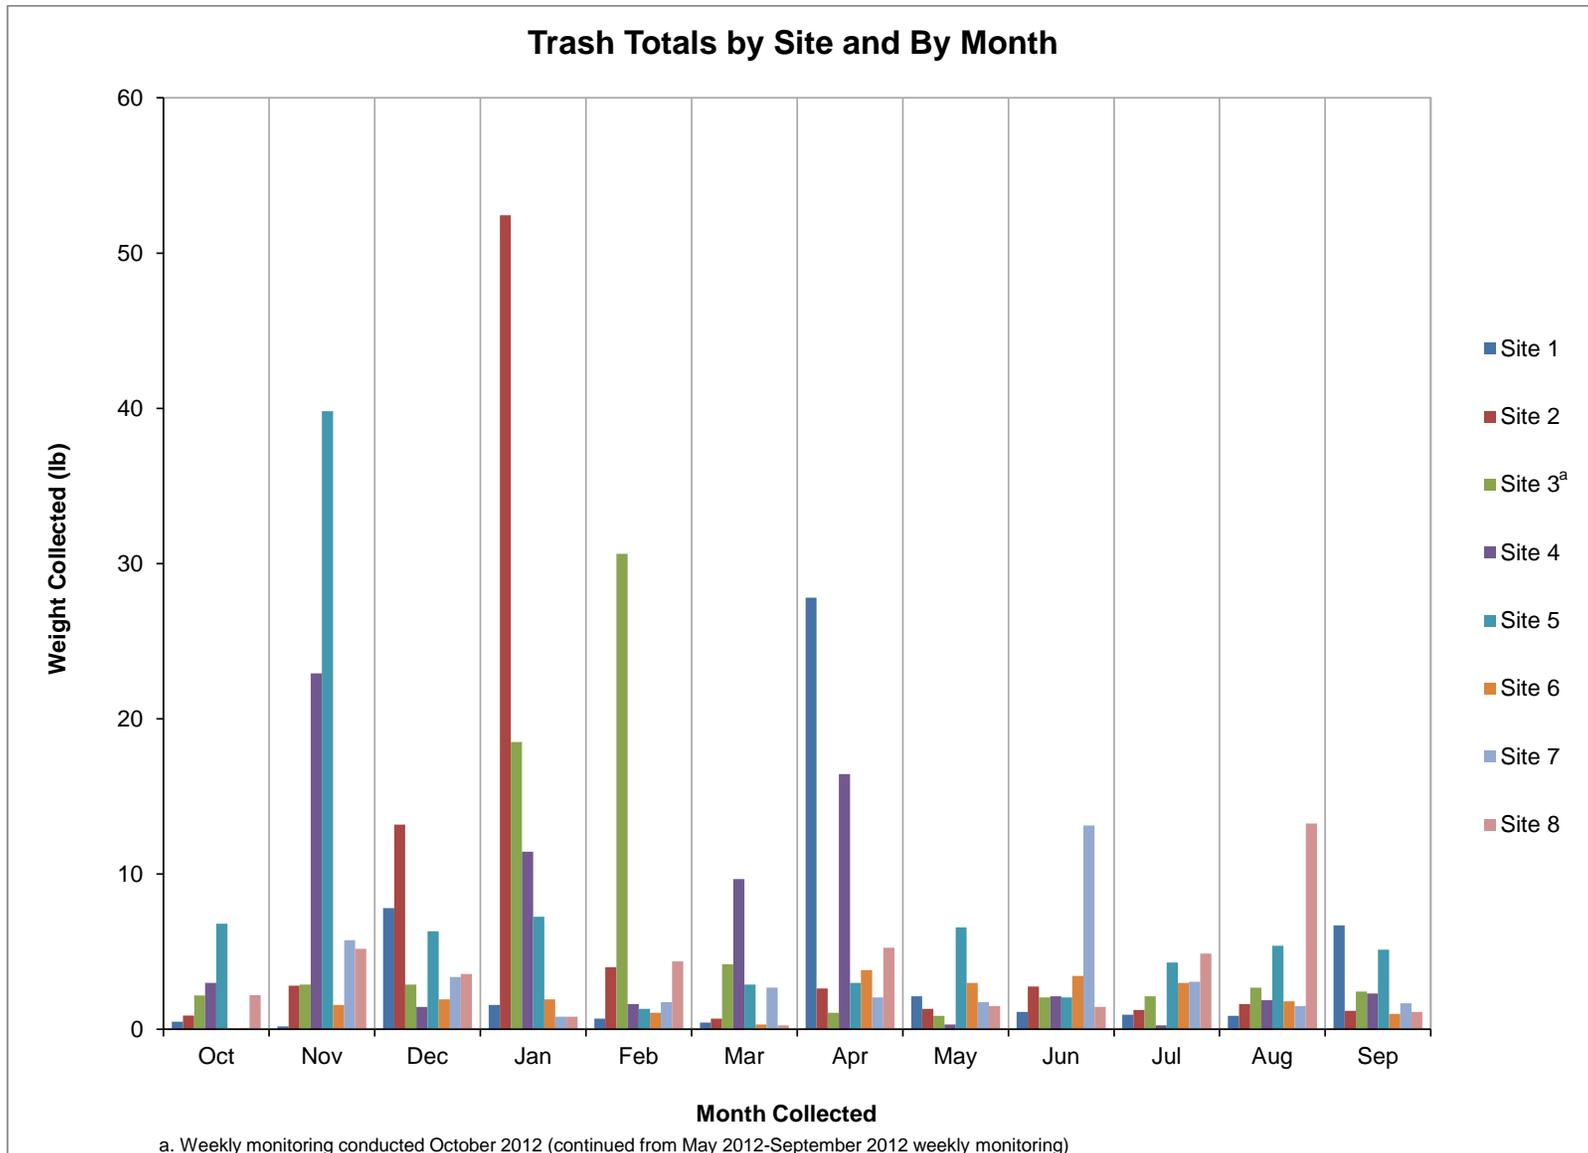
**Figure 2. Weight of Trash Collected per Month per Site (October 2012 – September 2013)**

During the fourth year of monitoring, approximately 476.6 pounds of total trash were collected. Elevated levels of trash were found primarily during January 2013 and November 2012, and also during April 2013. In addition, Site 5, Site 2, Site 4, and Site 3 had higher amounts of trash compared with the other monitored sites, although the collection frequency at Site 3 was slightly greater than that performed at the other sites. **Table 4** lists the total weight of trash collected per site and per month for the 2012-2013 monitoring year.

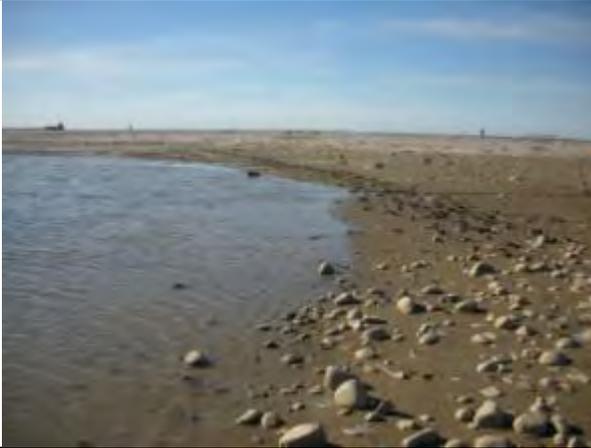
<p><b>Site 1 - Lower Ventura River Estuary</b></p> <p>This site is located below the U.S. 101 Freeway on the southwest side of the estuary. The site consists of beach areas and the open water areas of the intermittent lagoon that develops adjacent to the main water body of the Estuary.</p> <p><u>GPS Coordinates:</u> Lat: 34.27697 Lon: -119.308593</p>

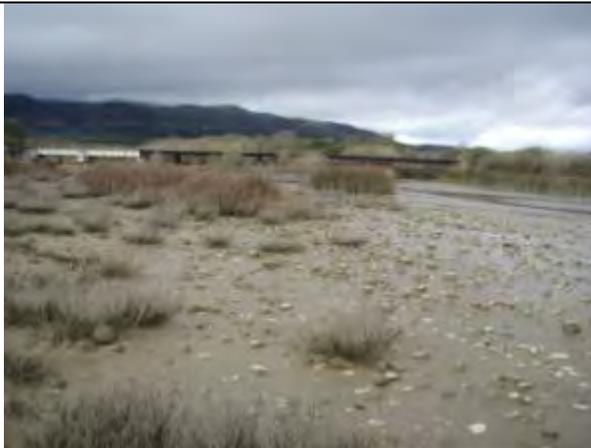
<p><b>Site 2 - Upper Ventura River Estuary</b></p> <p>This site is located below the U.S. 101 Freeway on the west side of the estuary. The site consists of mud flats, open water, and emergent vegetation depending on water levels.</p> <p><u>GPS Coordinates:</u> Lat: 34.278968 Lon: -119.308874</p>

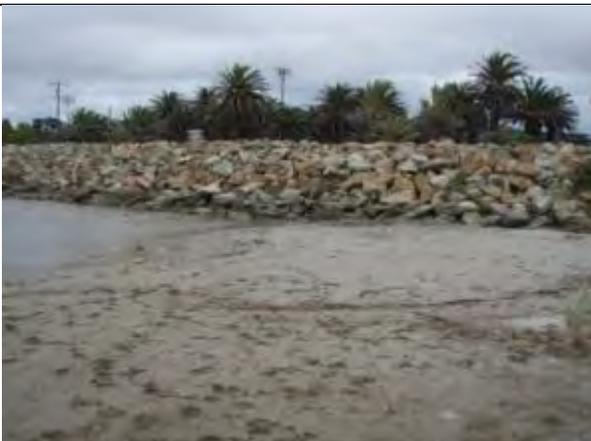
<p><b>Site 3 - Sandy Beach Area between the Ocean and the Estuary</b></p> <p>This site consists of the beach areas between the end of the estuary's main water body and the ocean as well as the rip rap along the bike path on the east side of the Estuary.</p> <p><u>GPS Coordinates:</u> Lat: 34.275035 Lon: -119.308217</p>

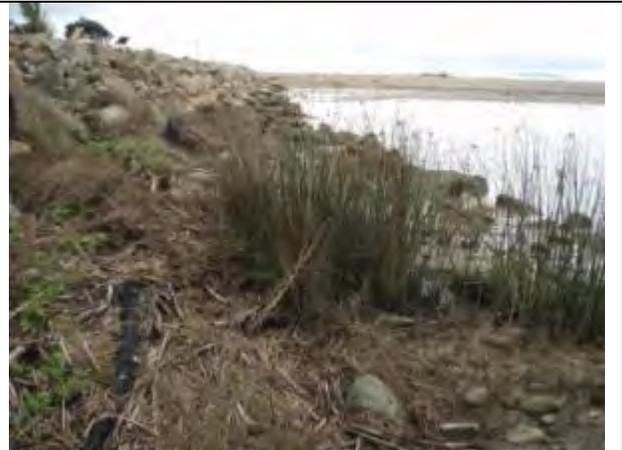
**Site 4 - Ventura County Fairgrounds**

This site consists of the rip rap, vegetation, and portions of the estuary's main water body near where stormwater is discharged from a catch basin into the Estuary on the east side of the Ventura River and runs for approximately 100 feet.

Site 4 had the third highest total trash weight of all the sites. Site 4 is located between Site 3 and Site 5 on the other side of the bike path from the Ventura County Fairgrounds and consists of rip rap, vegetation, and portions of the estuary's main water body. As with Site 3, this area has high visitation due to its proximity to the bike path and the beach. In addition, the majority of the trash is found within the rip rap along the bank of the estuary and often includes food- and drink-related waste, and other items indicating that the trash is from people using the rip rap as a place to associate.

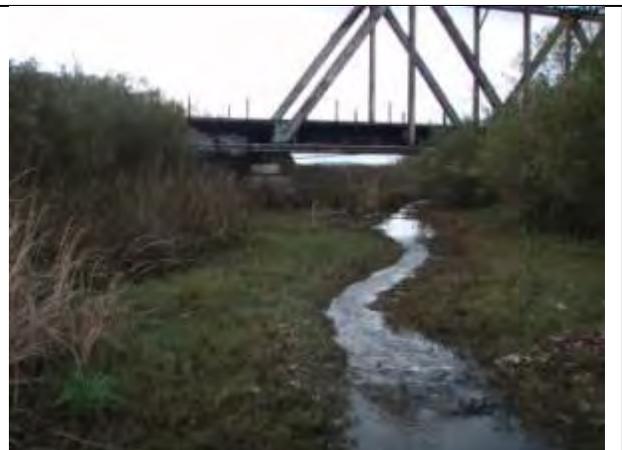
**Site 5 - Front Street Storm Drain**

This site is located north of the train track trestle and begins at the base of the Front Street storm drain (bottom left corner of the picture) and consists of the area inside the channel as well as the vegetation along the sides of the channel and runs north-south for approximately 100 feet.

significant amount of trash buried in the stream substrate just below the Front Street Storm Drain that is continually being exposed due to erosion, and that its existence may lead to the elevated amounts of trash found at the site.

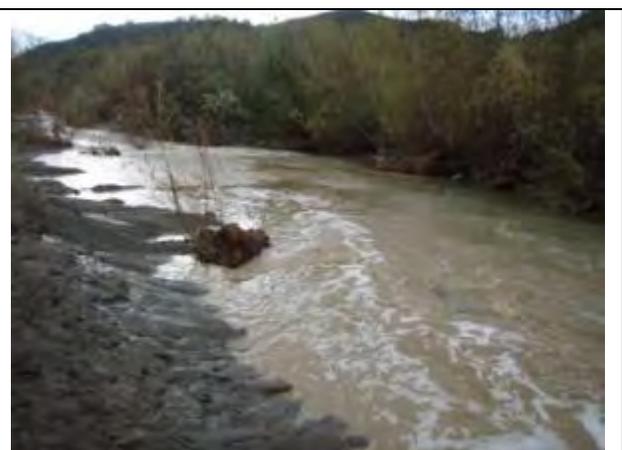
**Site 6 - Ventura River at State Freeway 33 and Shell Road**

This site consists of both banks along the Ventura River as well as the accessible portions of the river for approximately 100 feet running upstream to downstream.

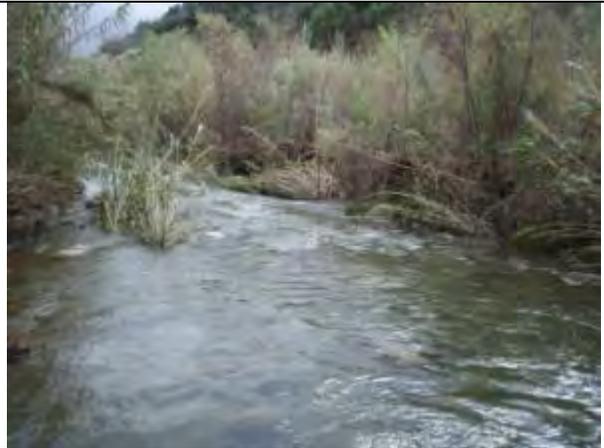
**Site 7 - Ventura River at State Freeway 33  
at Casitas Vista Road**

This site consists of the accessible portions of the Ventura River as well as both bank areas along the river for approximately 100 feet upstream to downstream. This site also consists of the rip rap on top of the bank on the east side of the river.

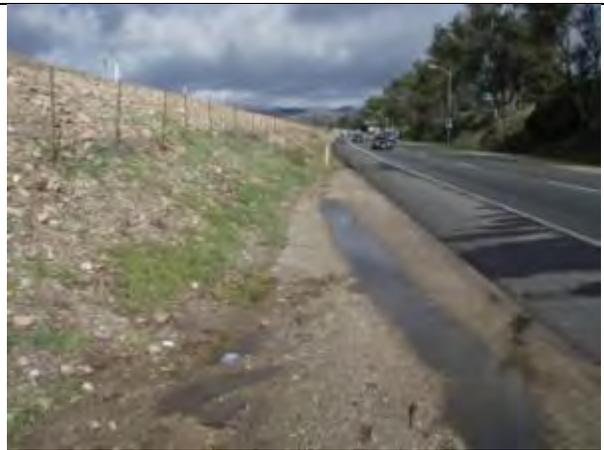
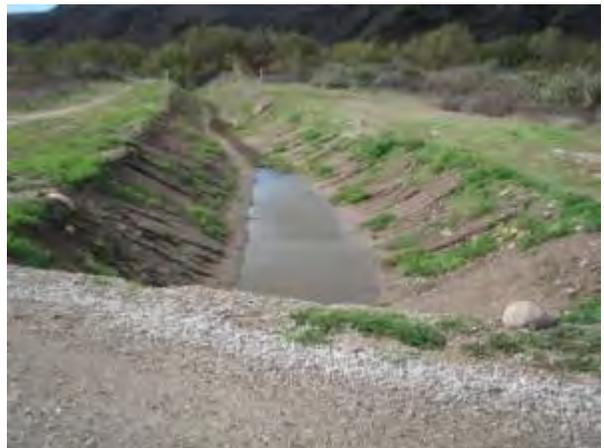
**Site 8 - Caltrans Site on State Freeway 33**

This site consists of the area south of a catch basin (white pole in middle of picture) located along the west side of State Freeway 33 adjacent to the Stanley Avenue on-ramp. This site also consists of the stormwater channel connected to the catch basin on the other side of an earthen embankment to the west of the freeway. The stormwater channel receives drainage from the immediate area on the freeway and a substantial drainage area in the City of Ventura to the east.

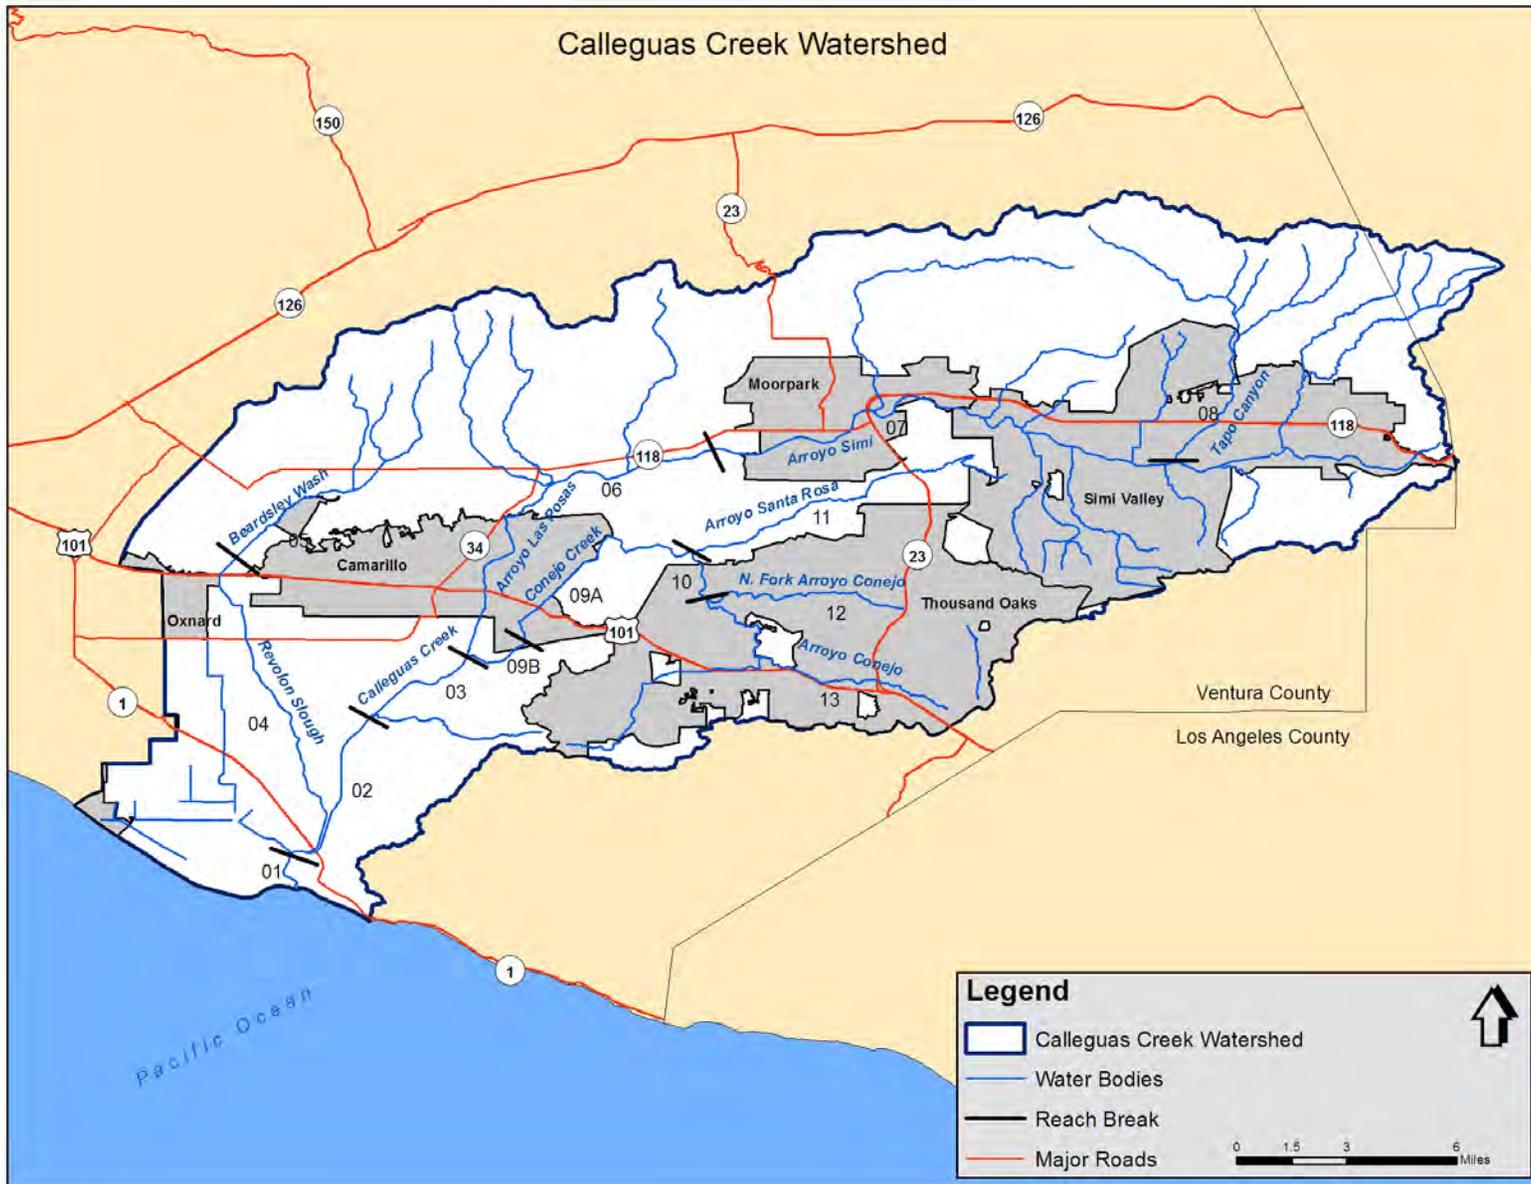
Figure 1. Calleguas Creek Watershed

Calleguas Creek drains an area of approximately 343 square miles from the Santa Susana Pass in the east to Mugu Lagoon in the southwest. The main surface water system drains from the mountains in the northeast part of the watershed toward the southwest where it flows through the Oxnard Plain before emptying into the Pacific Ocean through Mugu Lagoon. The watershed, which is elongated along an east-west axis, is approximately thirty miles long and fourteen miles wide. The Santa Susana Mountains, South Mountain, and Oak Ridge form the northern boundary of the watershed; the southern boundary is formed by the Simi Hills and Santa Monica Mountains. Figure 1 depicts the CCW and Table 1 presents the reaches of the CCW as identified in the TMDLs covered by the CCWTMP.

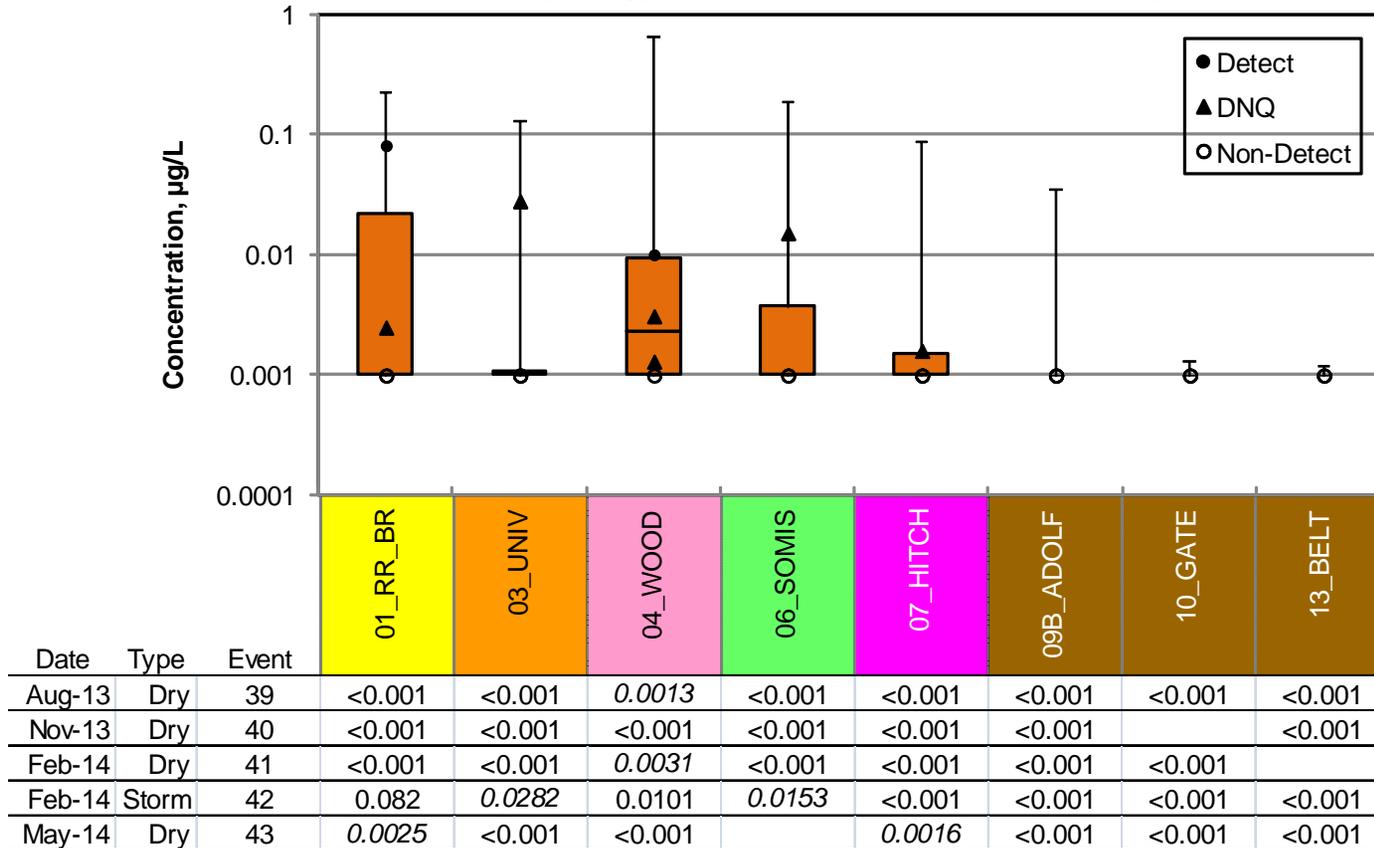
**Figure 10. 4,4'-DDD Water Column Concentrations in Receiving Water Sites: 2008-2014**

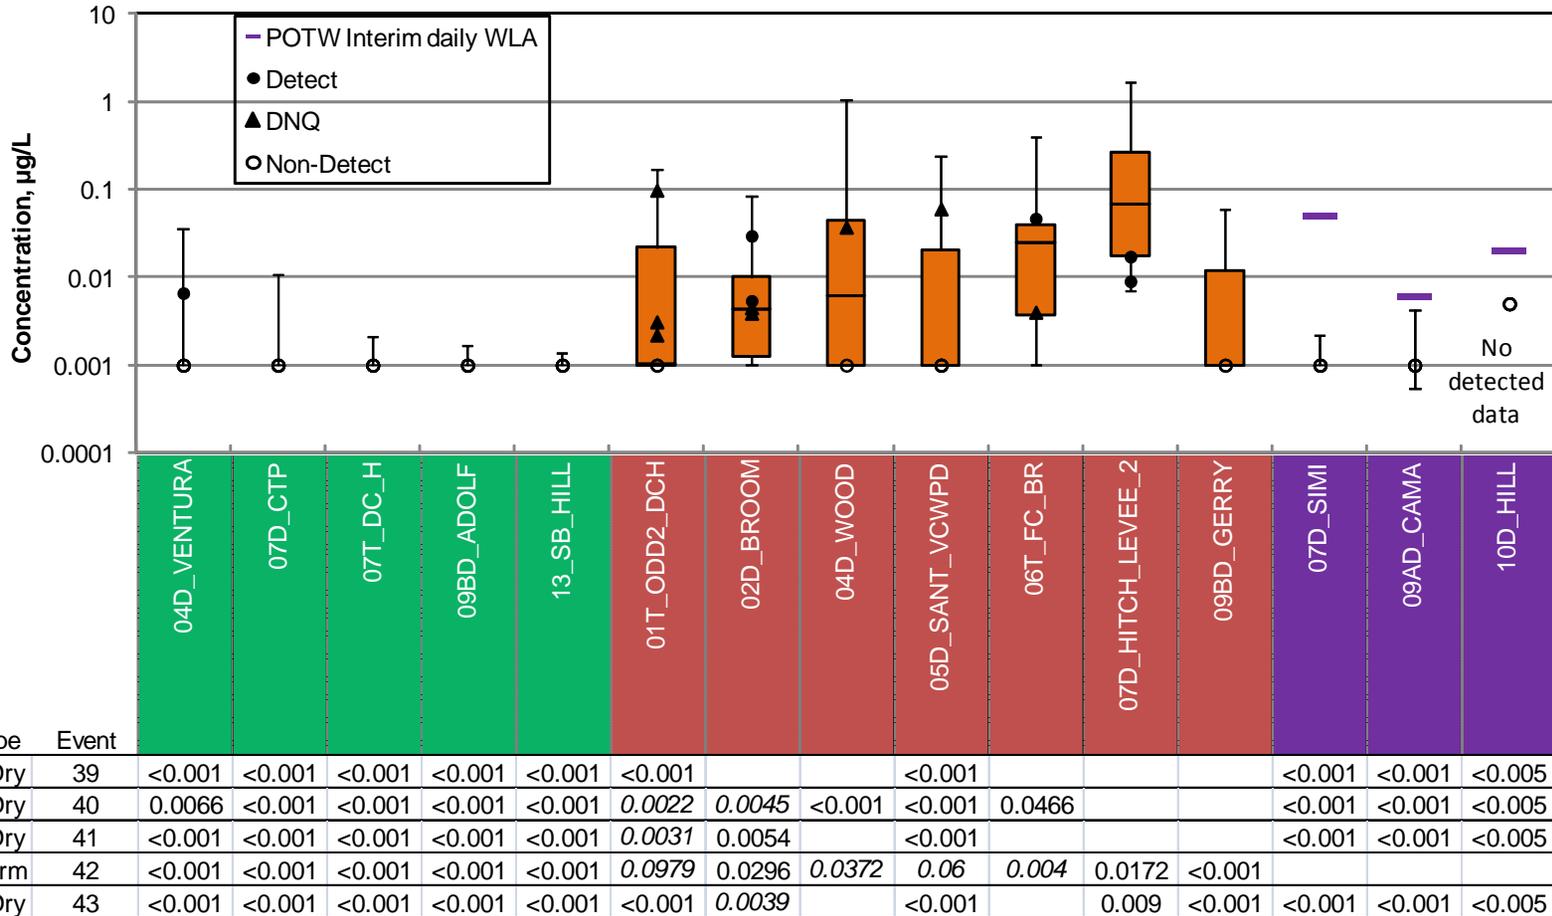
**Figure 11. 4,4'-DDD Water Column Concentrations in Urban, Ag, and POTW Sites: 2008-2014**

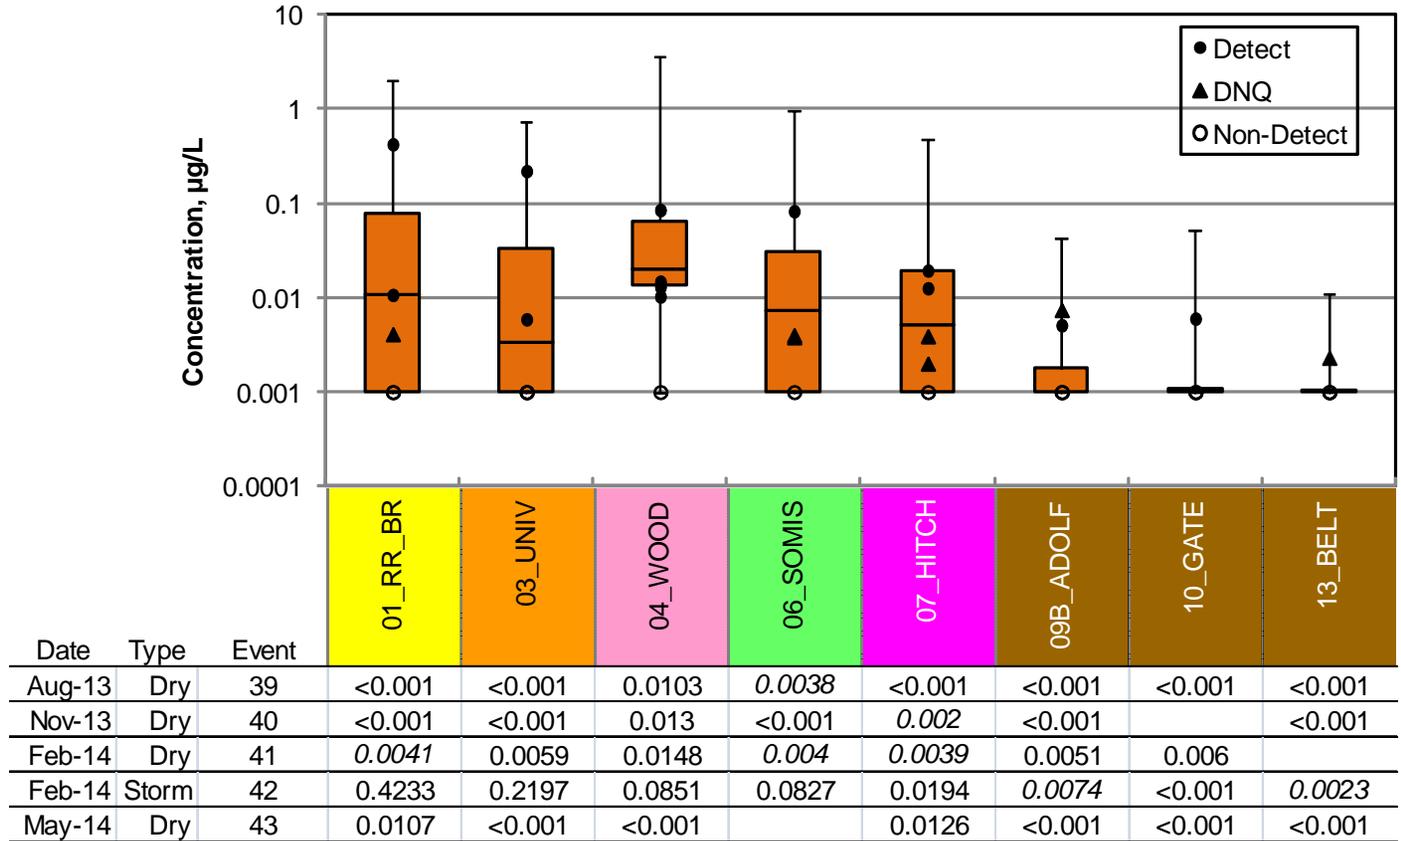
**Figure 12. 4,4'-DDE Water Column Concentrations in Receiving Water Sites: 2008-2014**

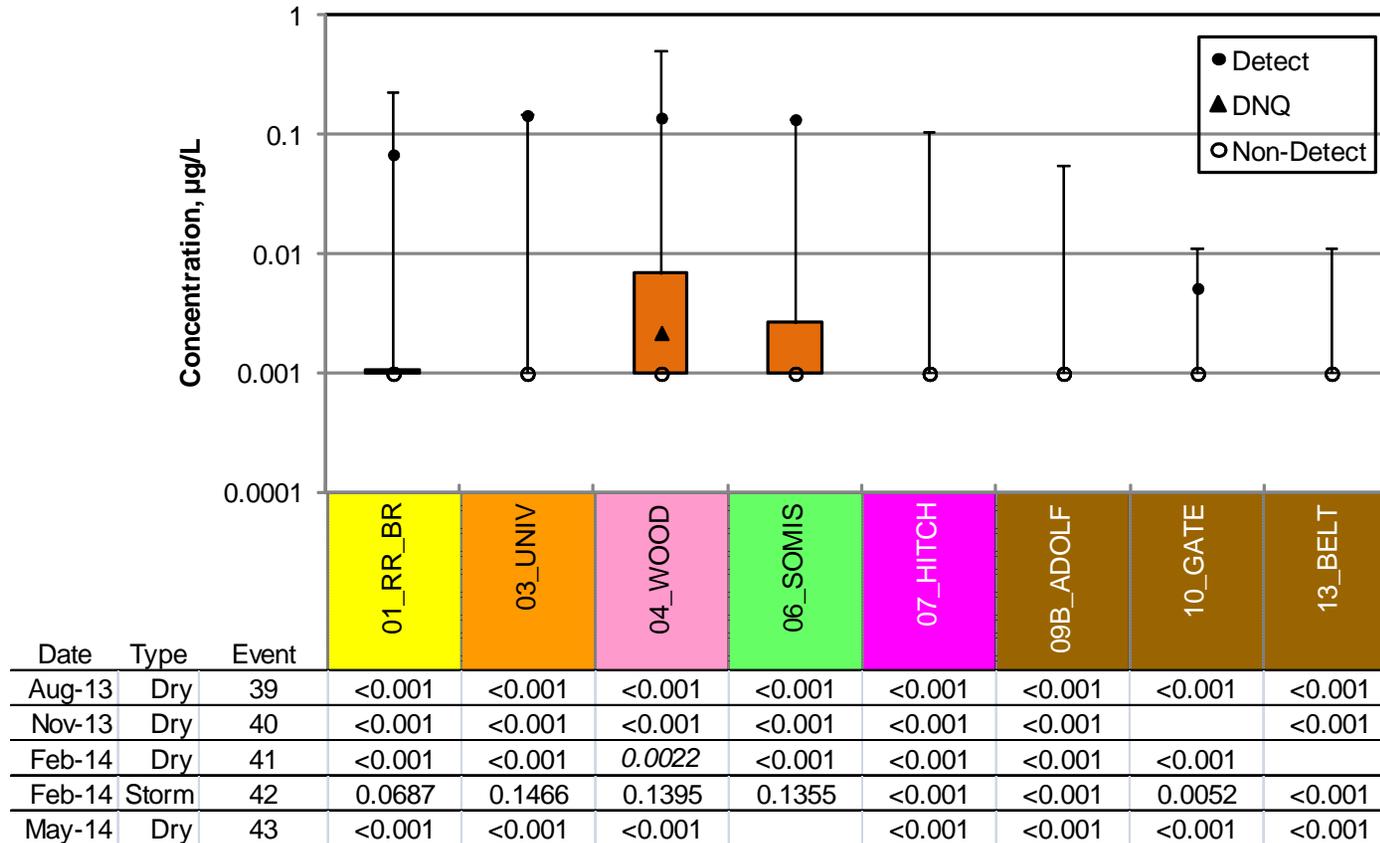
**Figure 14. 4,4'-DDT Water Column Concentrations in Receiving Water Sites: 2008-2014**

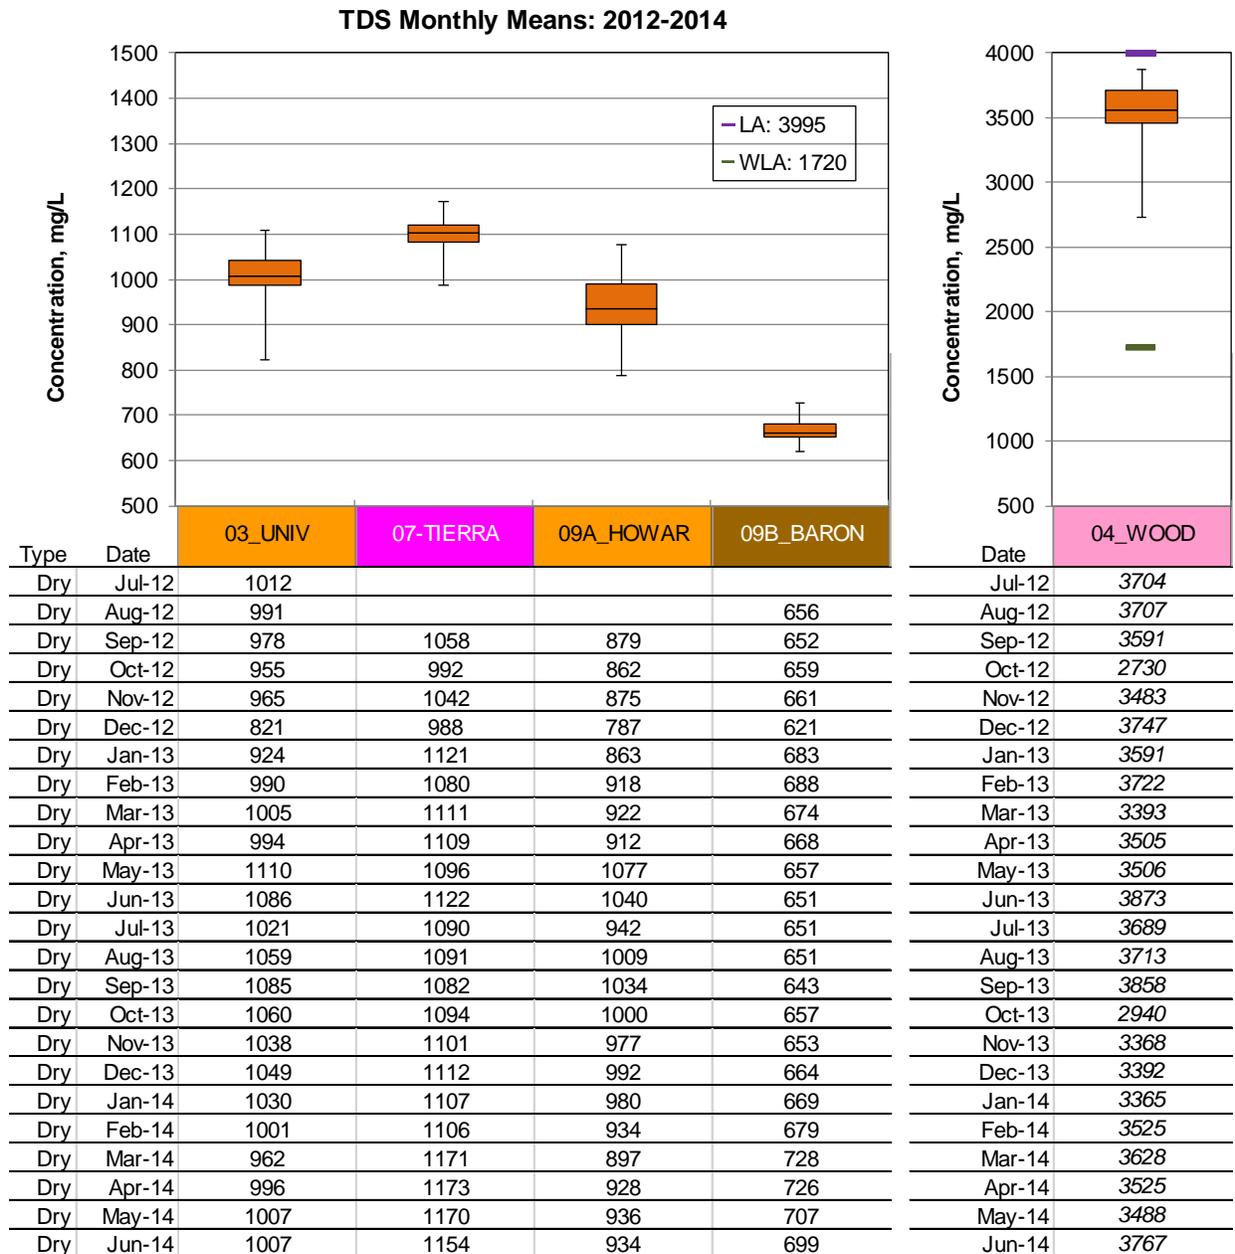
**Figure 61. TDS Monthly Means for Receiving Water Sites Collected During Dry Weather**

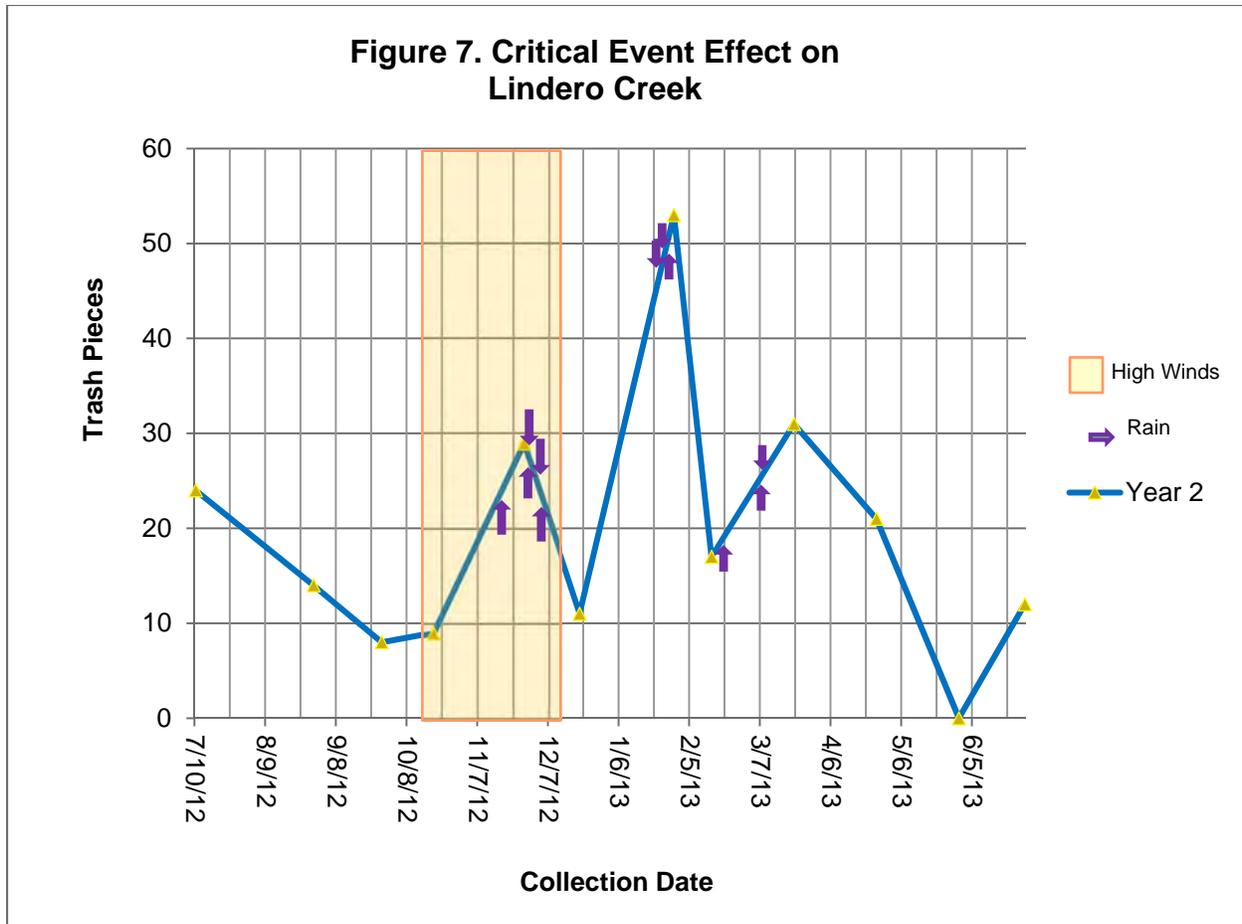
The additive effect of wind and rains caused increased loading as evidenced in November's piece count peak. Being the first storm of the season, a greater relative amount of trash might have been expected. Alternatively, the forces related to the magnitudes of these smaller storms may have been inadequate to dislodge trash and move it through the system. This hypothesis gains additional strength considering that the largest peak occurred after the most intense rain event (January).

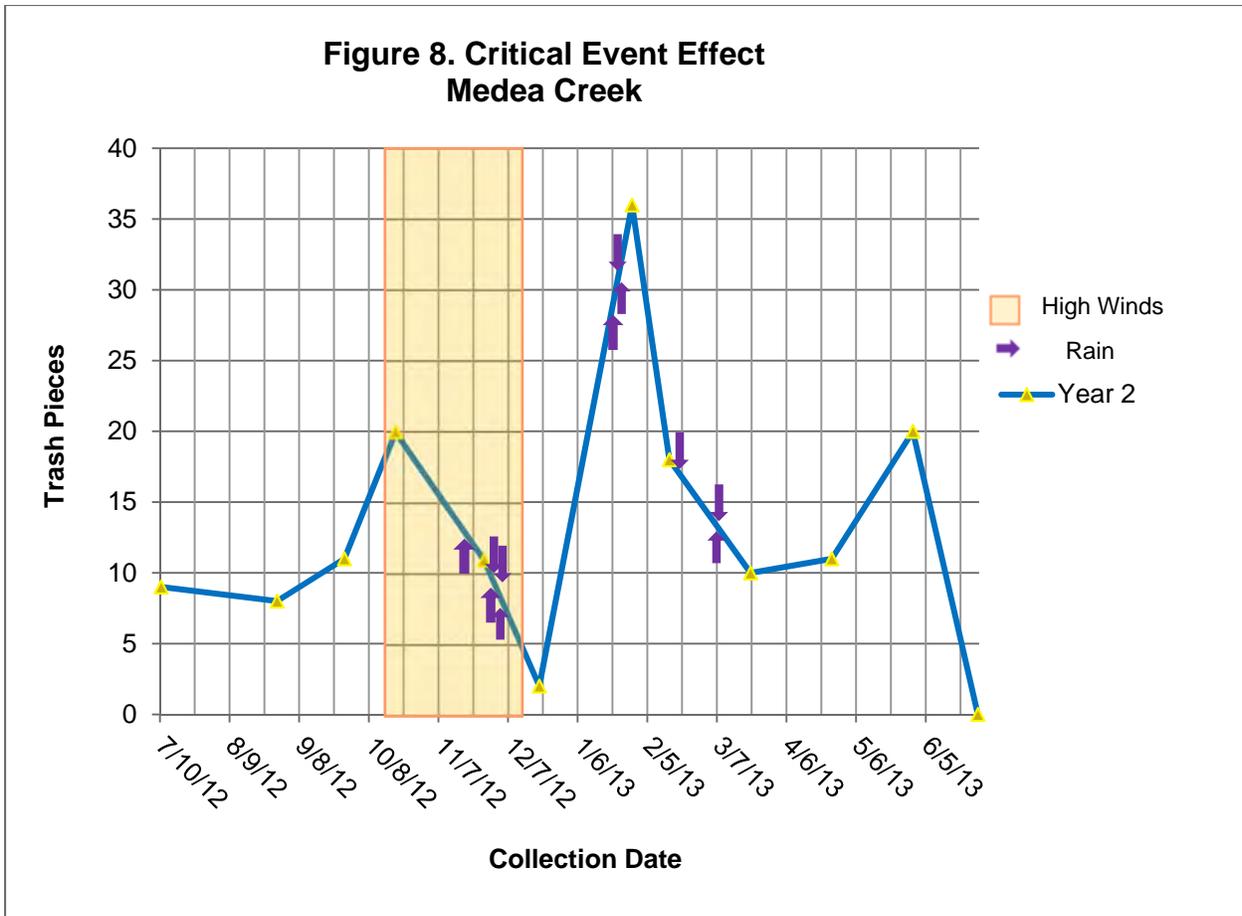
The high wind period and first rains, for example, coincide with a decreasing trend in total pieces. The trio of storms in January, however, does prove adequate to cause an increase in trash pieces (20 vs. average of 14). This storm favored the movement of light-weight pieces or there were more of them available. Smaller tandem rain events in March 2013 were insufficient at causing a loading peak for the month. These storms may have lacked adequate motive force.
