Ventura Countywide Stormwater Quality
Management Program Annual Report

Upper Malibu Creek Dry Weather Source Identification Study

**UPPER MALIBU CREEK WATERSHED
DRY WEATHER SOURCE IDENTIFICATION STUDY**

MEMORANDUM REPORT

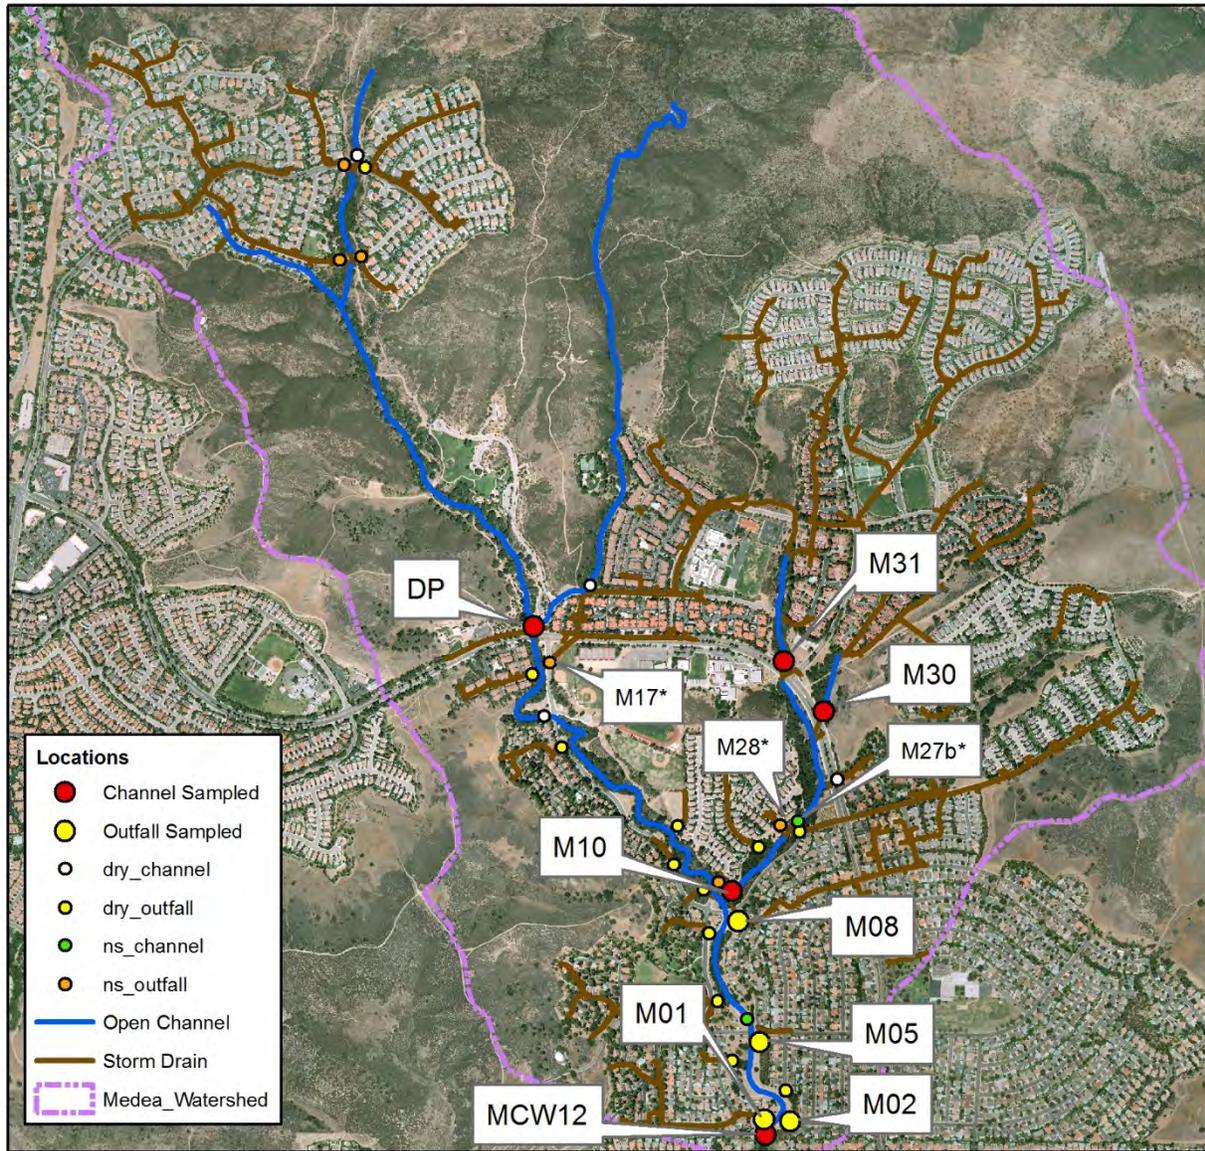
Upper Medea: Sampling Locations

Fig. 2.1 Surveied and sampled locations in Upper Medea Creek drainage area. Large symbols and labels indicate sampled locations with flow measurements. Small symbols indicate locations surveyed but not sampled because dry (white, yellow) or other reason (green, orange); small symbols with labels indicate locations with flow measurements.

Twenty-three storm drain outfalls and eight creek locations were identified using GIS and surveyed in the field for access, flow and potential sources of fecal pollution (Fig. 2.1). Average flows, where measurable, are reported in Table 2.1, and summarized in Fig. 2.2. Appendices B and C include maps and photos of all locations. High-flow events temporarily increased flow in the morning, and originated from a large outfall upstream of M31 and were observed downstream at M27b and M10. While the increased discharge at the outfall was a potential illicit discharge (Fig. 2.3), water quality sampling at M31 suggested the flow inputs did not contribute significant *E. coli*, nutrients or detergents (as MBAS) to the receiving water (see sections below).

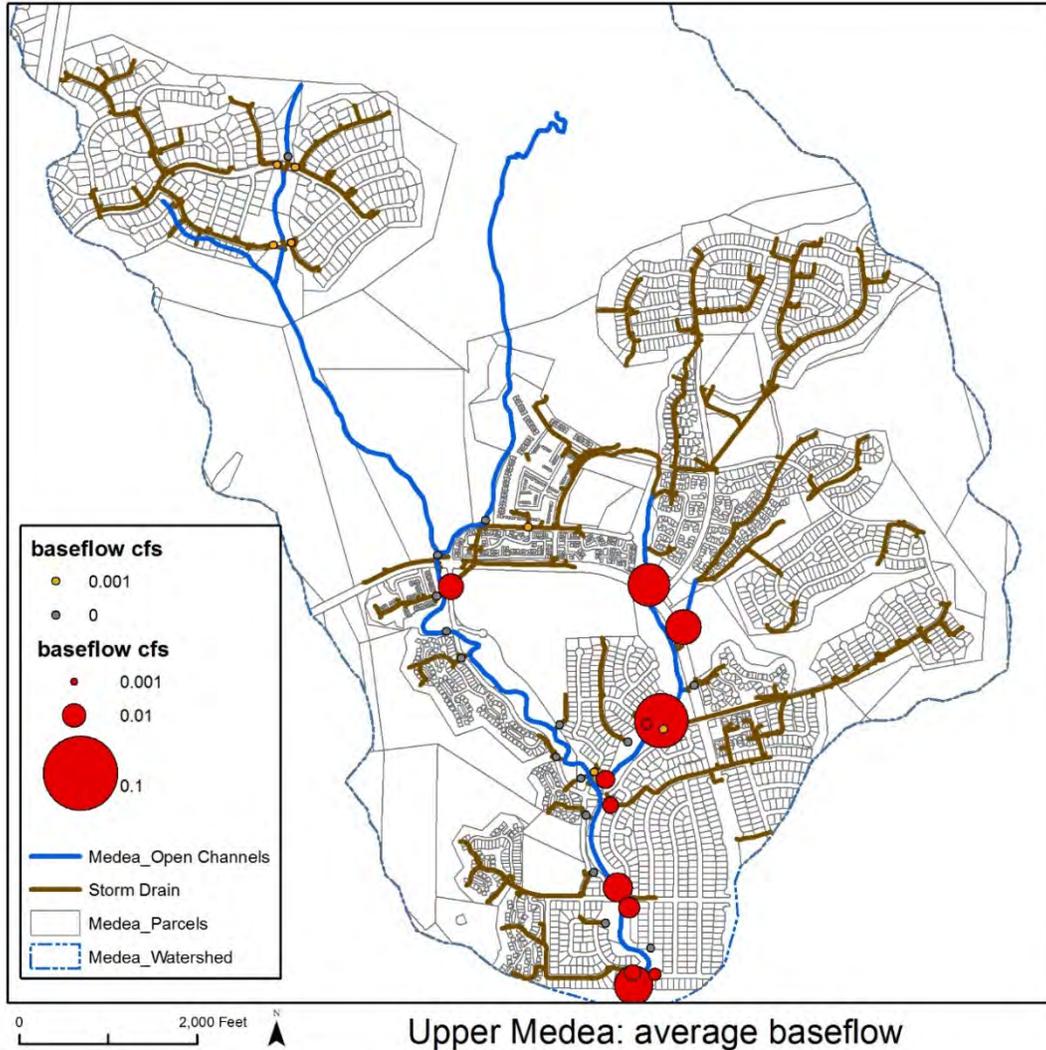
Fig. 2.2. Average baseflow in Upper Medea Creek drainage area. Only surface flows linked to MCW12 are indicated, by red circles proportional to flow. Dry reaches of the creek are highlighted with text.

Based on flow assessment on four occasions between May 30th and July 11th of 2013, it was determined that large portions of the drainage area did not contribute surface flow to the compliance station (MCW12), because there was no discharge from the storm drain, or because the discharge infiltrated before reaching the compliance station. These areas were therefore not targeted for sampling.

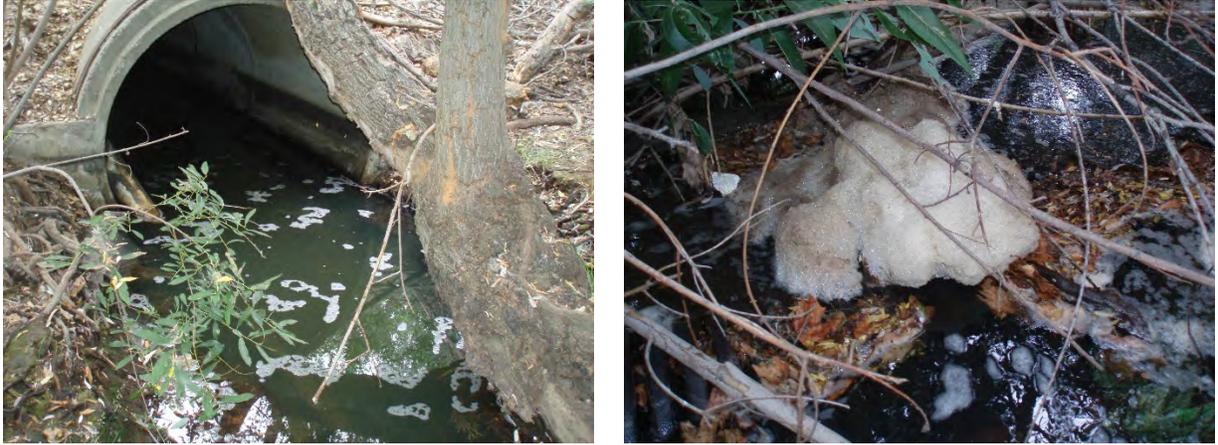
Fig. 2.3. Storm drain outfall with temporary high flow outputs (left) and resulting foam in creek downstream (right)

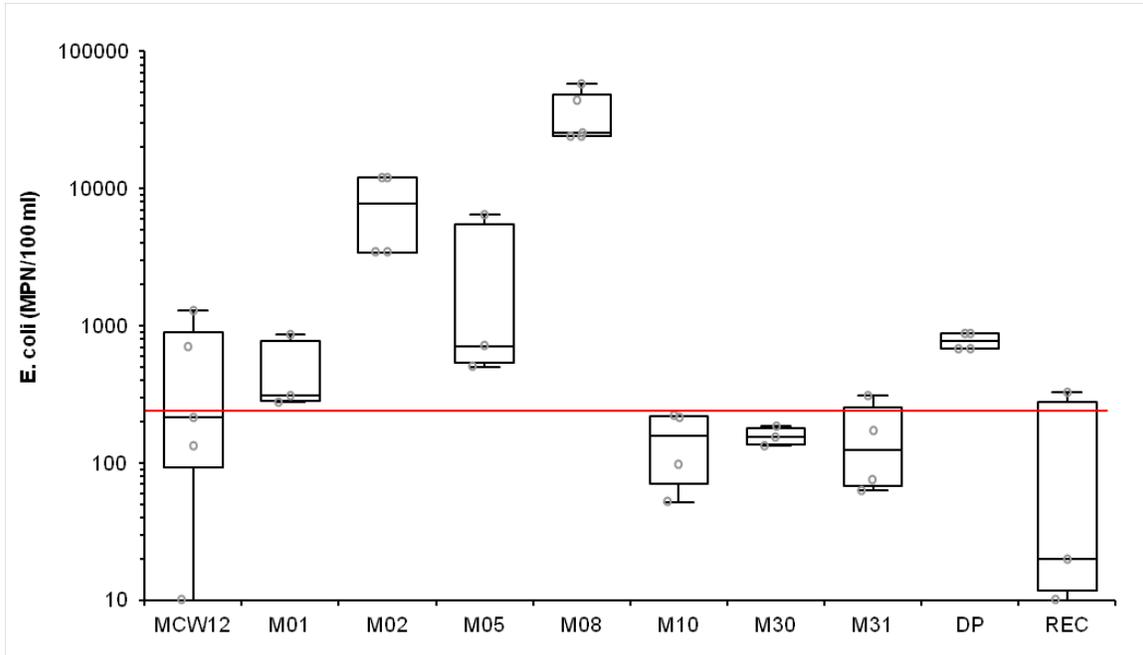
Fig. 2.4. *E. coli* concentrations in Upper Medea drainage area. Numeric limit is indicated by red line (235 MPN/100 ml). Box plots indicate median, and 25th and 75th percentiles; whiskers indicate minima and maxima. M01 – M08: storm drain outfalls, M10 – M31: upper creek, DP: duck pond, REC; reclaimed water.

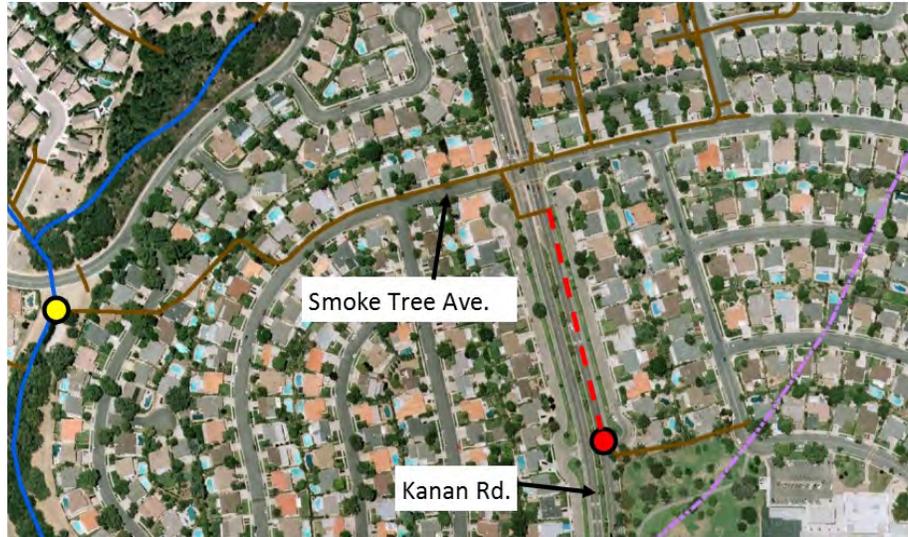
Fig. 2.5. Gutter sampling location (red circle) with potential gutter flow (red dotted line) to storm drain at M08 (yellow circle)

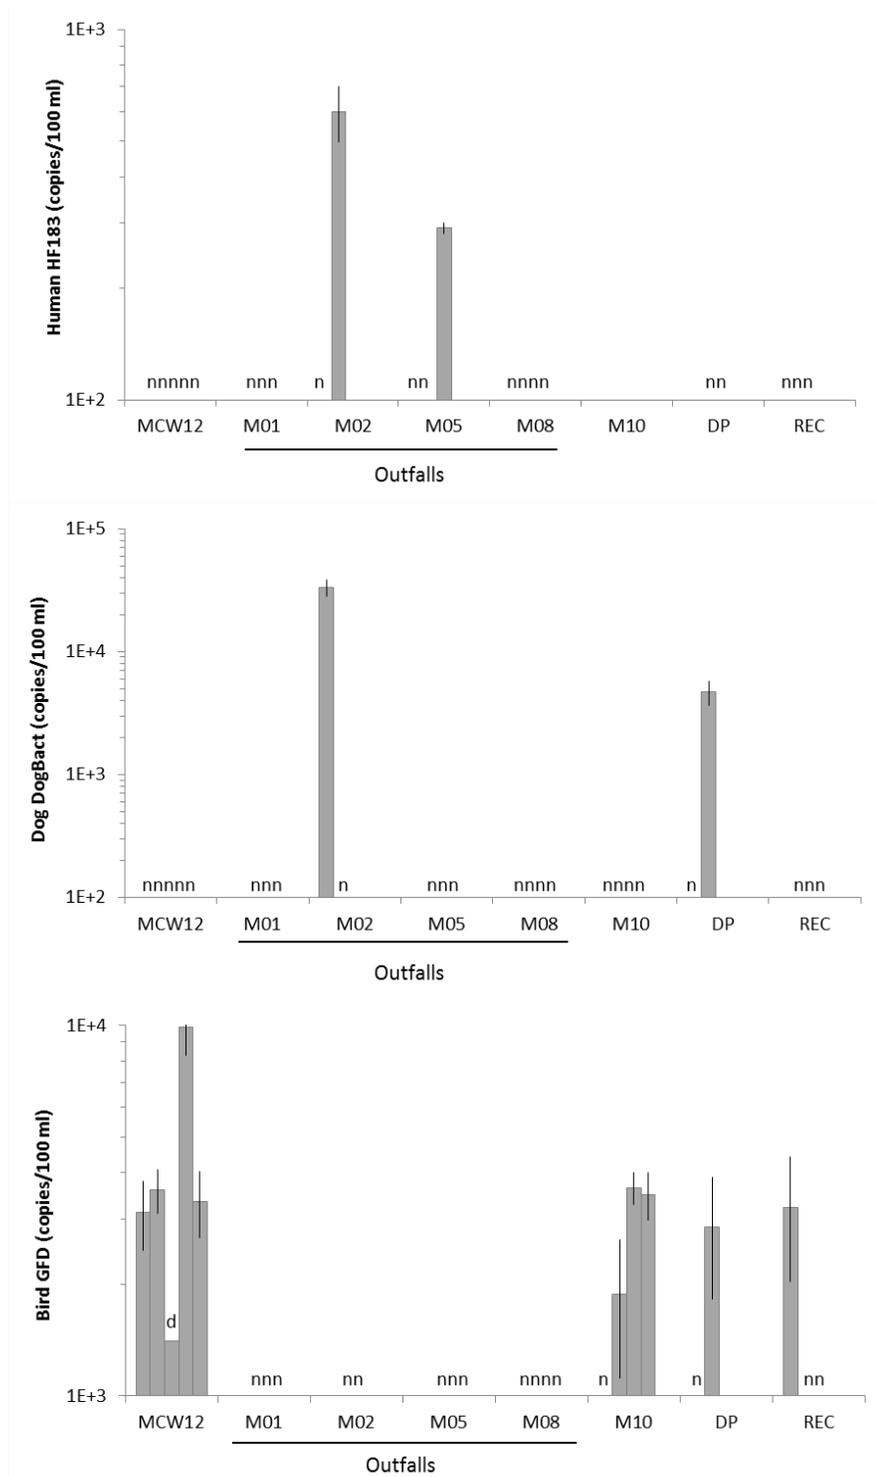
Fig. 2.6. Concentrations of host-specific markers in Upper Medea Creek drainage area. Error bars indicated standard deviation of technical replicates. Symbol “n” indicates non-detects, “d” indicates detected but not quantifiable.

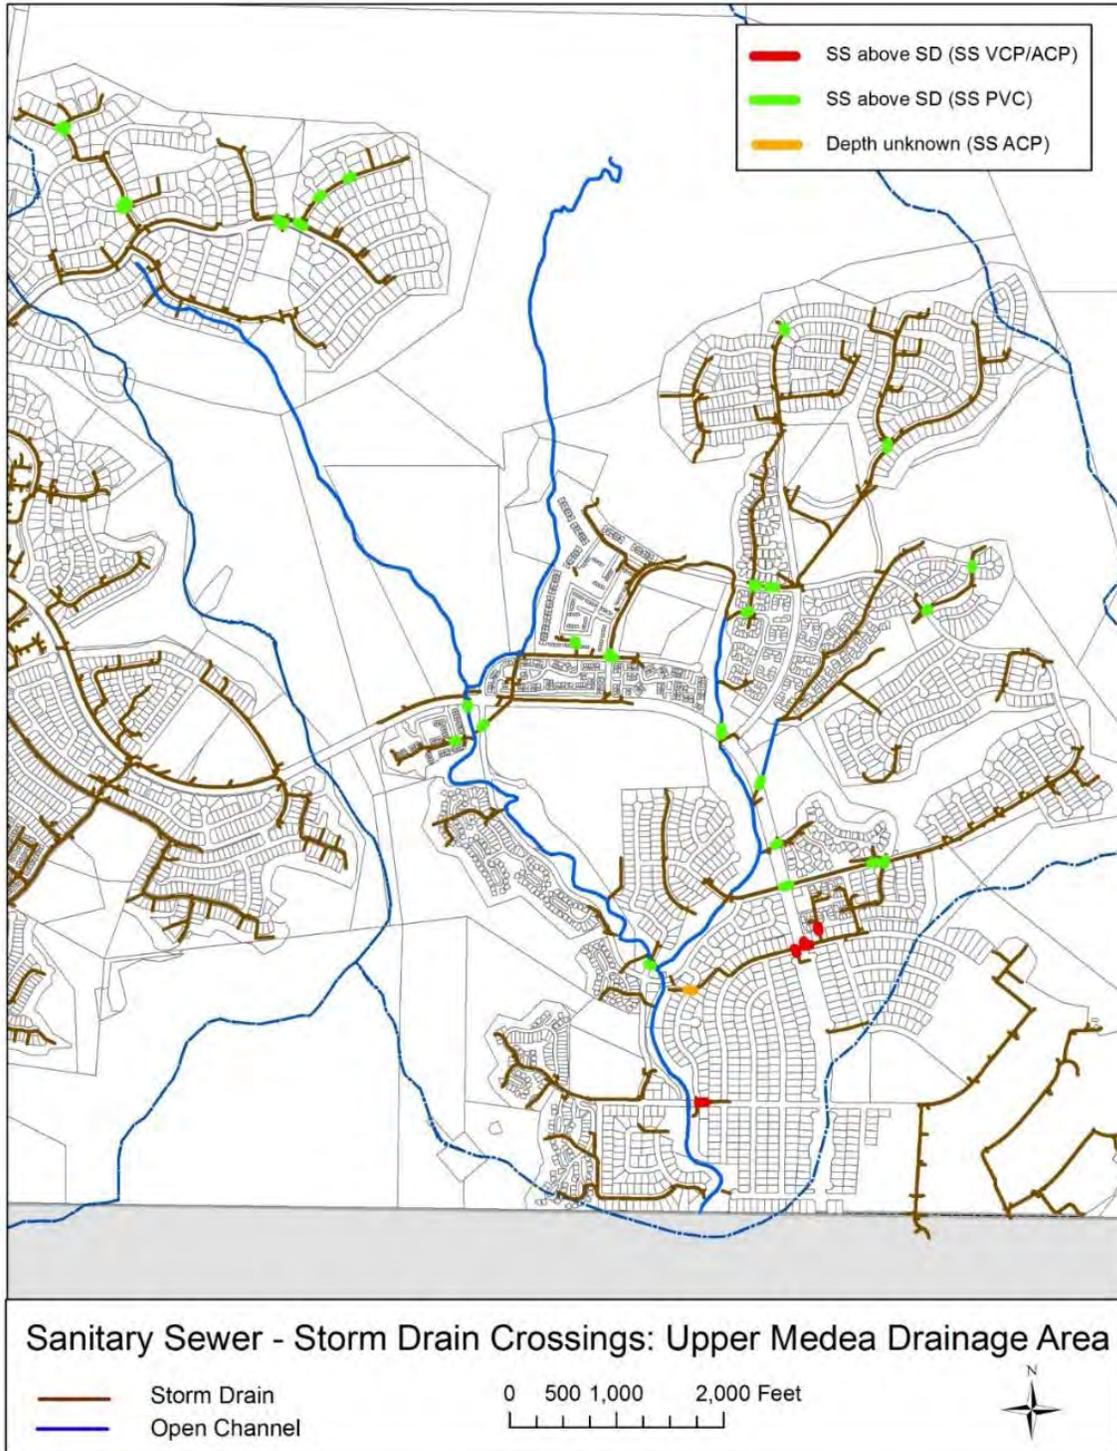
Fig. 2.7. Crossings with sanitary sewer overlaying storm drain in Upper Medea drainage area. Crossings are coded according to construction material of sanitary sewer: clay or concrete (red), PCV (green), unknown storm drain depth (orange).

exfiltration (Fig. 2.7). At two locations older clay or concrete sanitary sewer mains cross above the storm drain. In one outfall downstream of these crossings (M8), human markers were never detected, therefore sewage contamination is likely not an issue. In the other case, at M5, human markers were detected. A detail of the infrastructure there (Fig. 2.8, left) shows the location of the sanitary sewer main – storm drain crossing. However, more work is needed to determine if sewer main leakage, leakage from compromised sewer laterals or other sources are causing detection of human markers at M0.

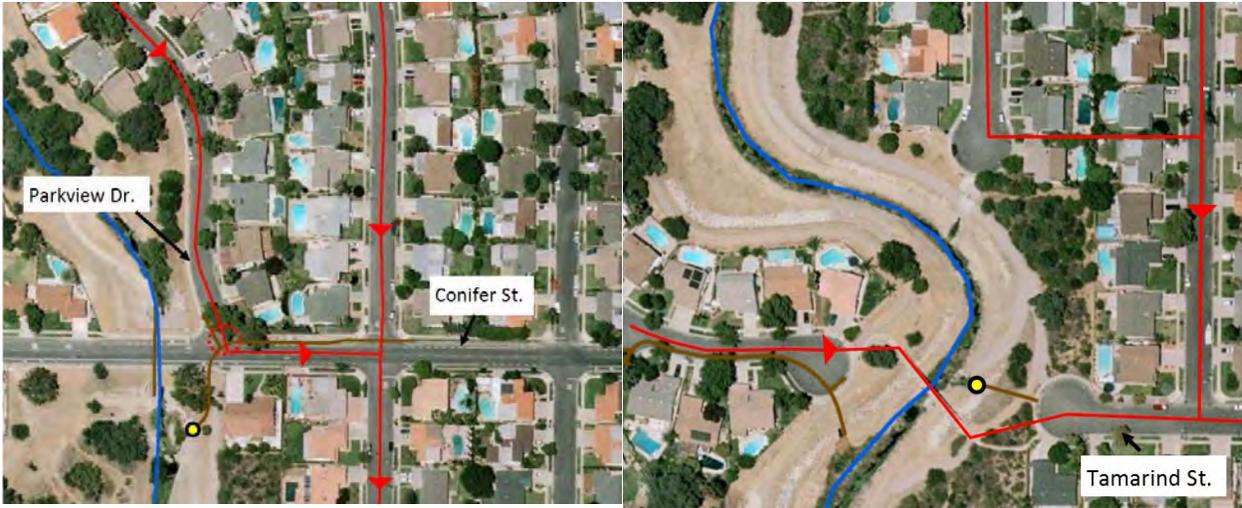
Fig.2.8. Detail of storm drain (brown) and sanitary sewer (red) infrastructure near M05 (yellow circle, left map) and M02 (yellow circle, right map). Sanitary sewer crossing above storm drain is indicated by dotted red circle.

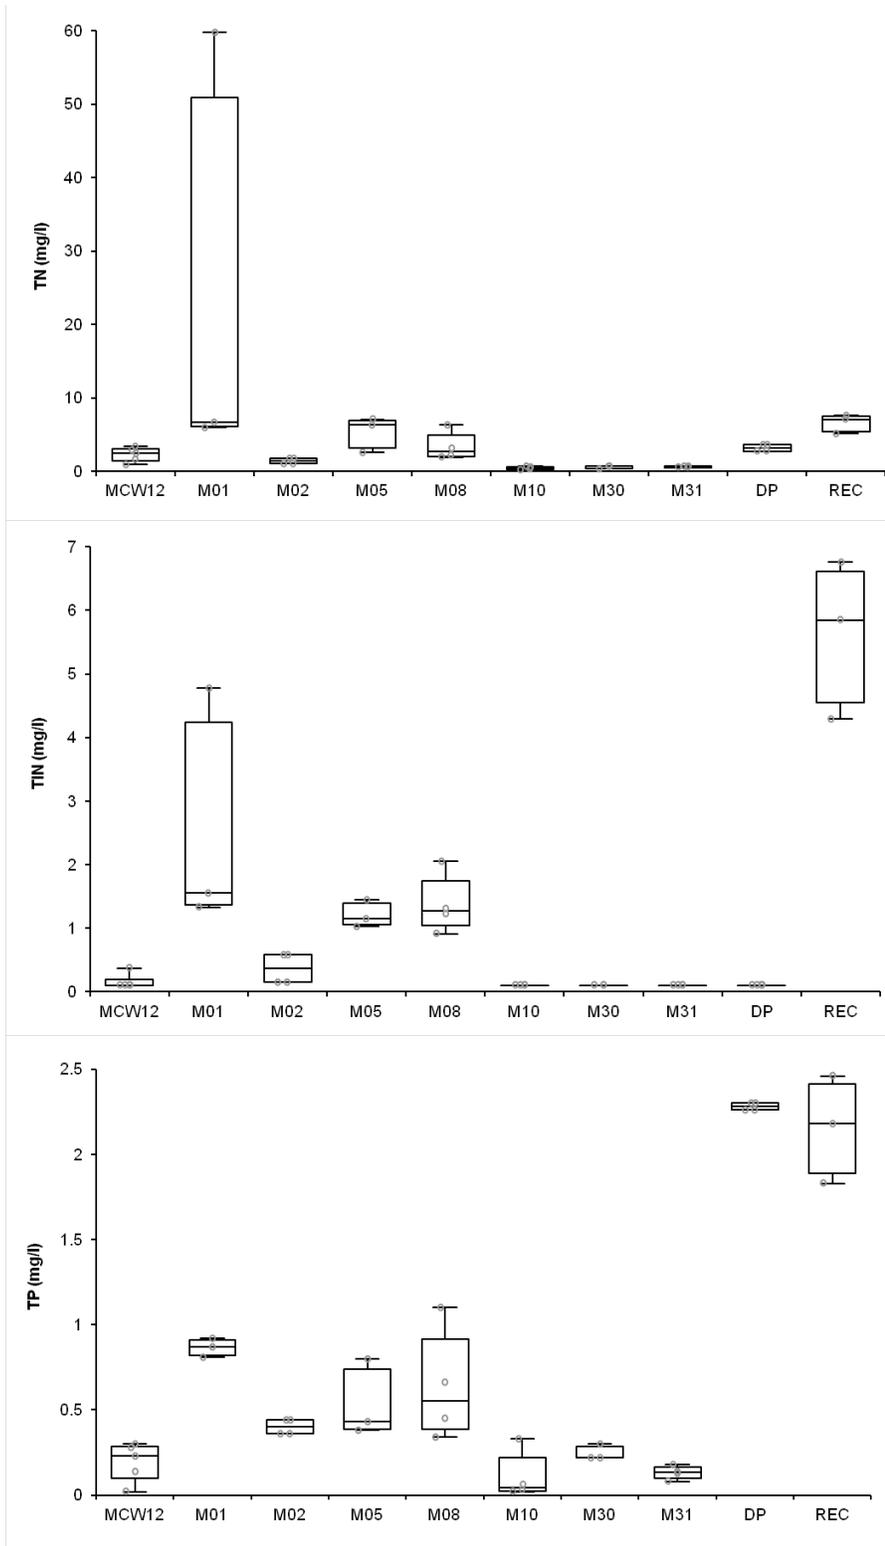
Fig. 2.10. Nutrient concentrations in Upper Medea Creek drainage area. TN: total nitrogen, TIN: total inorganic nitrogen (nitrate and nitrite), TP: total phosphorus.

Total nitrogen concentrations were lowest (0.2 – 0.7 mg/l) in the East fork of Upper Medea Creek (M10, M30, M31). Higher and quite variable concentrations were observed in urban outfalls (1 – 60 mg/l; average = 7.7 mg/l). Concentrations were intermediate at the most downstream receiving water station MCW12 (0.9 – 3.4 mg/l), suggesting inputs from storm drains affected in-stream total nitrogen

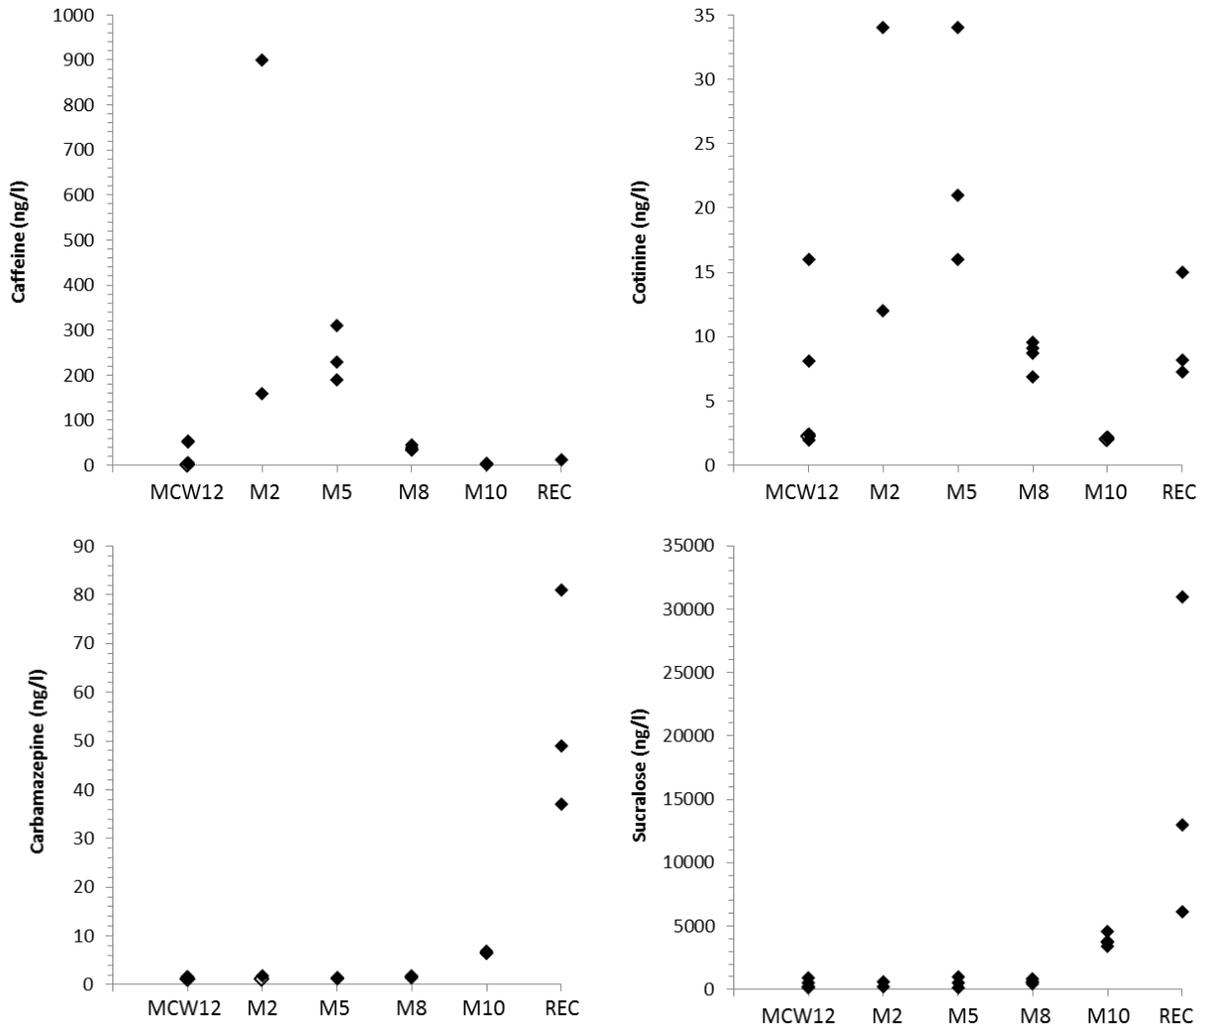
Fig. 2.11. Concentrations of potential chemical sewage indicators in Upper Medea Creek drainage area.

Four chemicals with potential to indicate sewage pollution or other anthropogenic inputs were analyzed: caffeine, cotinine (nicotine metabolite), carbamazepine (anticonvulsant and mood-stabilizing drug) and sucralose (artificial sweetener). All are present in relatively high concentrations in raw sewage, but rates of degradation in the environment vary (very low for sucralose and carbamazepine). Due to the cost of the analysis, a subset of locations was analyzed for these constituents: compliance station (MCW12), urban outfalls M2, M5, and M8, creek location M10 and reclaimed water (Fig. 2.11).

Concentrations patterns of **caffeine** and **cotinine** were similar, with highest concentrations in urban outfalls M2 and M5, lowest in the east fork creek location (M10) and intermediate at the compliance station and outfall M8. Concentrations in reclaimed water were in the low (caffeine) to intermediate (cotinine) range of observed concentrations. Caffeine and cotinine correlations with *E. coli* or human markers were weak or insignificant, suggesting that these chemicals are not useful for identifying sources of fecal pollution.

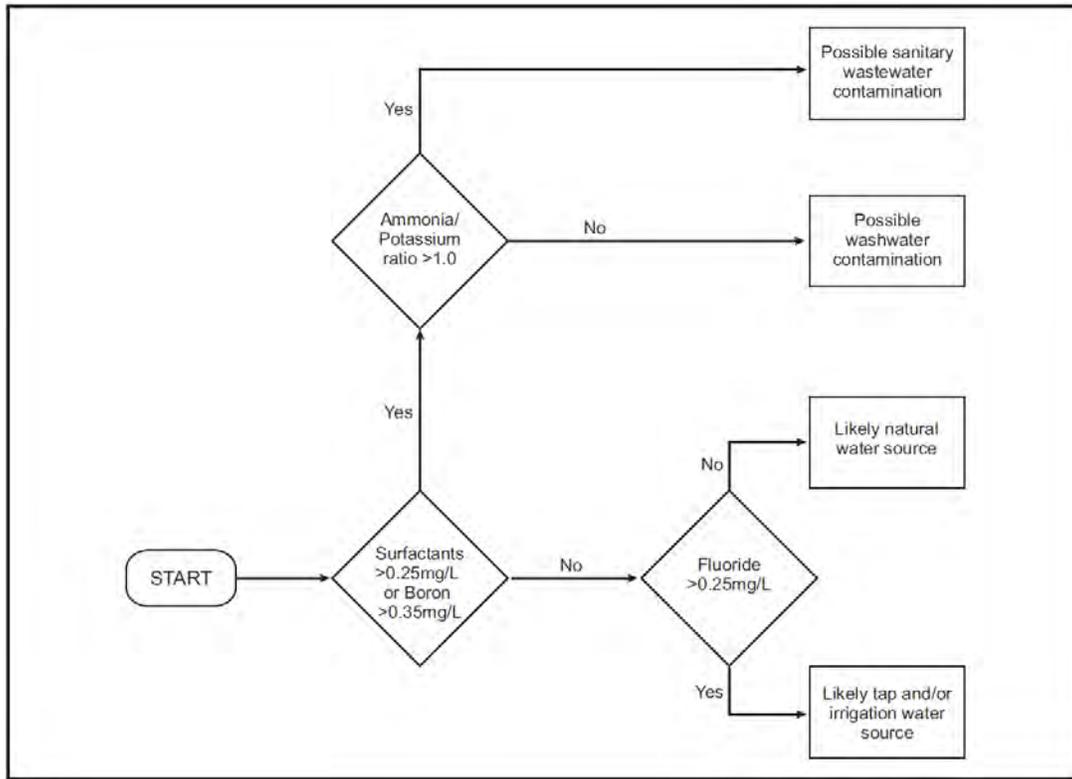
Fig. 2.12. Flow chart to identify illicit discharges in residential watersheds.

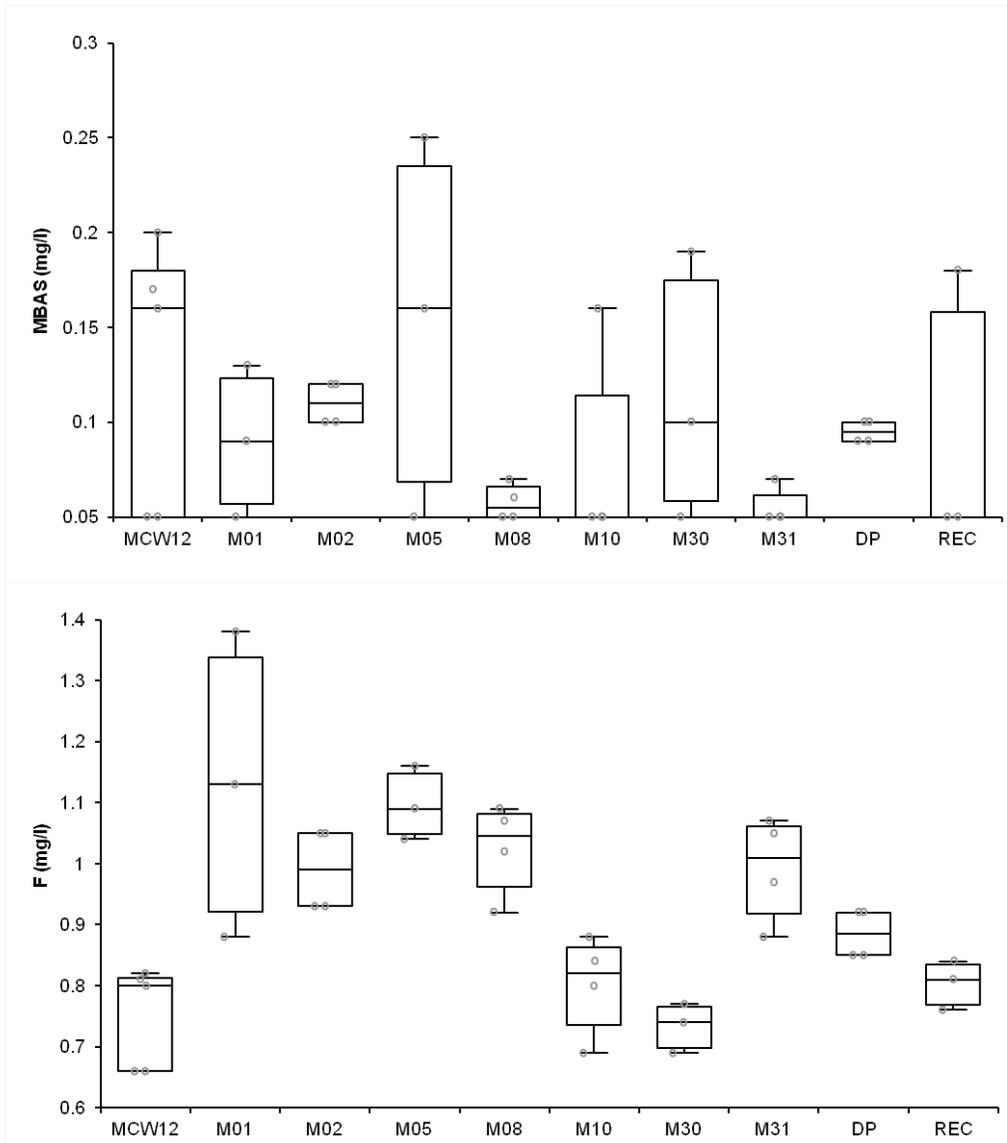
Fig. 2.13. Concentrations of MBAS (top) and fluoride (bottom) in Upper Medea Creek drainage area.

Fluoride concentrations in most creek locations were between 0.66 – 0.88 mg/l, but higher concentrations were observed in the urban outfalls (0.88 – 1.38 mg/l) (Fig. 2.13). It's unclear why the latter concentrations are higher than those measured in recycled water (~ 0.8 mg/l) and reported in tap water (0.6 – 1.0 mg/l) (Calleguas Municipal Water District, 2013), and therefore fluoride was deemed unsuitable to distinguish flow inputs from natural sources versus tap/reclaimed water.

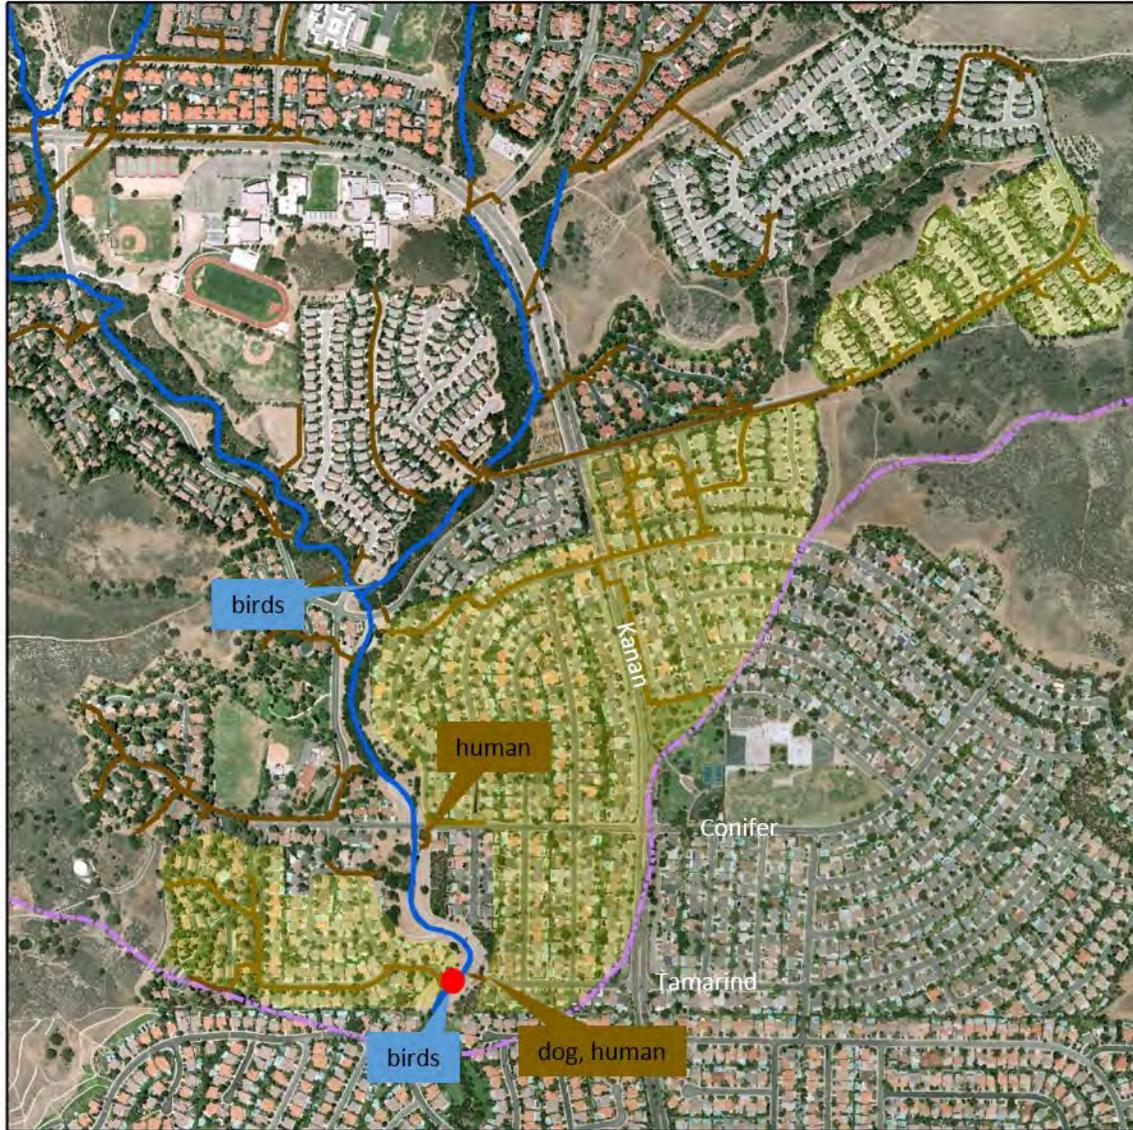
Fig. 2.14. Urban areas (yellow) potentially contributing to elevated *E. coli* concentrations at the compliance station (red dot). Storm drains are indicated in brown, creek in blue lines. Detected fecal sources are indicated in blue (creek) and brown (storm drain) text boxes.

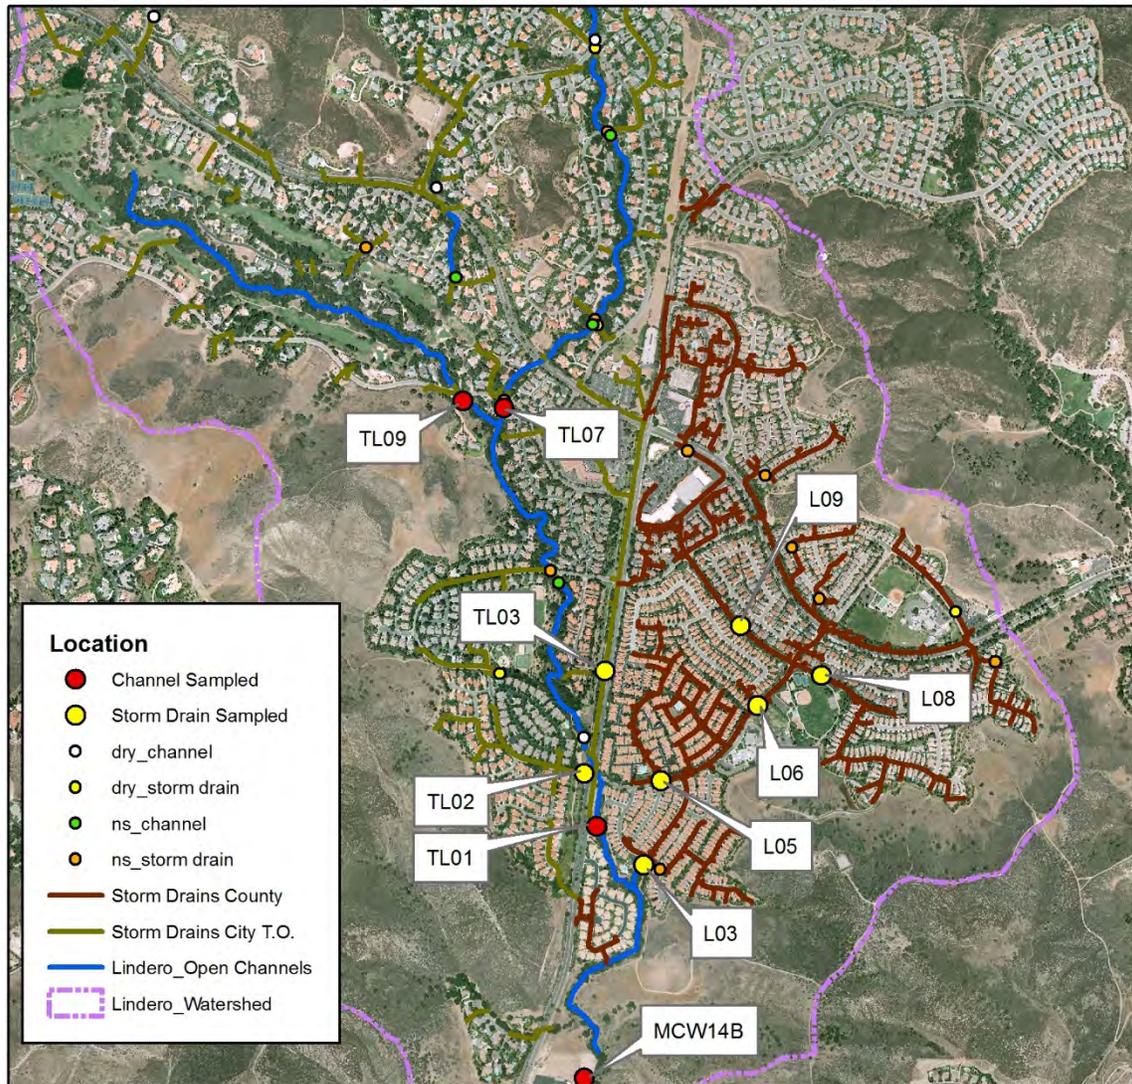
Upper Lindero: Sampling Locations

Fig. 3.1. Surveyed and sampled locations in Upper Lindero Creek drainage area. Large symbols and labels indicate sampled locations with flow measurements. Small symbols indicate locations surveyed but not sampled because dry (white, yellow) or other reason (green, orange); small symbols with labels indicate locations with flow measurements.

One outfall and eleven manhole locations were identified using GIS and surveyed in the field for access, flow and potential sources of fecal pollution within the County area (Fig. 3.1). Locations in the upper storm drain network had the lowest flows, and often runoff from lawn irrigation could be identified as a dominant source of observed flows. Location L3 was the most downstream point surveyed and the network's outfall to the creek.

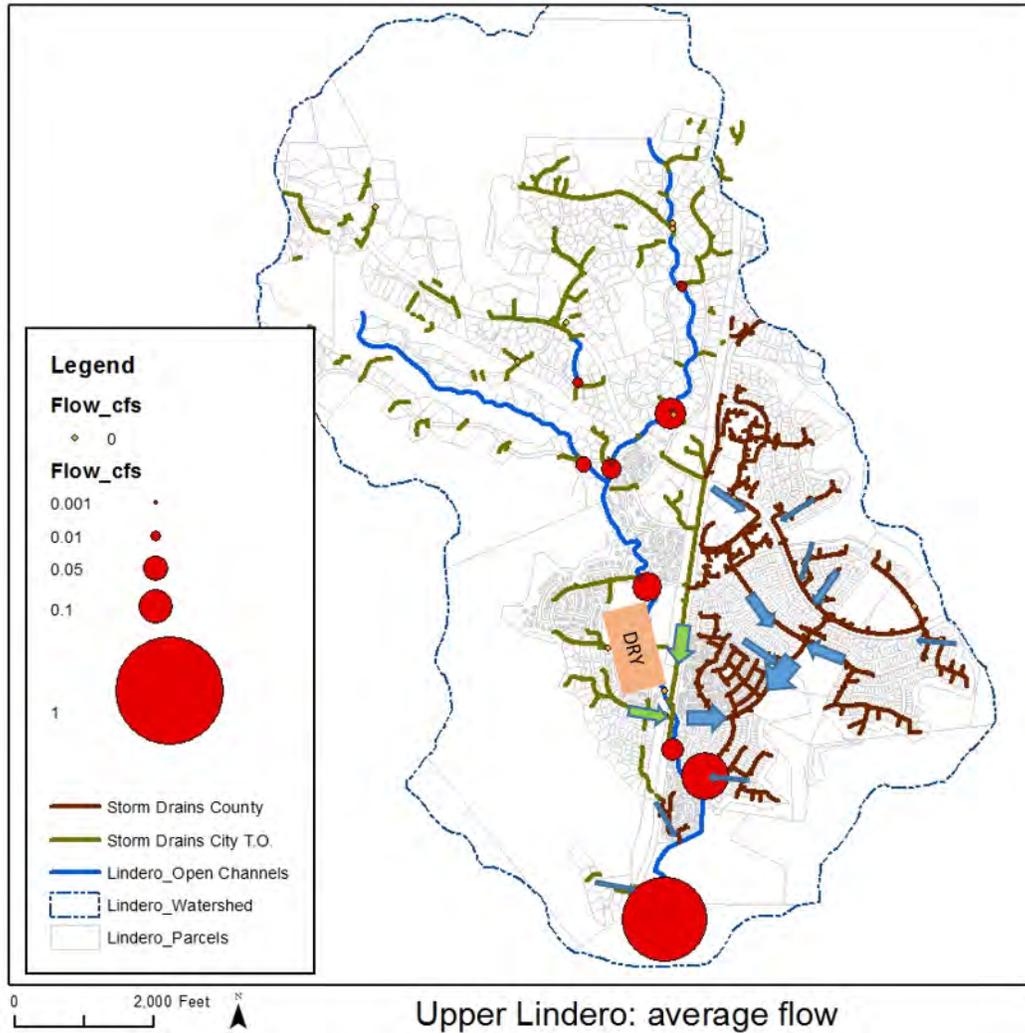
Fig. 3.2. Average baseflow in Upper Lindero Creek drainage area. Red circles are proportional to flow, arrows sizes indicate semi-quantitative flow assessment based on visual observations. Dry reaches of the creek are highlighted with text.

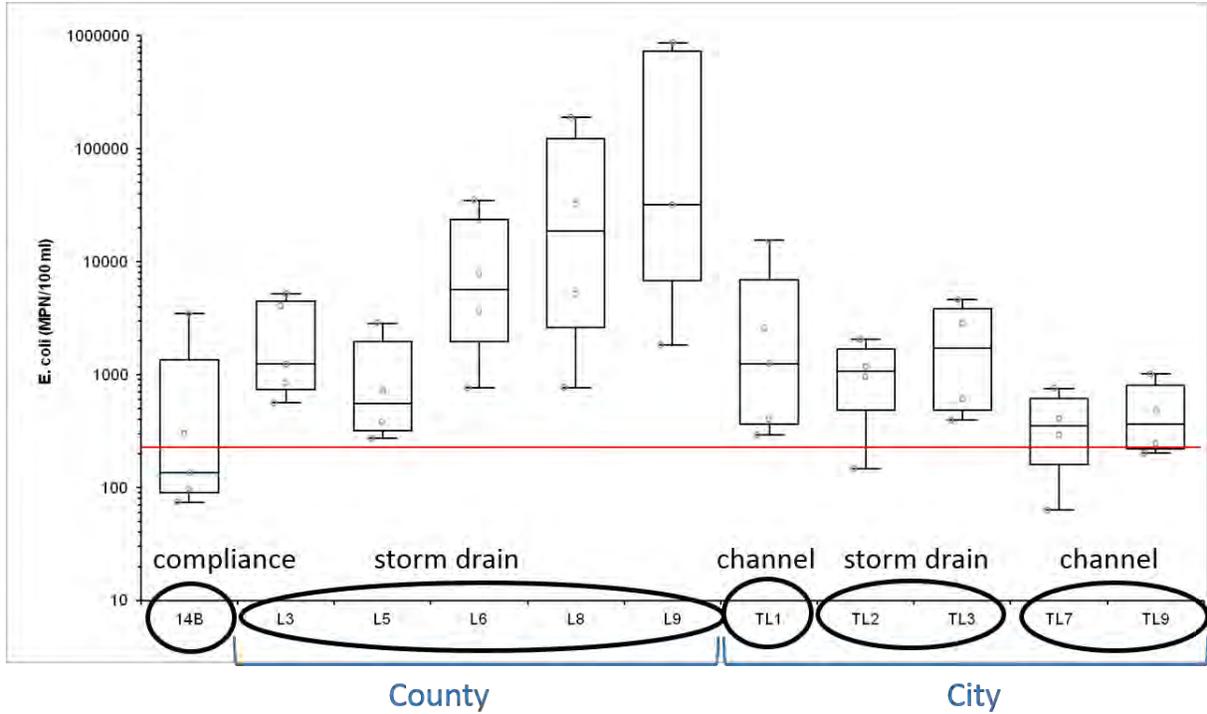
Fig. 3.3. *E. coli* concentrations in Upper Lindero drainage area. Numeric limit is indicated by red line (235 MPN/100 ml). Box plots indicate median, and 25th and 75th percentiles; whiskers indicate minima and maxima.

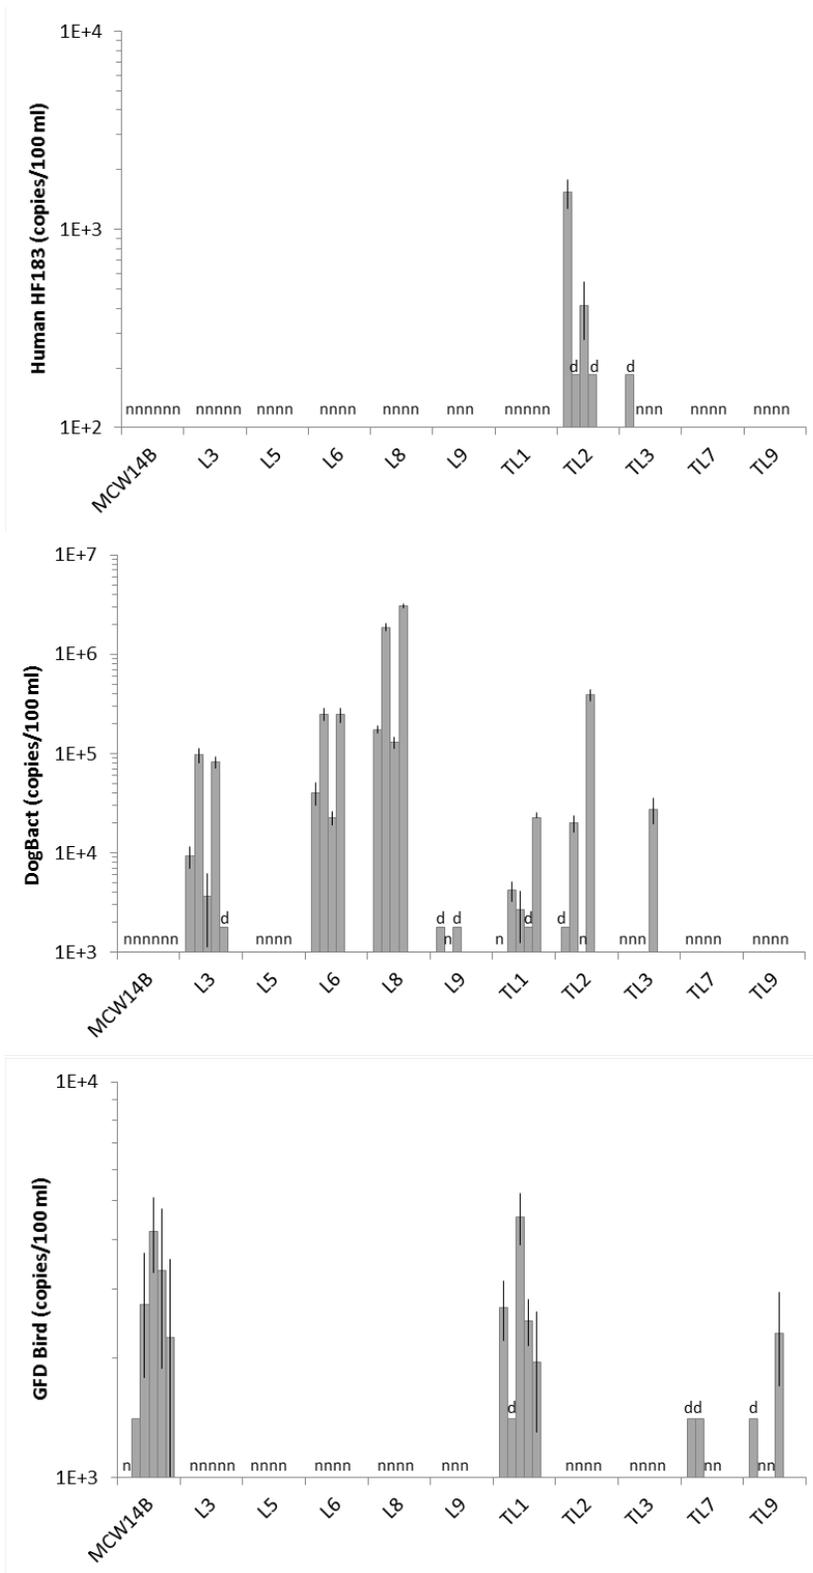
Fig. 3.4. Concentrations of host-specific markers in Upper Lindero Creek drainage area. Error bars indicated standard deviation of technical replicates. Symbol “n” indicates non-detects, “d” indicates detected but not quantifiable.

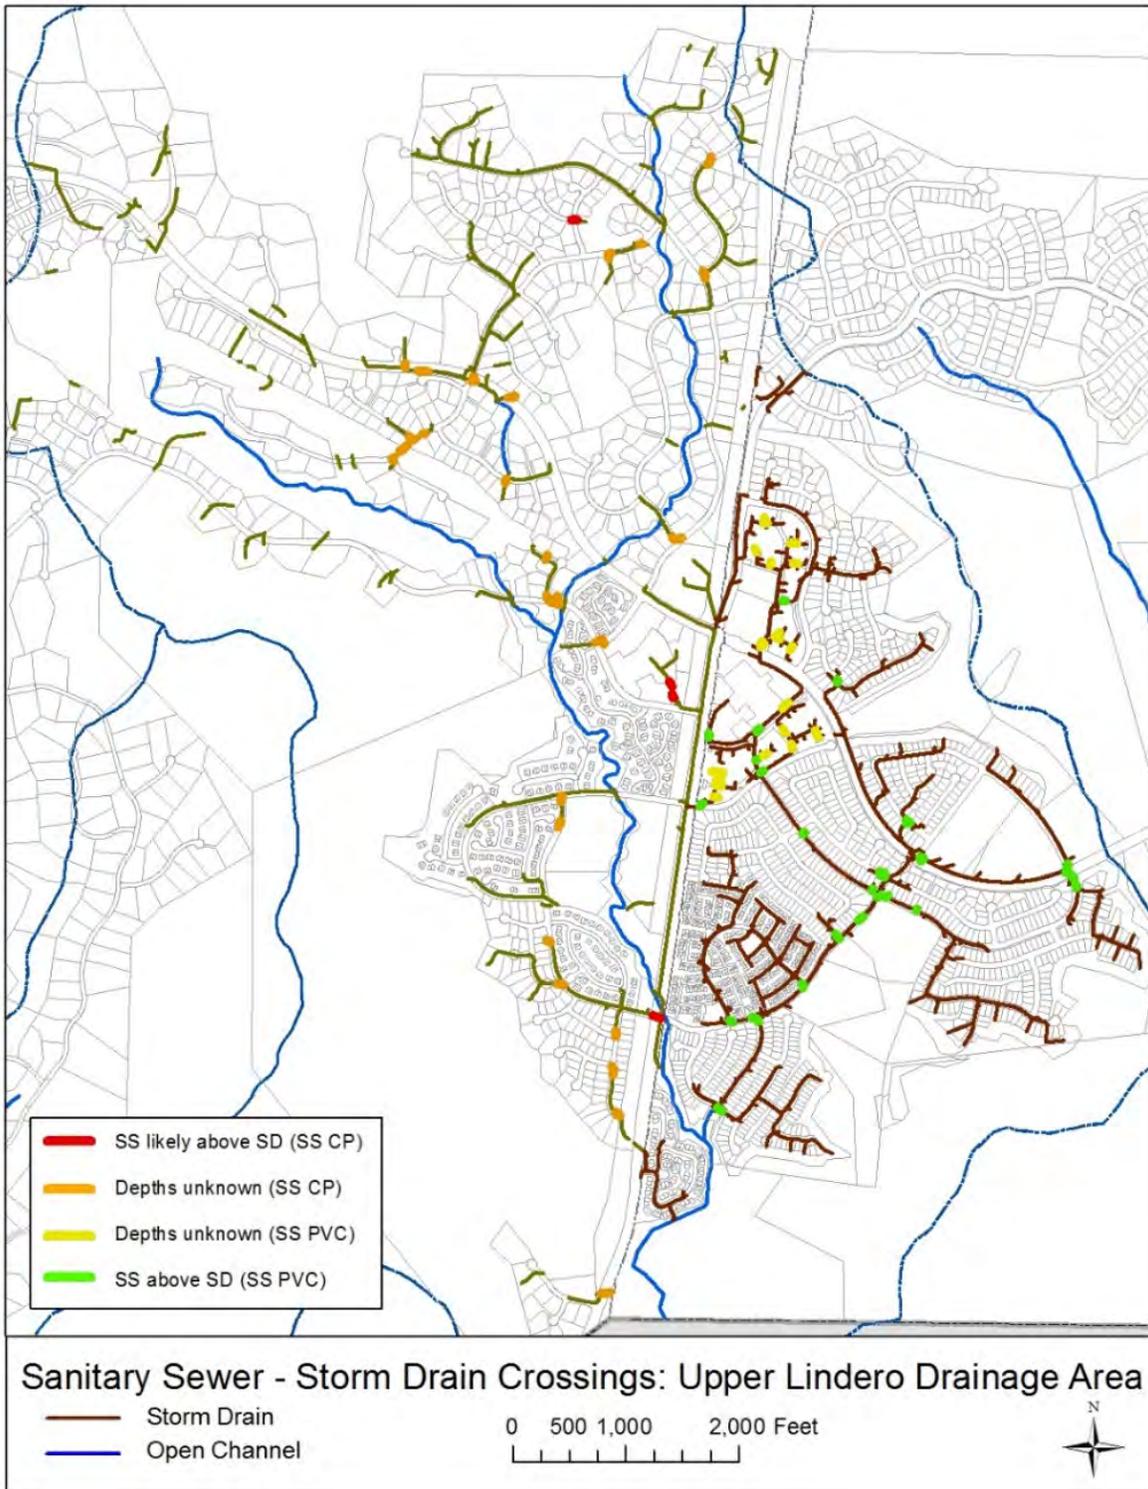
Fig. 3.5. Crossings with sanitary sewer overlaying storm drain in Upper Lindero drainage area. Crossings are coded according to construction material of sanitary sewer: concrete (red), PCV (green). Crossings where storm drain depths are unknown are indicated in yellow (PVC) and orange (concrete).

All sanitary sewers mains in the County jurisdiction of the Upper Lindero drainage area are PVC, with low risk of exfiltration, which corroborate the absence of human markers in the County samples (Fig. 3.5).

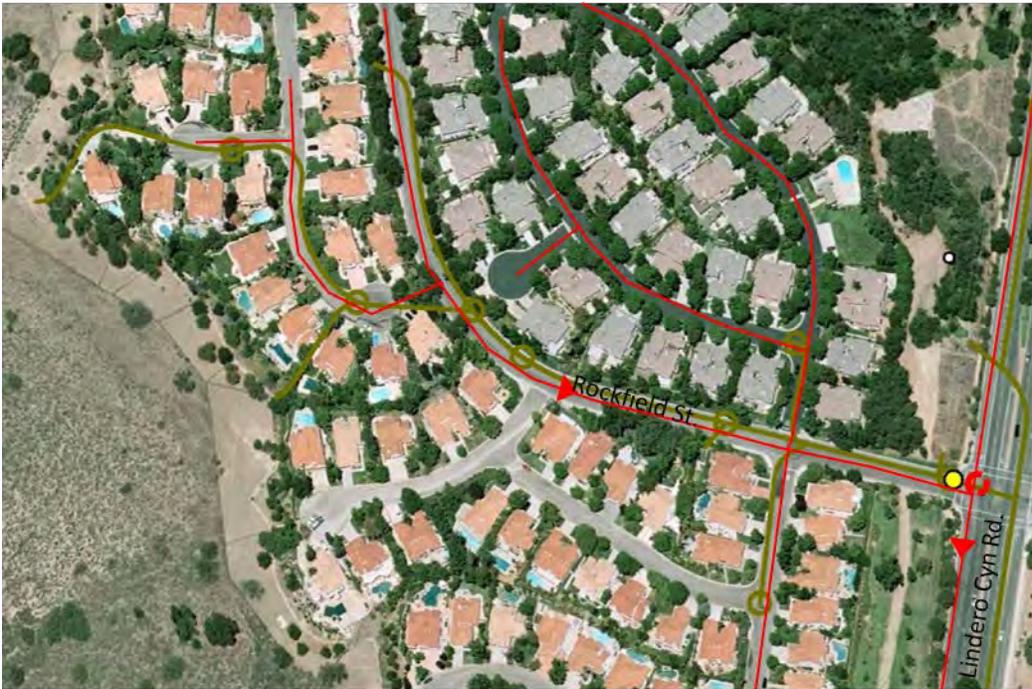
Fig.3.6. Detail of storm drain with manholes (green) and sanitary sewer infrastructure (red) near TL2 (yellow circle). Sanitary sewer crossing above the storm drain is indicated by dotted red circle.
