Ventura Countywide Stormwater Quality
Management Program Annual Report

Upper Malibu Creek Dry Weather Source Identification Study

**UPPER MALIBU CREEK WATERSHED
DRY WEATHER SOURCE IDENTIFICATION STUDY**

MEMORANDUM REPORT

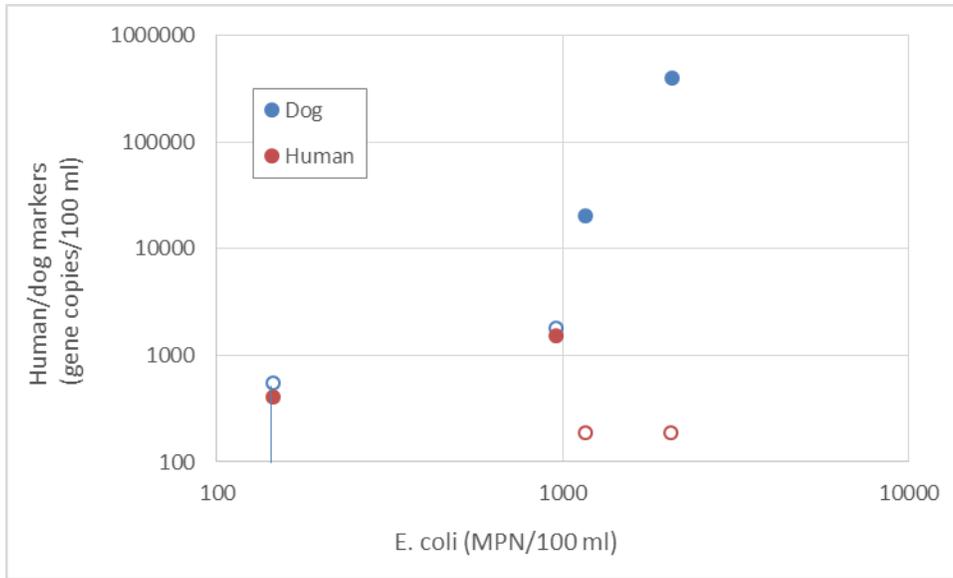
Fig. 3.7. Correlation between human or dog markers and *E. coli* concentrations at TL2. Open symbols indicate samples below the limit of quantification (DNQ and ND). Vertical lines are used to indicate range between zero and limit of detection for samples qualified as ND.

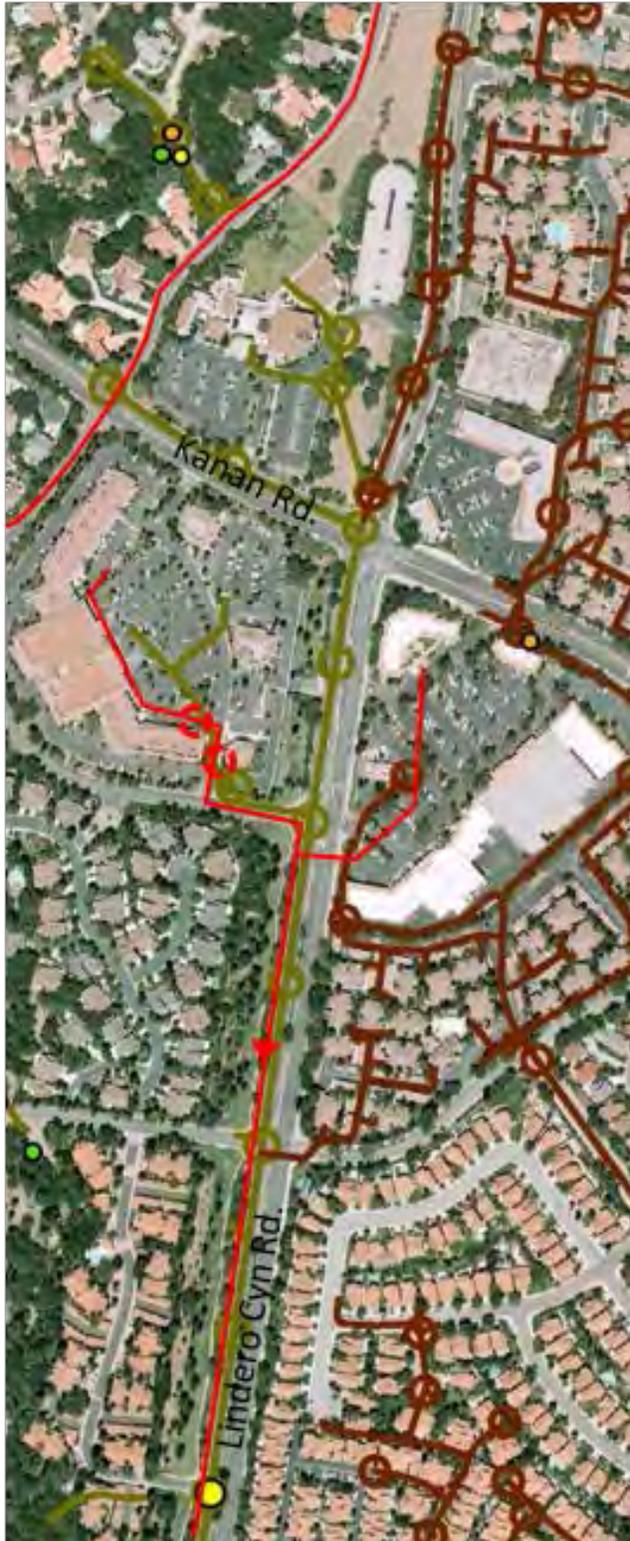
Fig.3.8. Detail of storm drain with manholes (City: green, County: brown) and sanitary sewer infrastructure (red) near TL3 (large yellow circle). Sanitary sewer crossings above the storm drain are indicated by dotted red circles.

In the case of TL3, two “high risk” sanitary sewer-storm drain crossings were upstream of the storm drain sampling location, in the North Ranch Pavilions area (Fig. 3.8), therefore this area should be highest priority for investigating sources of human waste. However, the storm drain also receives potential runoff from the St. Maximilian Kolbe Catholic Church, and from County storm drains draining portions of the Oak Park Apartments on Skyridge Ln. and Oak Park Ln. These apartments are served by PVC sewer mains, which are less likely to leak. Potential sources from the church area are unknown.

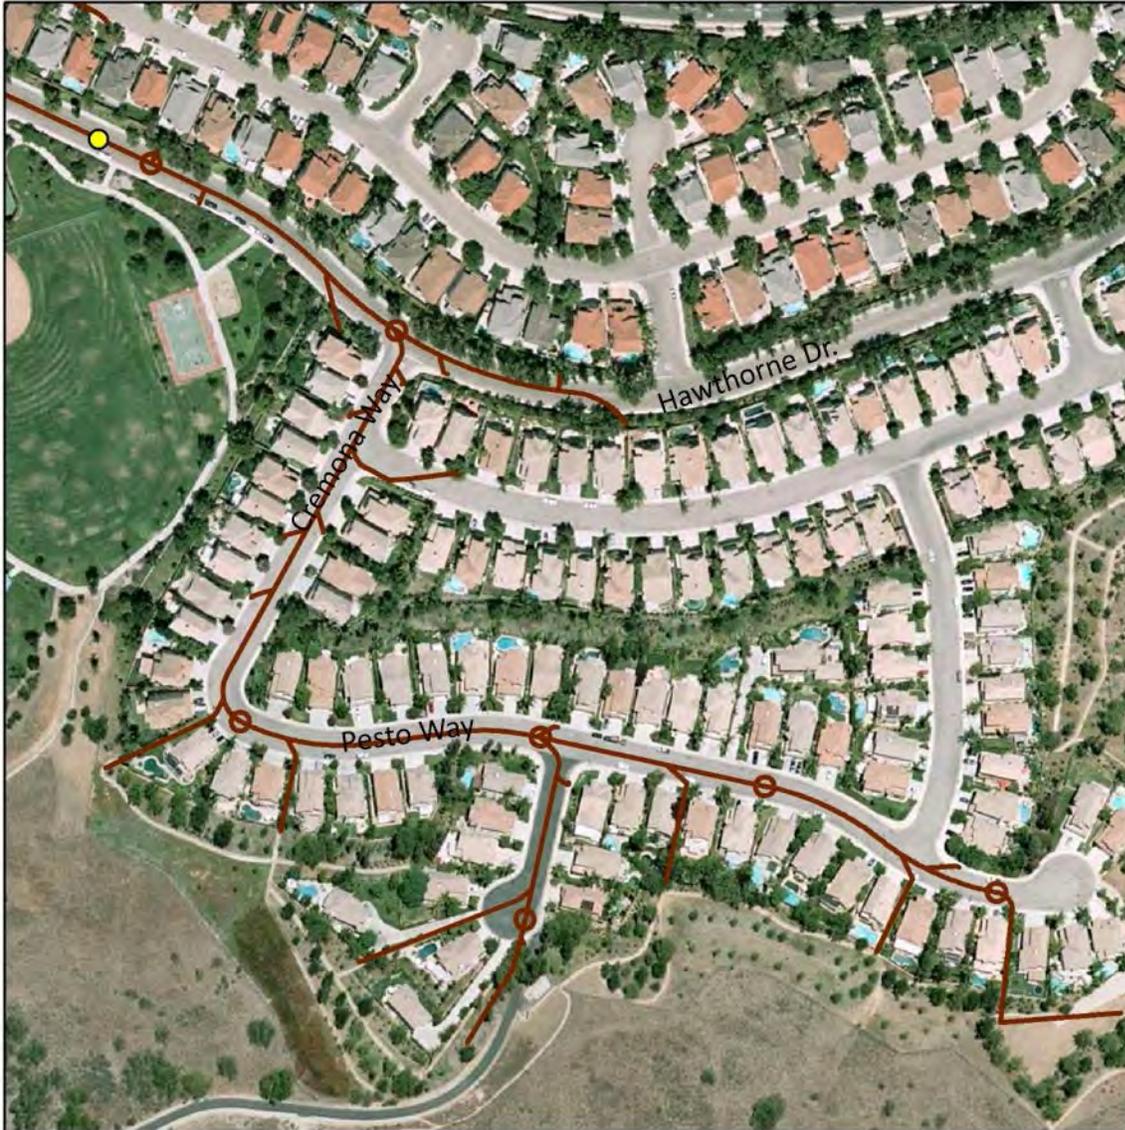
Fig.3.9. Detail of area upstream of L8 (yellow circle) where high concentrations of dog markers were found.

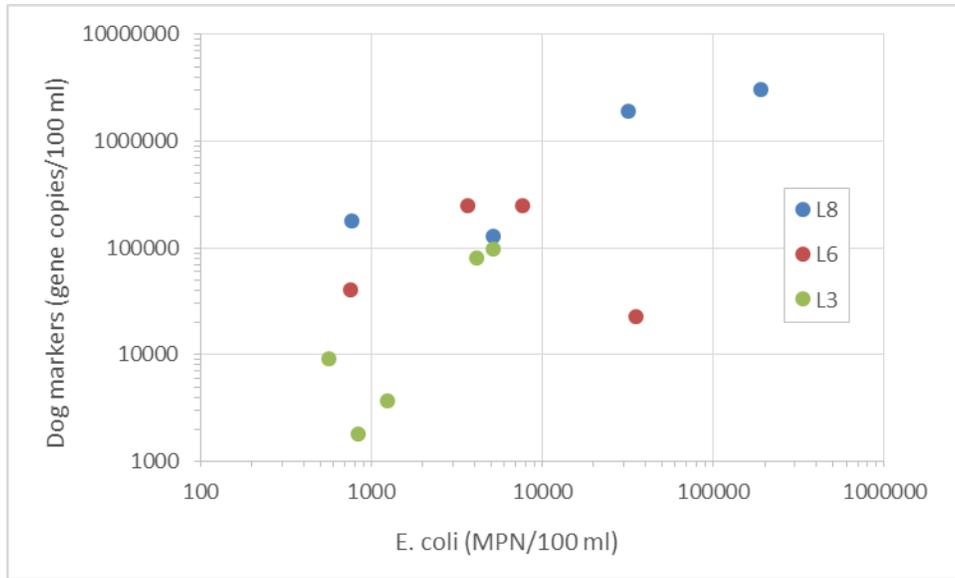
Fig. 3.10. Correlation between dog marker and *E. coli* concentrations at County locations L3, L6 and L8.

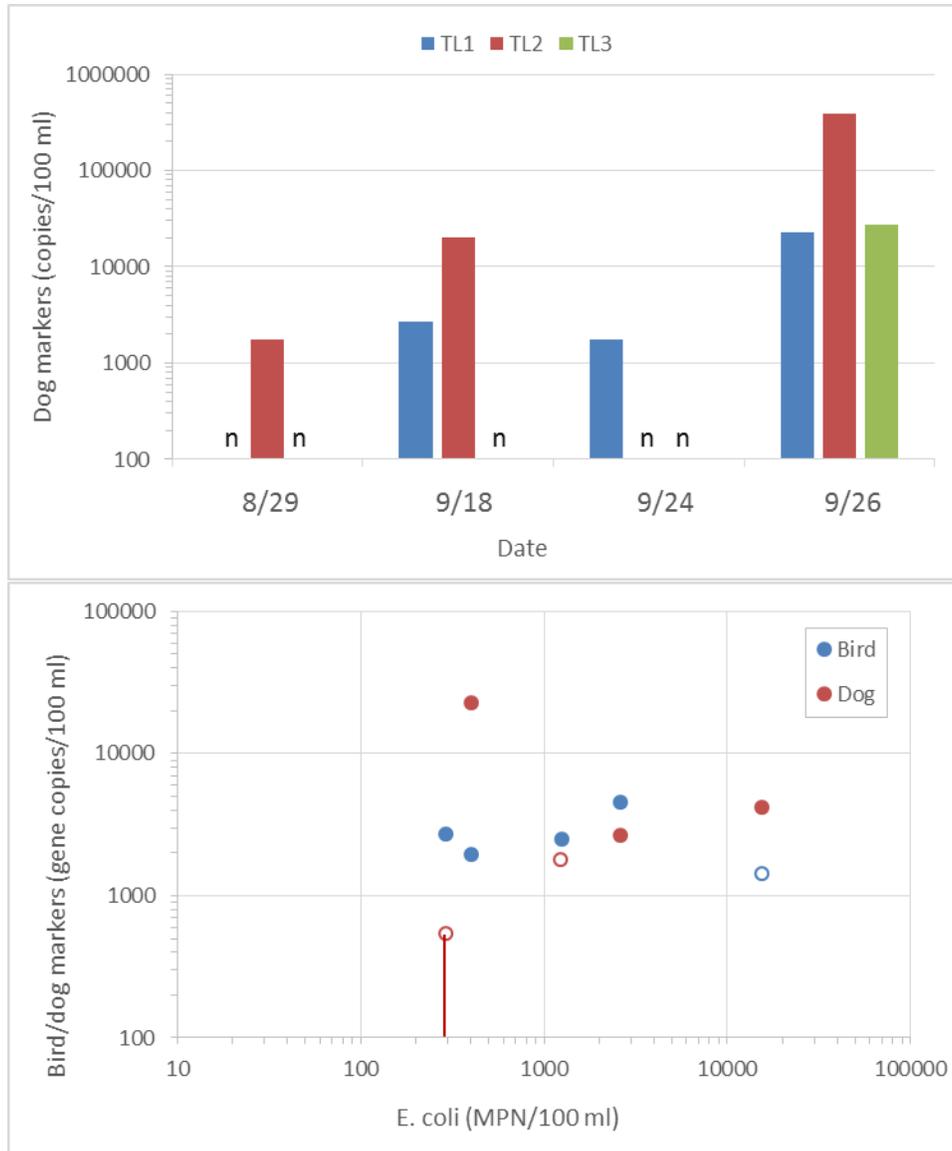
Fig. 3.11. Dog marker concentrations at TL1, TL2 and TL3 (top) and correlation between bird or dog marker and *E. coli* concentrations TL1 (bottom). Open symbols indicate samples below the limit of quantification (DNQ and ND). Vertical lines are used to indicate range between zero and limit of detection for samples qualified as ND.

Dog markers were not detected in any of the samples at the compliance station. However, many County samples showed consistent detection of dog markers. Based on consistent detections and a decreasing concentration pattern, results indicate that the source of dog markers was upstream of L8. Decreasing concentrations were consistent with decay and/or dilution upon transport to L6 and L3. Dog markers were also detected at L9 (detectable but not quantifiable), but not at L5. For the City, dog markers were detected at variable frequencies (25 – 80%) at TL1, TL2 and TL3, but not at the upstream creek locations TL7 and TL9.

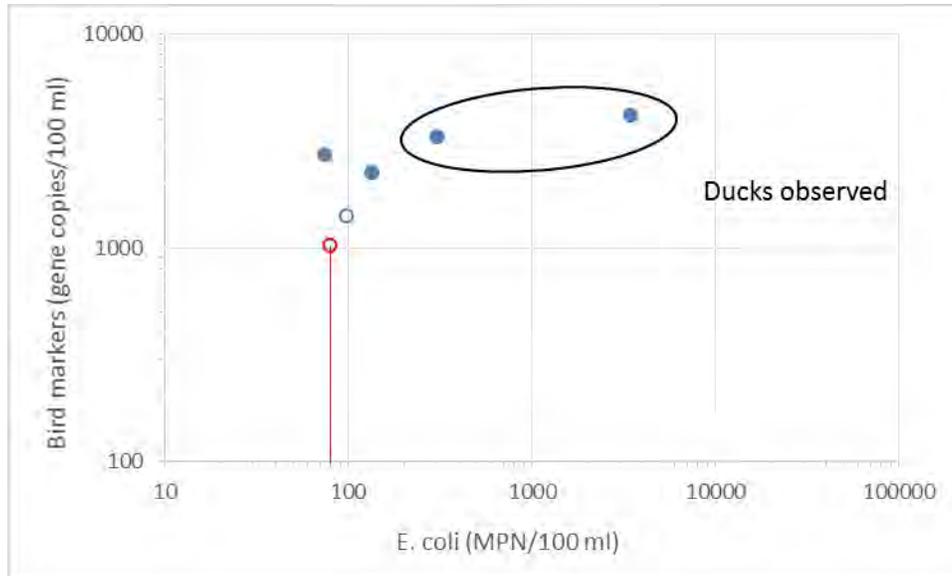
Fig. 3.12. Correlation between bird marker and *E. coli* concentrations at MCW14B. Open symbols indicate samples below the limit of quantification (blue: DNQ, red: ND). Vertical lines indicate range below limit of detection for samples qualified as non-detectable.

The Upper Lindero Creek is impacted by bird waste, but urban outfalls are not the source. Occurrence of in-stream sources was confirmed by duck sightings on two occasions just upstream of MCW14B. Concentrations of bird markers and *E. coli* at the compliance location were positively but not significantly correlated (Tau correlation = 0.6, $p = 0.09$), and duck observations coincided with the highest *E. coli* and bird marker concentrations (Fig. 3.12). Therefore, data suggest that fresh duck feces are the dominant source of *E. coli* and may even cause of numeric limit exceedances at MCW14B, although more sampling is needed to confirm.

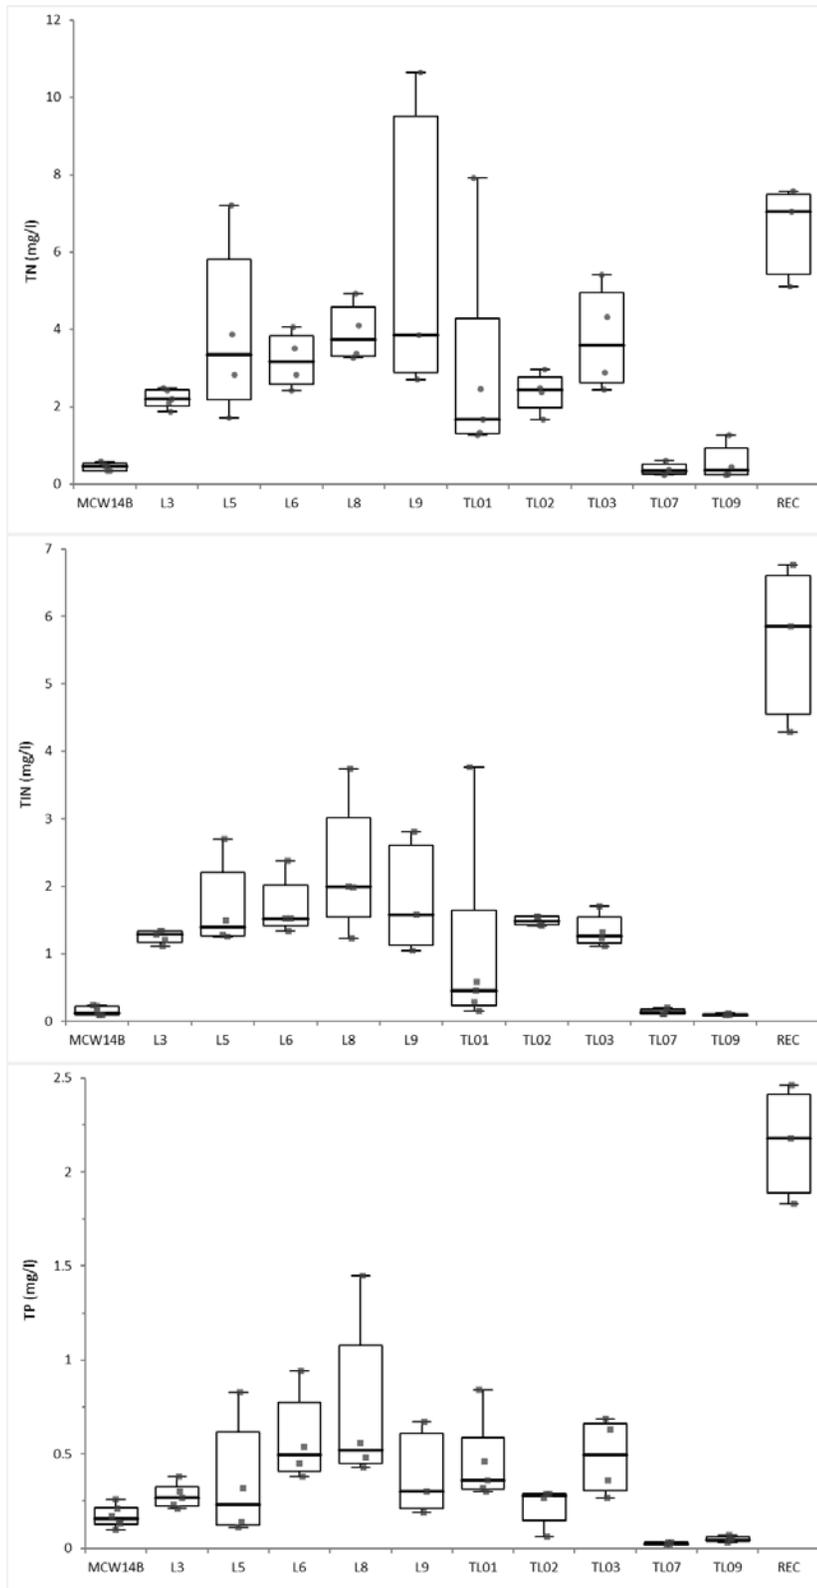
Fig. 3.13. Nutrient concentrations in Upper Lindero Creek drainage area. TN: total nitrogen, TIN: total inorganic nitrogen (nitrate and nitrite), TP: total phosphorus.

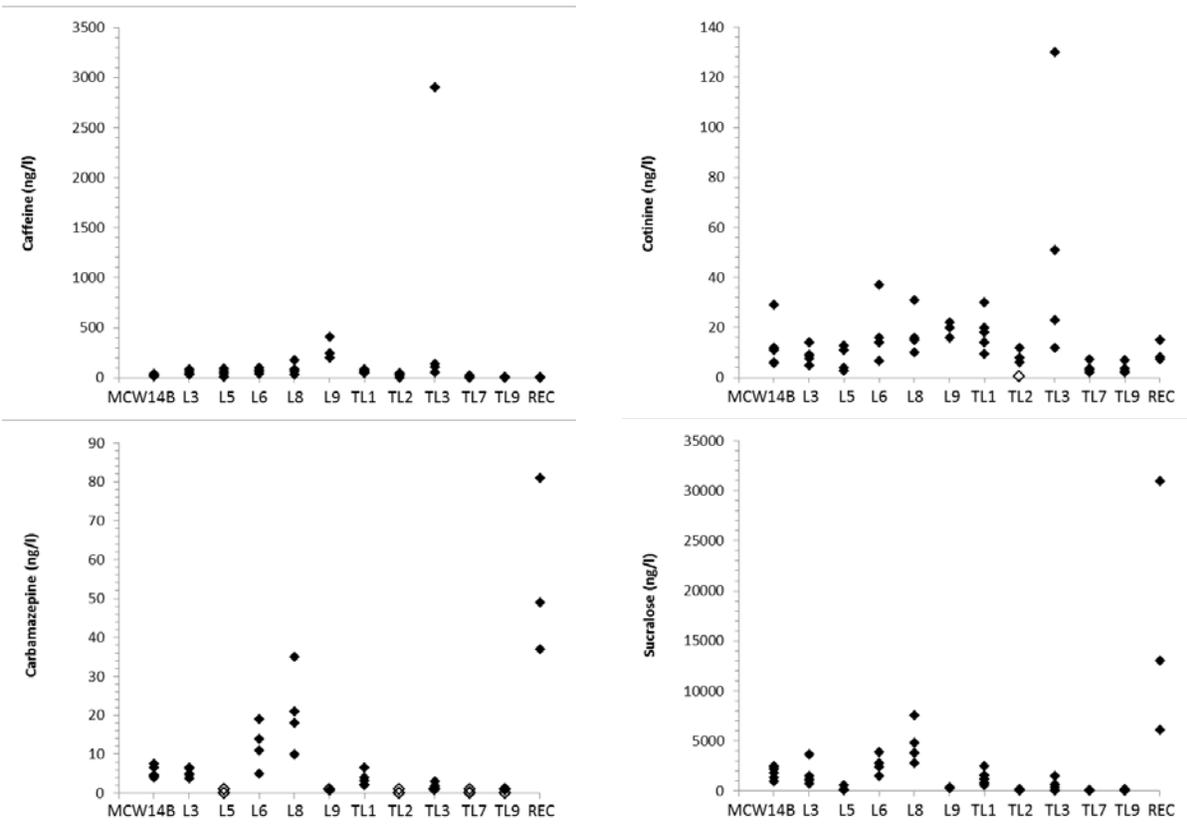
Fig. 3.14. Concentrations of potential chemical sewage indicators in Upper Lindero Creek drainage area.

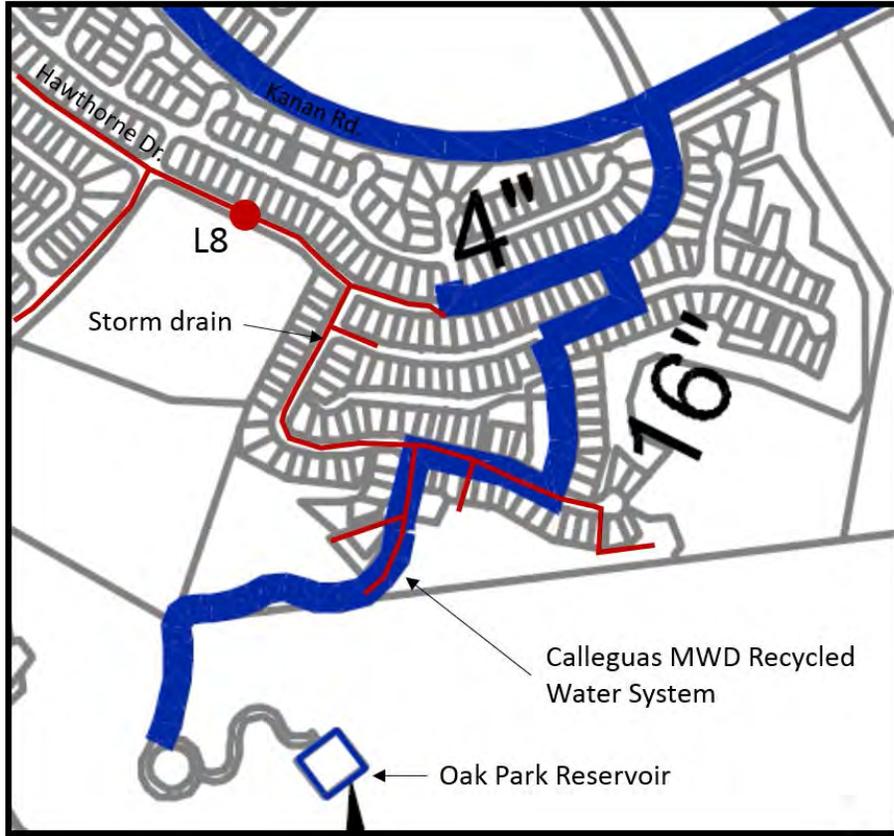
Fig. 3.15. Reclaimed and storm drain infrastructure upstream of location L8.

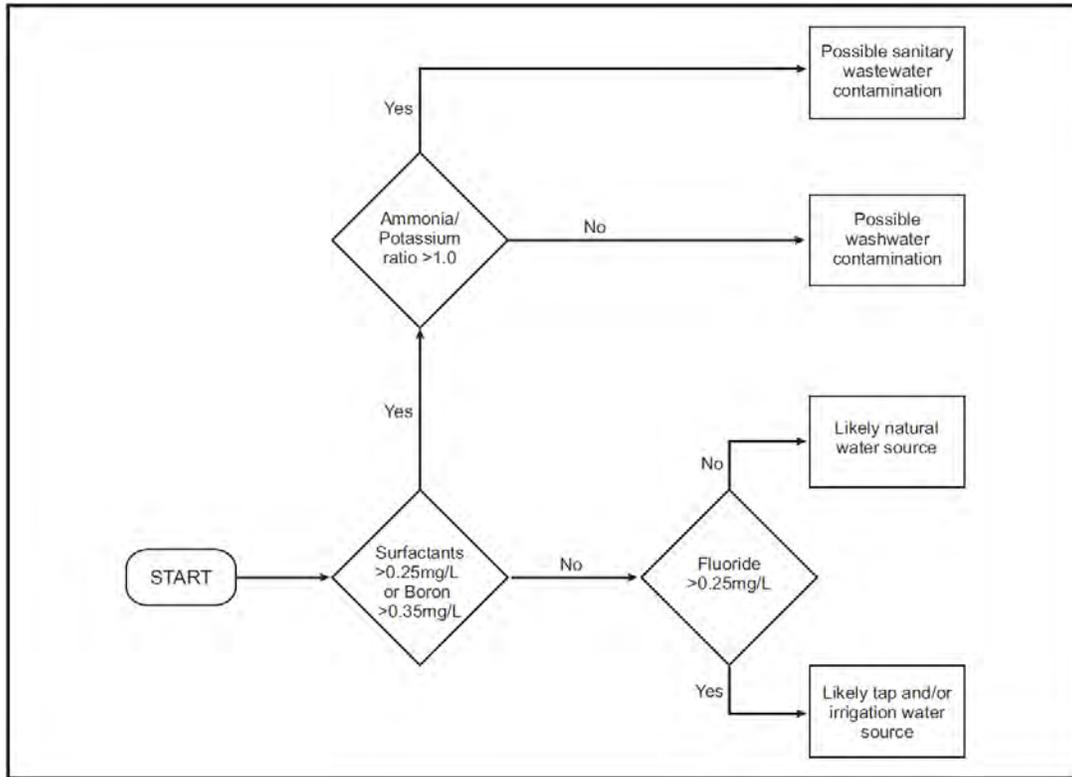
Fig. 3.16. Flow chart to identify illicit discharges in residential watersheds.

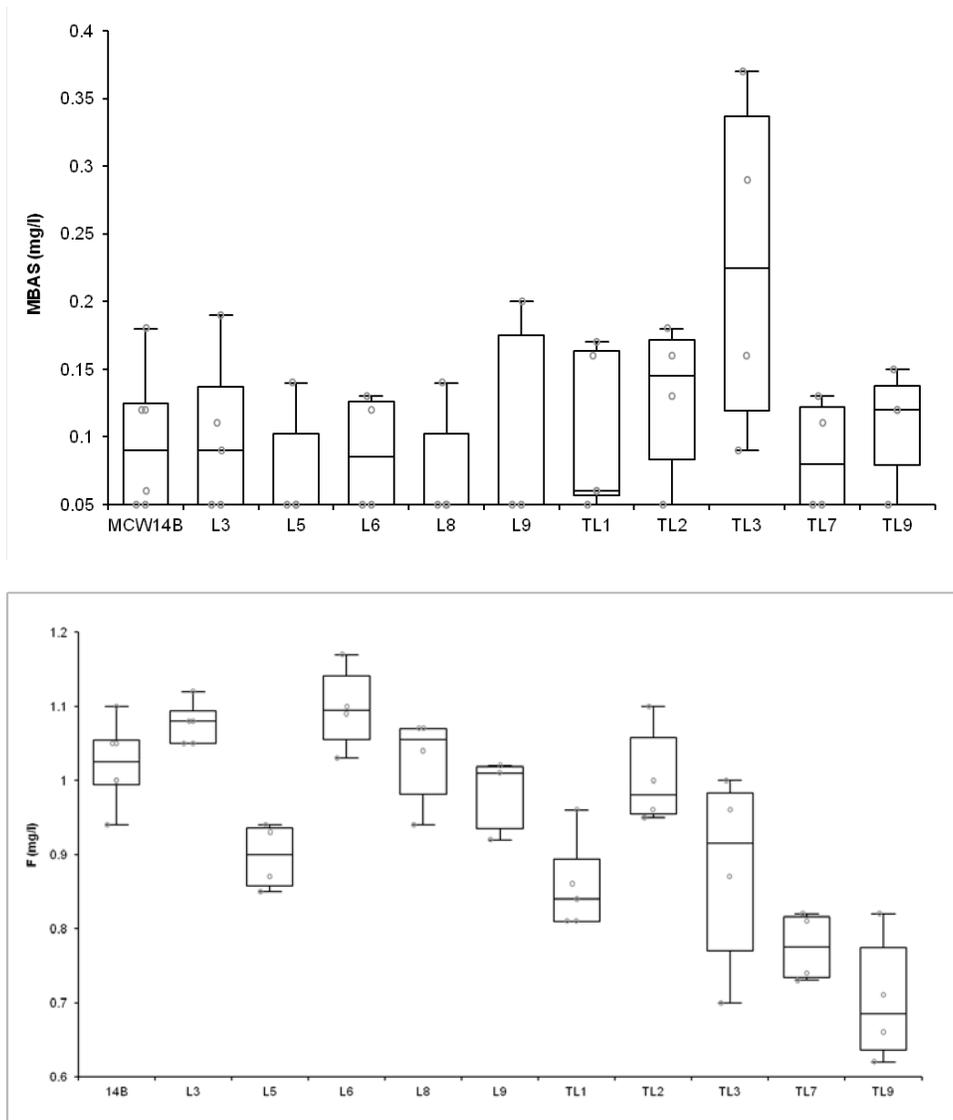
Fig. 3.17. Concentrations of MBAS (top) and fluoride (bottom) in Upper Lindero Creek drainage area.

Fluoride concentrations in the Upper Lindero Creek locations TL7 and TL9 were between 0.62 – 0.82 mg/l, but higher concentrations were observed in the urban outfalls in City and County (0.70 – 1.1 mg/l) (Fig. 3.17, bottom). It's unclear why the latter concentrations are higher than the approximately 0.8 mg/l measured in reclaimed water and the range of 0.6 – 1.0 mg/l reported for local drinking water (Calleguas Municipal water district, 2013), therefore fluoride was deemed unsuitable to distinguish flow inputs from natural sources versus tap/reclaimed water.

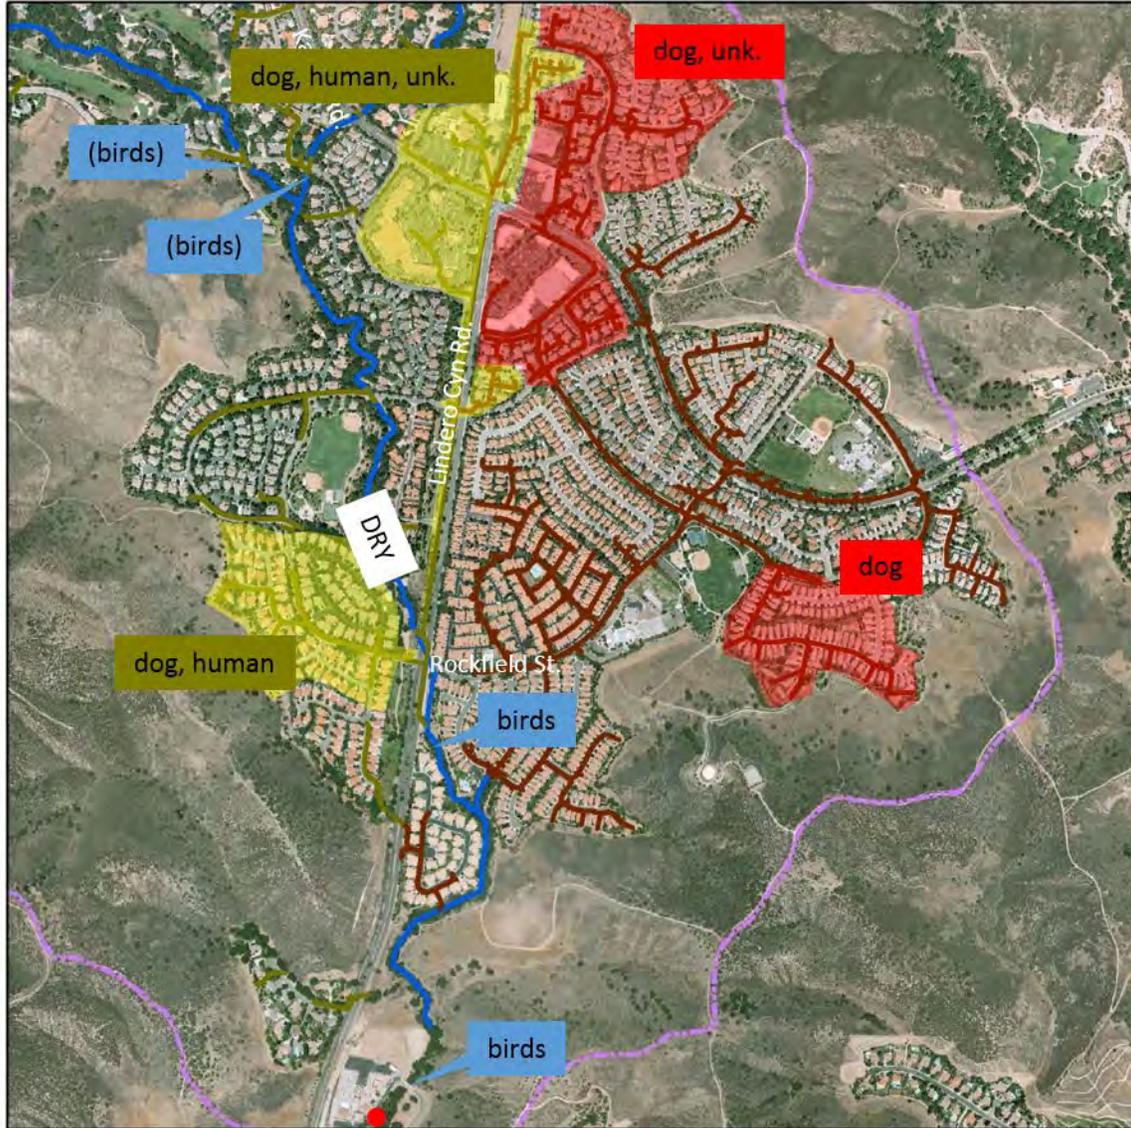
Fig. 3.18. Approximate urban areas (yellow/red) potentially contributing to elevated *E. coli* concentrations at the compliance station (red dot). Storm drains are indicated in brown (County) or green (City), creek in blue lines. Detected fecal sources are indicated in blue (creek) and green/red (storm drain) text boxes. Sources in parentheses do not contribute to the compliance station. Unknown sources are included as “unk.”.

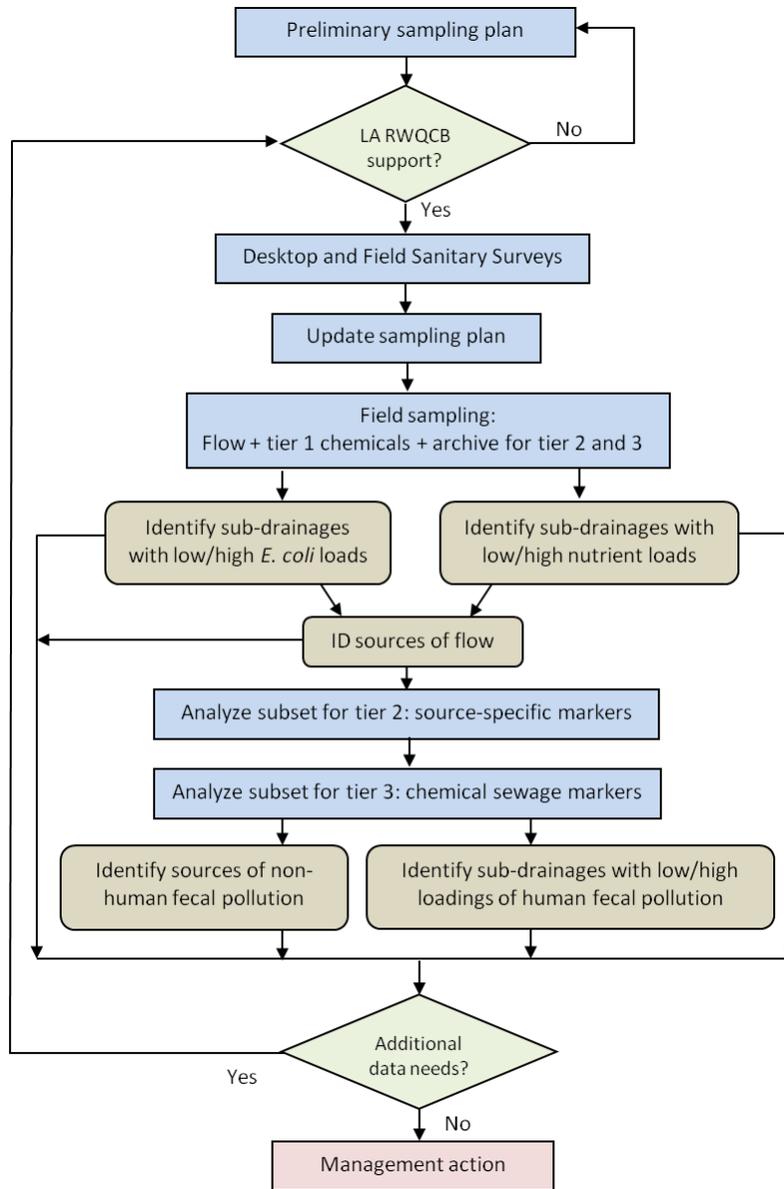
Figure 1. Source identification study general approach

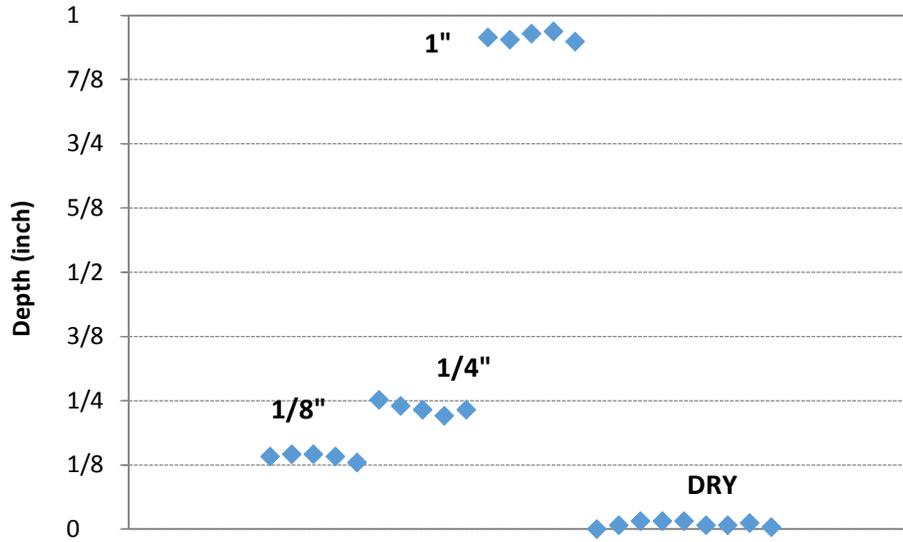
Fig. 2. Solinst Levellogger response in stagnant water depths between zero and 1 inch.

Occurrence of flow and temporal flow variation were also determined at selected locations using Solinst Levellogger Edge (2 m range) water level loggers. Sensitivity in stagnant water was tested before deployment, and levelloggers were sensitive enough to detect water levels/incremental changes of at least 1/8” (Fig. 2). Loggers were deployed attached to rocks placed in open channels or attached to the bottom of storm drain pipes (Fig. 3). One Solinst Barologger was deployed in the watershed (within 2 miles of each water level logger) for barometric pressure compensation.

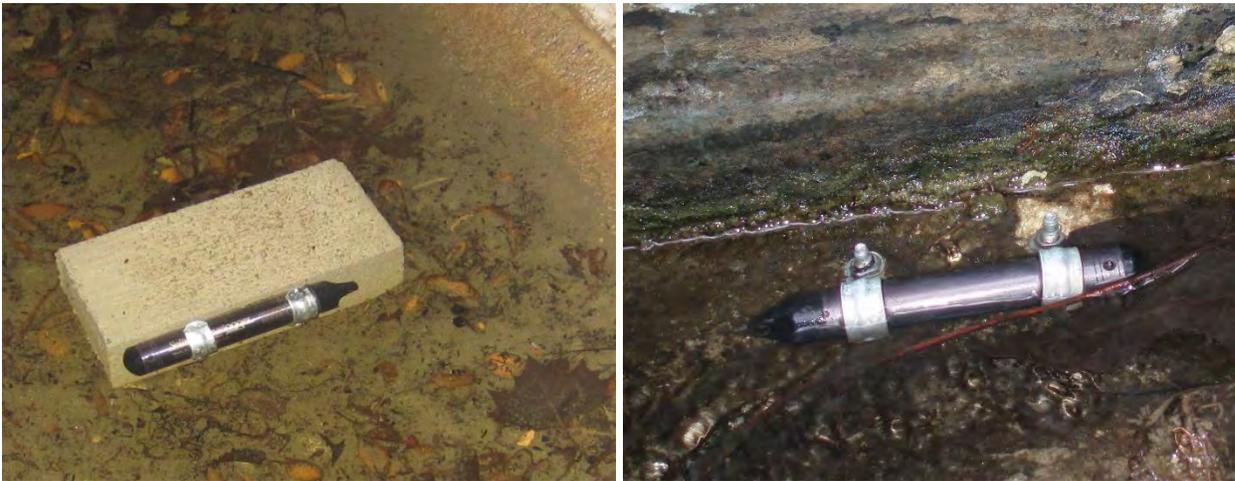
Fig. 3. Deployment of Solinst Levelloggers in storm drains and open channels
