*Ventura Countywide
Stormwater Quality
Management Program*

Ventura Countywide Stormwater Quality
Management Program Annual Report

Attachment E – TMDL Reports (3/3)

TOTAL MAXIMUM DAILY LOAD FOR ALGAE, EUTROPHIC CONDITIONS, AND NUTRIENTS IN VENTURA RIVER, INCLUDING THE ESTUARY, AND ITS TRIBUTARIES (VR ALGAE TMDL)

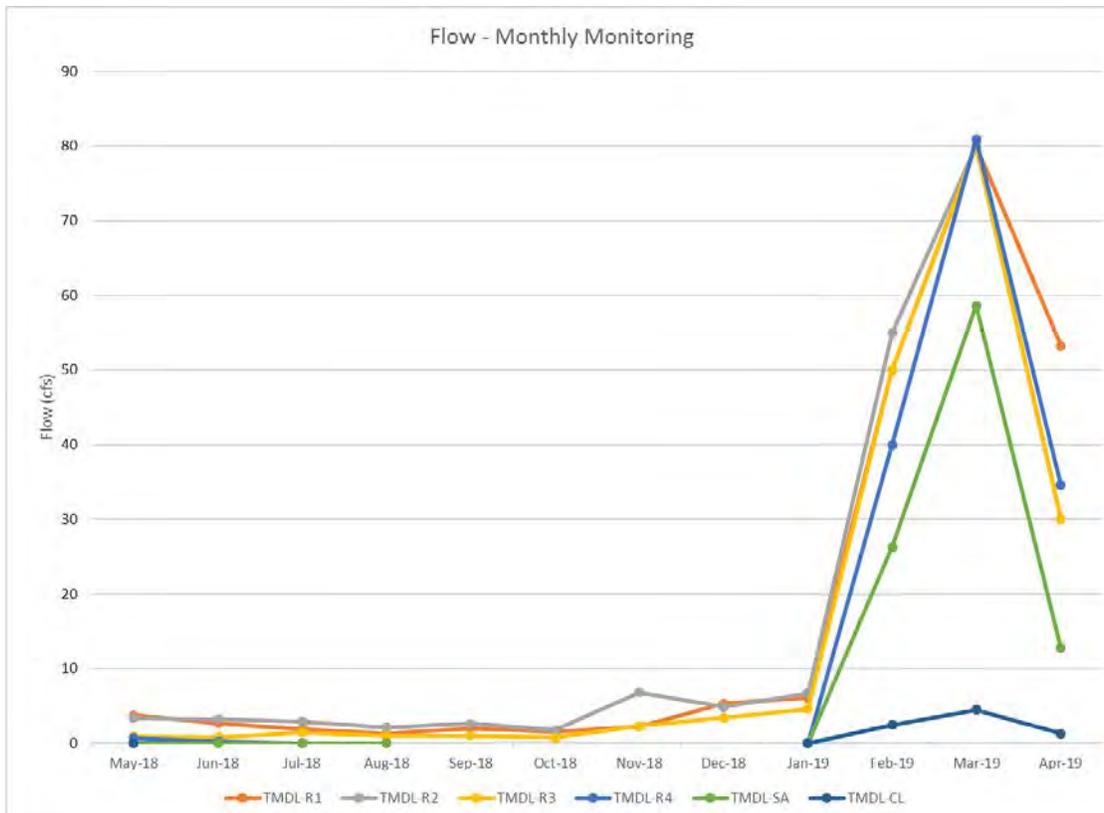
FIGURE 2. 2018 – 2019 MONTHLY MONITORING - FLOW

Year-round surface flow in the River starts around Foster Park (near the Casitas Vista Rd Bridge observation point) and is typically perennial at TMDL-R3 and below. The flow at TMDL-R2 is a combination of Ventura River surface flow downstream of TMDL-R3 and the discharge from the Ojai Valley Sanitary District’s wastewater treatment plant. Flow measurements taken during this reporting period were typically higher at TMDL-R2 than TMDL-R1 during ambient conditions but the reverse was true during the wettest periods (Feb - Apr 2019). Potential causes for changes in flow include surface/subsurface flow, groundwater interaction, geology and infiltration rates, antecedent moisture, agricultural and urban inputs and extractions, etc.

Absent data points indicate that the measurement could not be taken, i.e. the site was dry.

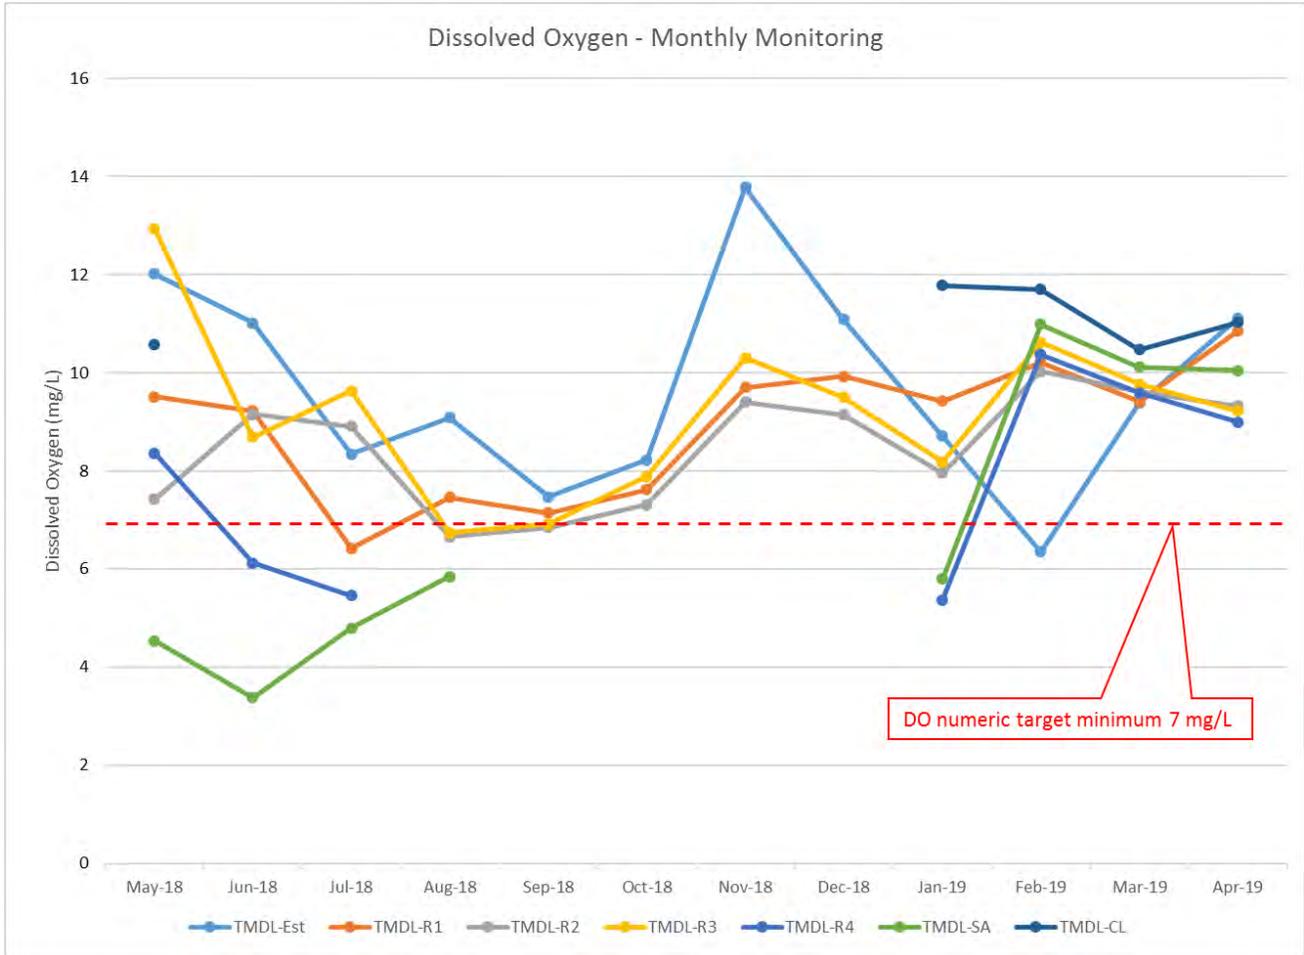
FIGURE 3. 2018 – 2019 MONTHLY MONITORING - DISSOLVED OXYGEN

Low levels of DO tended to occur during periods of low flow, possibly due to the ponding (and potential stagnation) of water observed upstream and/or at the measurement location.

Absent data points indicate that the measurement could not be taken, i.e. the site was dry.

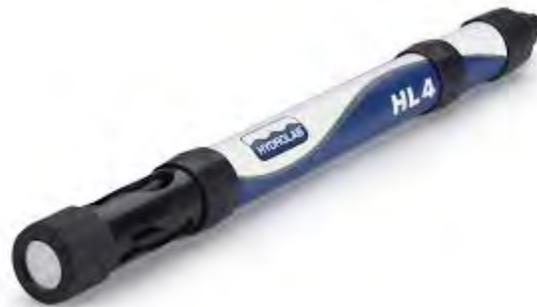
FIGURE 14. HYDROLAB HL4 SONDE

Seven Hydrolab HL4 water quality data sondes (Figure 14) are used for this program. The HL4 has the ability to accurately measure and log DO, conductivity, pH and temperature within a self-contained package that is 1.75" in diameter and just over two feet in length, which allows it to fit inside a short length of protective housing of 2" diameter schedule 40 pipe. The data sonde installations are vulnerable to potential vandalism and theft and so need to be as inconspicuous as possible (i.e. below the water surface among rocks and tree roots). Each sonde is assigned to a particular TMDL site and is labeled with the site name for additional consistency between events. Pre and post calibrations and/or calibration checks are performed for each deployed sonde for each event.

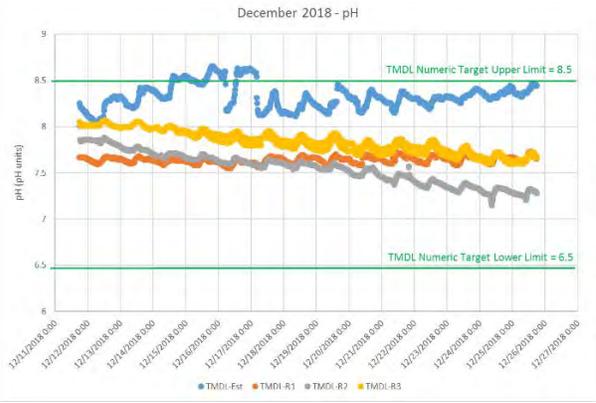
WET SEASON 2018-19

TMDL-R4, TMDL-SA, and TMDL-CL were dry during this event.

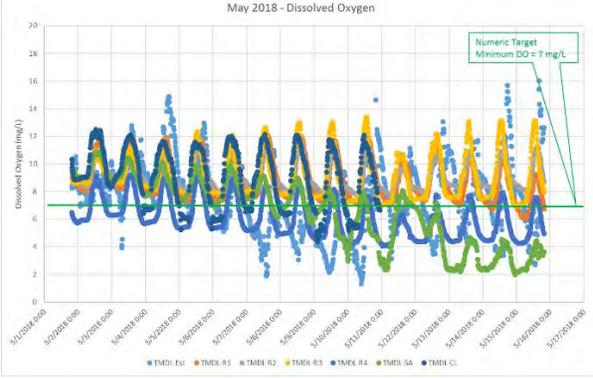
<p>May 2018 - Dissolved Oxygen</p> <p>Numeric Target Minimum DO = 7 mg/L</p> <p>Legend: TMDL-Est, TMDL-R1, TMDL-R2, TMDL-R3, TMDL-R4, TMDL-SA, TMDL-CL</p> <p>TMDL-SA: It is probable that the flow decreased towards the end of deployment, which caused changes in readings. TMDL-CL: The DO sensor became fouled two thirds of the way through deployment, so data is not included for that period.</p>

Low levels of DO (below the numeric target of 7 mg/L) were observed at most sites during the dry season deployments (May and September 2018), particularly at the low points of the diurnal variation. TMDL-CL also dipped below 7 mg/L during the low points of the diurnal variation in March 2019. All monitored sites were above the target in December 2018. Low DO appears to be generally associated with low flow, possibly due to the ponding of water upstream and/or at the measurement location. All sites exhibited diurnal variation in levels.

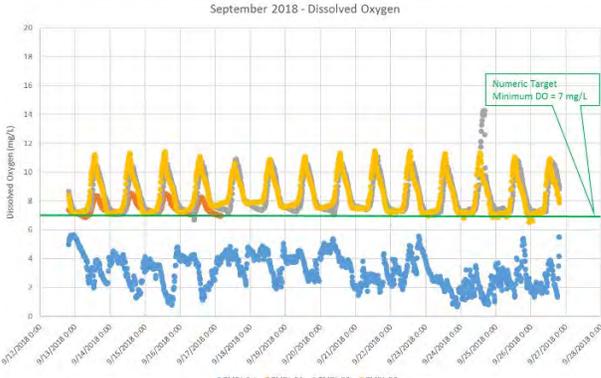
<p>September 2018 - Dissolved Oxygen</p> <p>Numeric Target Minimum DO = 7 mg/L</p> <p>Legend: TMDL-Est, TMDL-R1, TMDL-R2, TMDL-R3</p> <p>TMDL-R4, TMDL-SA, and TMDL-CL were dry during this event. TMDL-R1: The DO sensor became fouled near the end of the first week of deployment.</p>

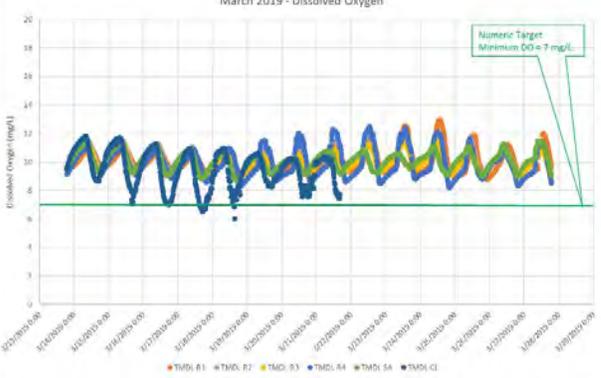
<p>March 2019 - Dissolved Oxygen</p> <p>Numeric Target Minimum DO = 7 mg/L</p> <p>Legend: TMDL-Est, TMDL-R1, TMDL-R2, TMDL-R3, TMDL-SA, TMDL-CL</p> <p>TMDL-Est: Sonde not deployed due to high risk of theft in current estuary (open river) condition. TMDL-CL: DO readings are in error for this deployment due to sensor fouling (suspected to have begun mid-deployment).</p>

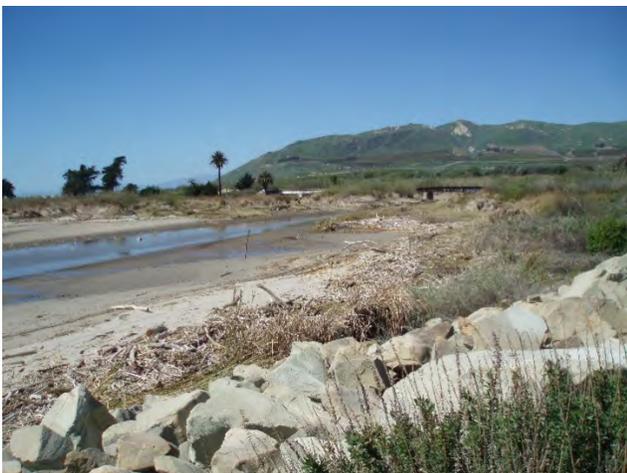
Photo 1. East end of estuary looking inland towards the former (now dry) connection to the main flow.

Heavy storms in early 2019 postponed sonde deployment for all sites until March due to heavy flow. The storms also reshaped the estuary, separating the east end of the estuary from the river (Photo 1) but maintaining its connection to the ocean (Photo 2), eliminating the vegetation cover and drying out the location where the sonde had been able to be discreetly deployed during previous monitoring events (Photo 3), and causing the west end of the estuary to exhibit riverine and exposed characteristics. High pedestrian/homeless traffic in the area and the shape of the wet portion of the estuary combined to create a high risk of theft/vandalism of the sonde (Photo 4 and Photo 5), so the estuary sonde was not deployed in 2019-Q1 (March 2019).

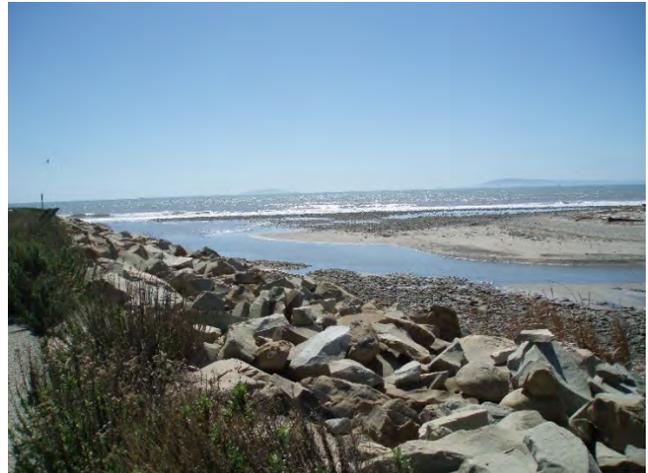
Photo 2. East end of estuary open to the ocean.

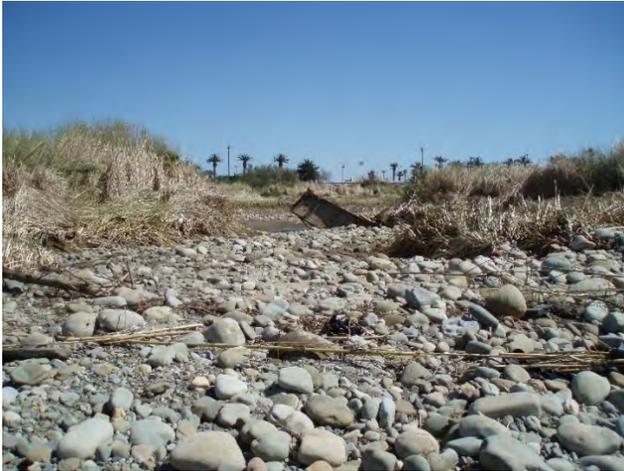
Photo 3. Former site of sonde deployment exposed and dry in 2019-Q1.

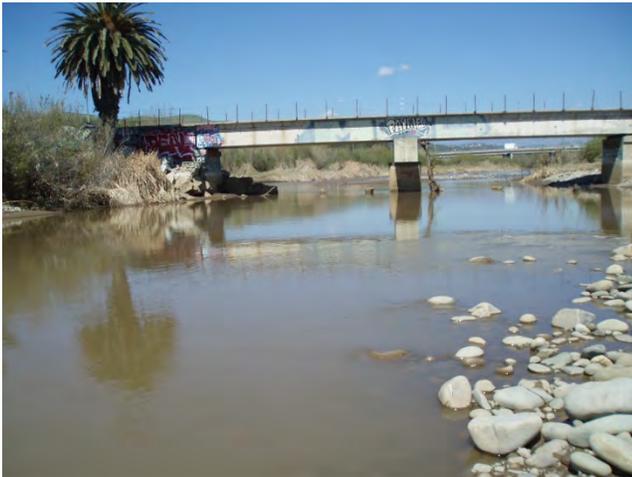
Photo 4. West end of estuary looking inland. Railroad bridge in foreground receives heavy pedestrian/homeless traffic.

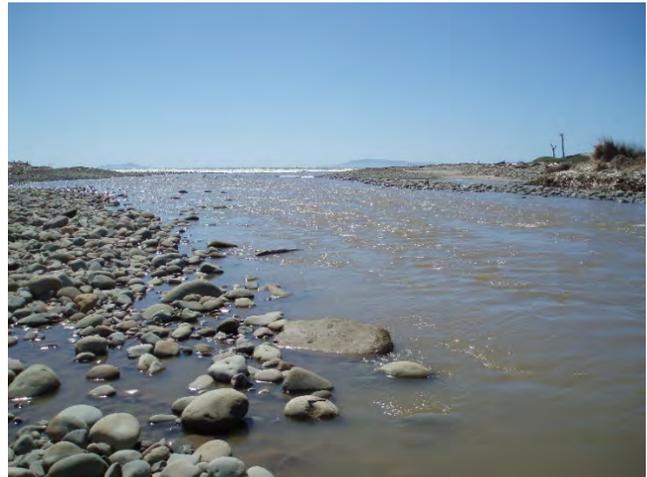
Photo 5. West end of estuary looking to the ocean. Berm was fully breached in 2019-Q1 and estuary resembled a river mouth.

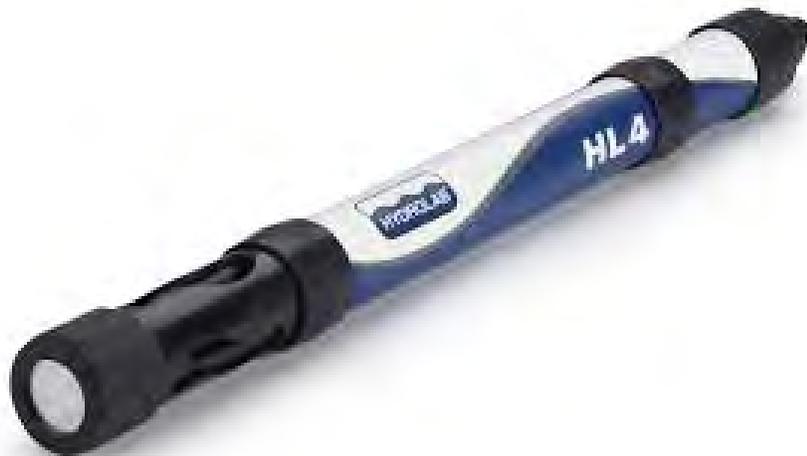
FIGURE 3. HYDROLAB HL4 SONDE

Seven Hydrolab HL4 water quality data sondes (Figure 3) are used for the continuous data monitoring requirement of this program. The HL4 has the ability to accurately measure and log DO, conductivity, pH and temperature within a self-contained package that is 1.75” in diameter and just over two feet in length, which allows it to fit inside a short length protective housing of 2” diameter schedule 40 pipe. The data sonde installations are vulnerable to potential vandalism and theft and so need to be as inconspicuous as possible (i.e. below the water surface among rocks and tree roots). Each sonde is assigned to a particular TMDL site and is labeled with the site name for additional consistency between events. Pre and post calibrations and/or calibration checks are performed for each deployed sonde for each event.

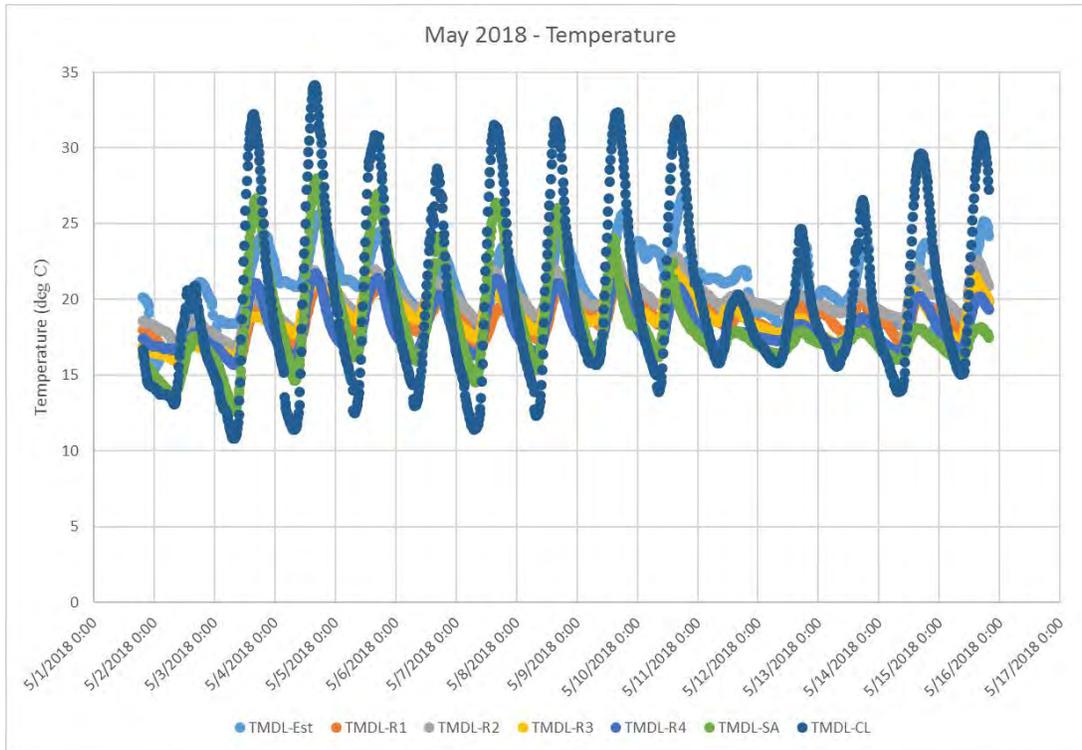
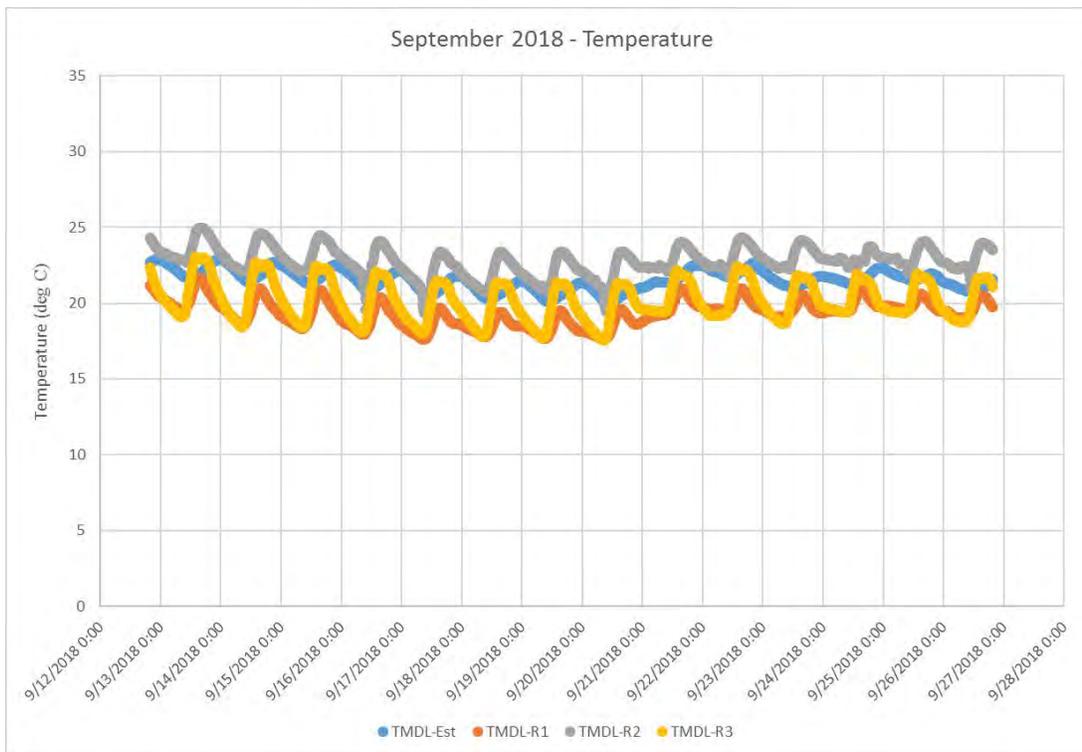
FIGURE 4. DRY SEASON 2018 - TEMPERATURE (CONTINUOUS DATA LOGGER)

TMDL-SA: It is probable that the flow decreased towards the end of deployment, which caused changes in readings.

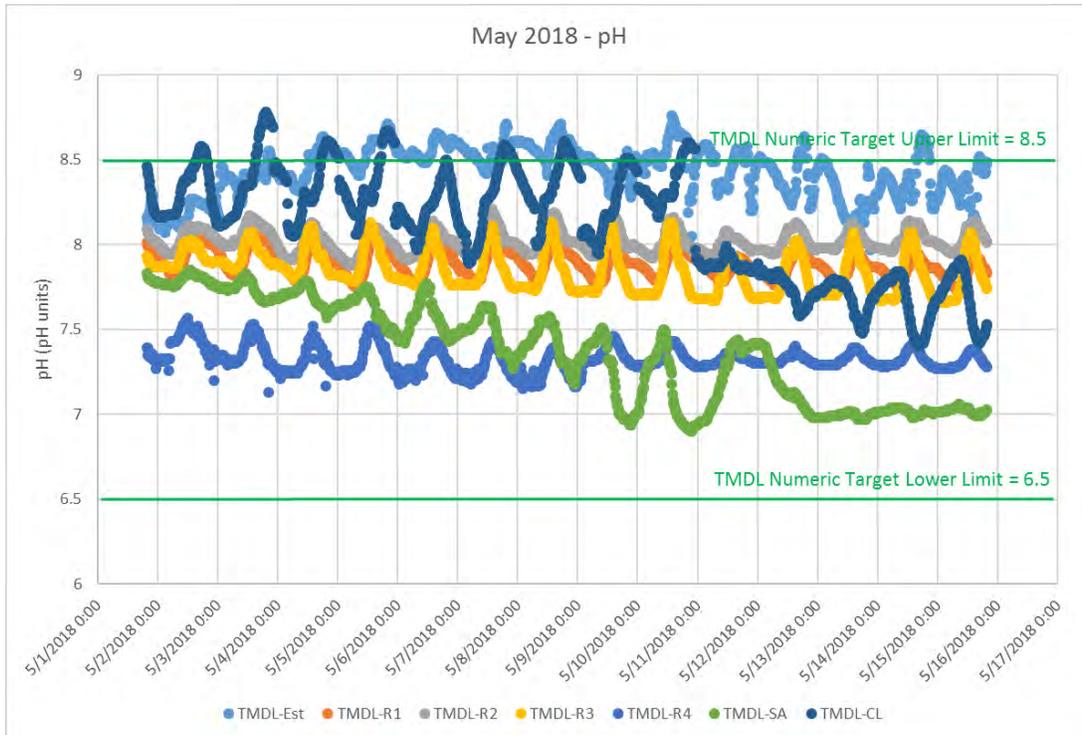
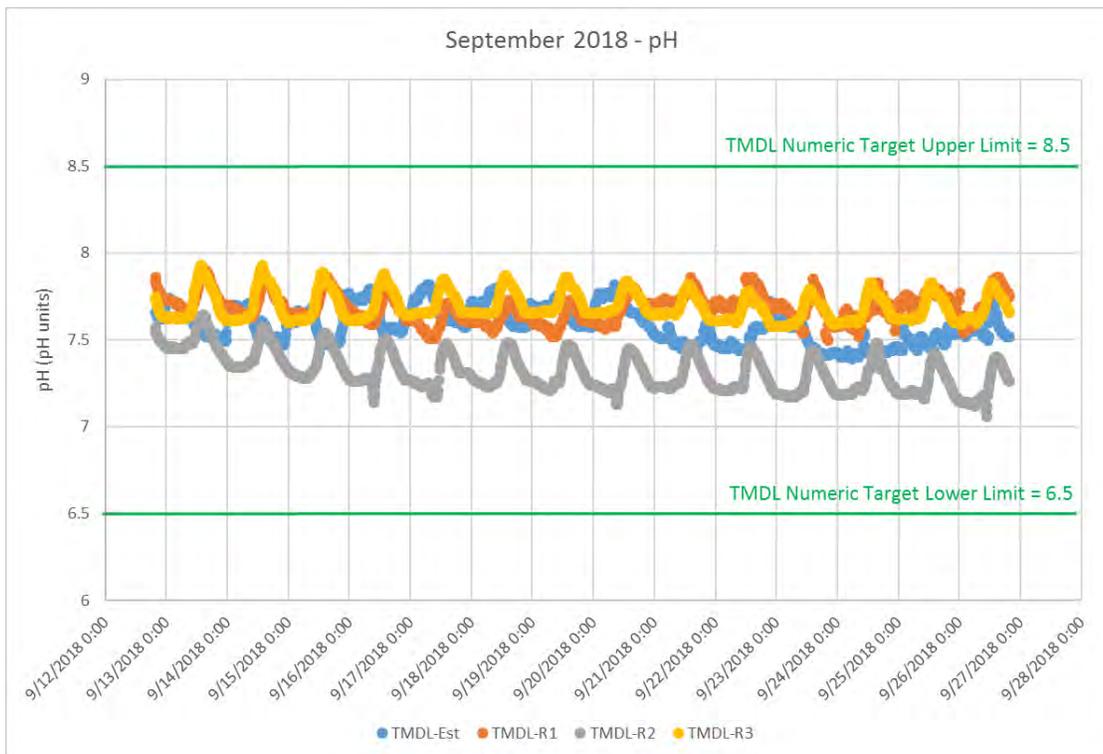
FIGURE 5. DRY SEASON 2018 - PH (CONTINUOUS DATA LOGGER)

TMDL-SA: It is probable that the flow decreased towards the end of deployment, which caused changes in readings.

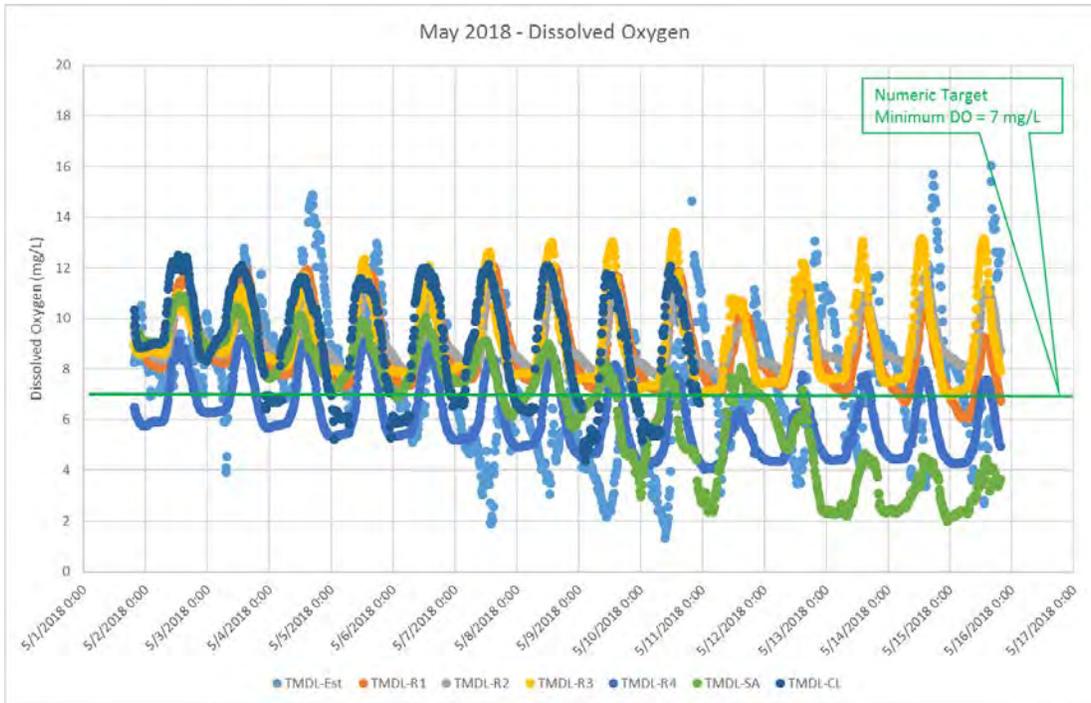
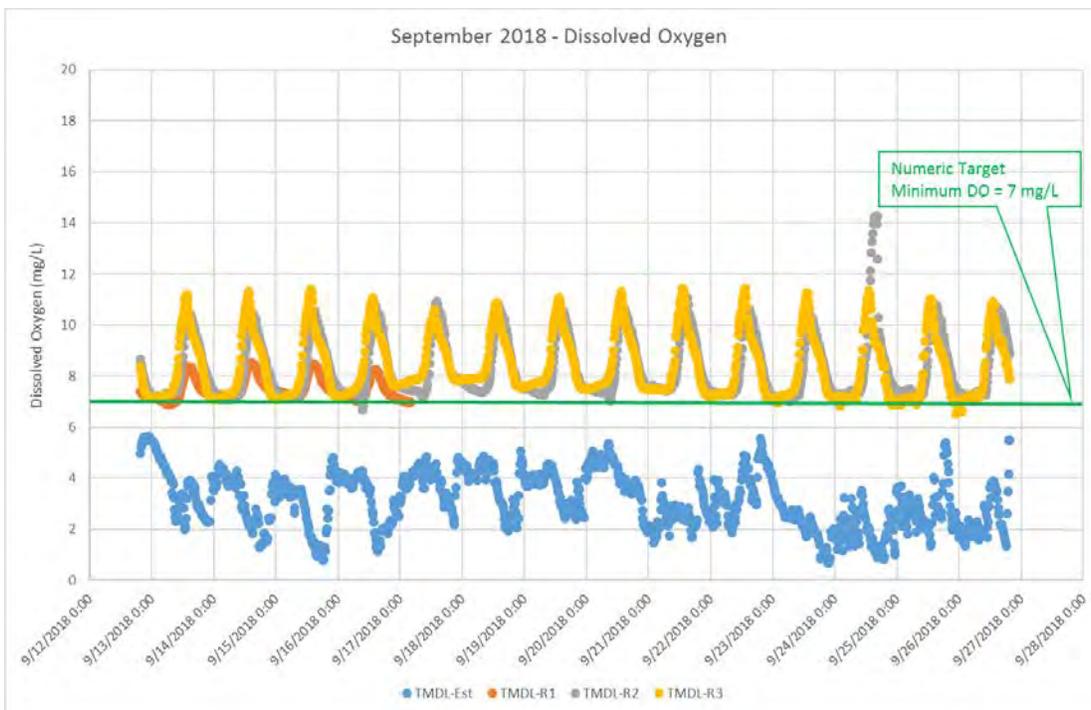
FIGURE 6. DRY SEASON 2018 - DISSOLVED OXYGEN (CONTINUOUS DATA LOGGER)

TMDL-SA: It is probable that the flow decreased towards the end of deployment, which caused changes in readings. TMDL-CL: The DO sensor became fouled two thirds of the way through deployment, so data is not included for that period.

TMDL- R1: The DO sensor became fouled near the end of the first week of deployment.

Low levels of DO (below the numeric target of 7 mg/L) were observed frequently at sites with low flow for the monthly grab monitoring, particularly at TMDL-R4 and TMDL-SA, and during the dry season sonde deployments at almost all sites. The general association with low flow is possibly due to the ponding of water upstream and/or at the measurement location, as well as higher temperatures. Similar to 2017, DO levels below the numeric target were observed during the continuous monitoring at most sites during the May deployment, and again at the September deployment. All sites exhibited diurnal variation in levels. The lower levels during the diurnal cycles resulted in a few dips below the numeric threshold for TMDL-CL in March. All sites were above the DO threshold in December.

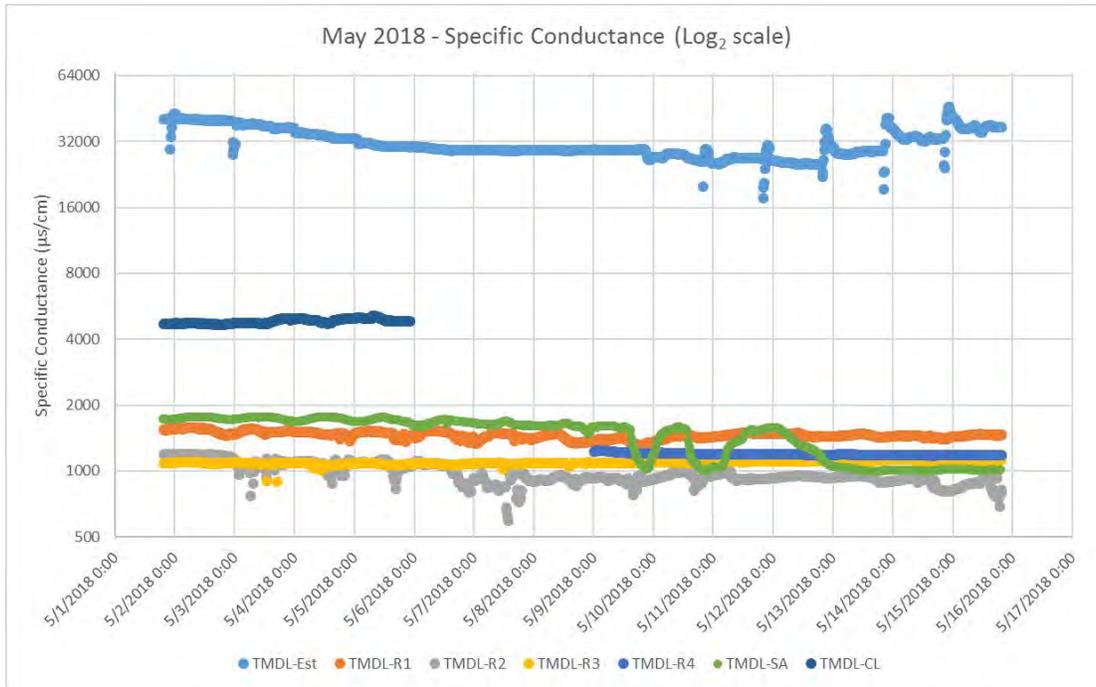
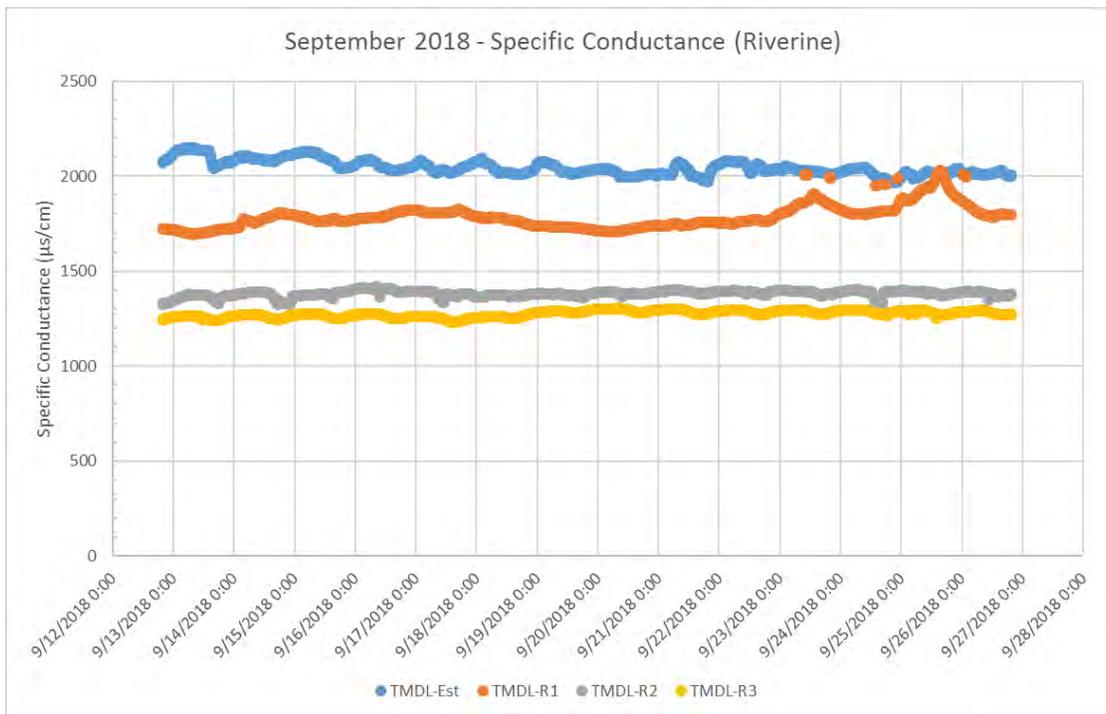
FIGURE 7. DRY SEASON 2018 - SPECIFIC CONDUCTANCE (CONTINUOUS DATA LOGGER)

TMDL-R4: Conductivity readings were in error for the first half of the deployment. TMDL-CL: Conductivity sensor became fouled a third of the way through deployment. Conductivity is not a required parameter for these sites and the erroneous measurements are not included in this chart. TMDL-SA: It is probable that the flow decreased towards the end of deployment, which caused changes in readings.

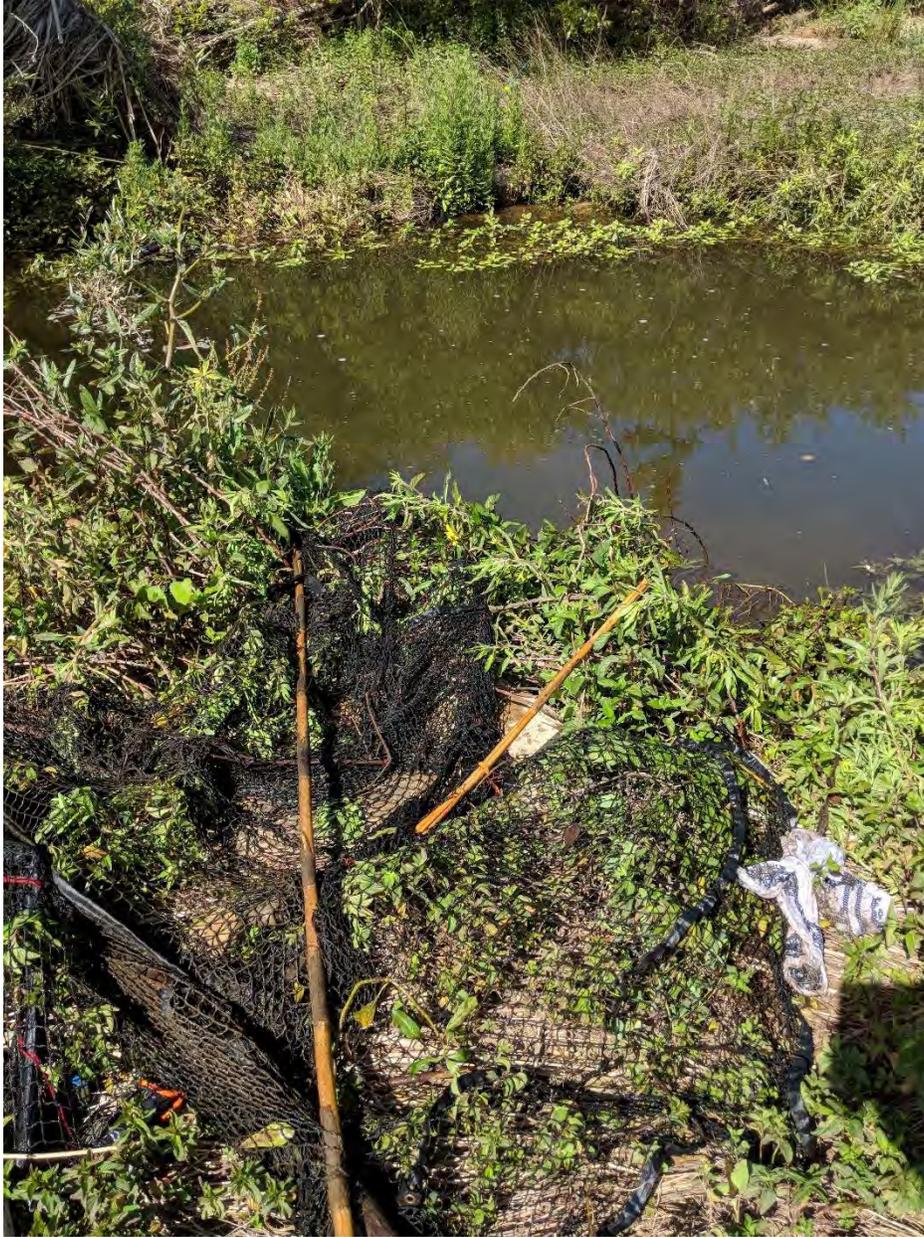
6.12.18 Cleanup: Net removed from the river. This is the third net pulled from this area and it was blocking all fish passage. Rocks tied in to weigh down the bottom and Arundo across the top for floatation. FWS contacted about the issue.

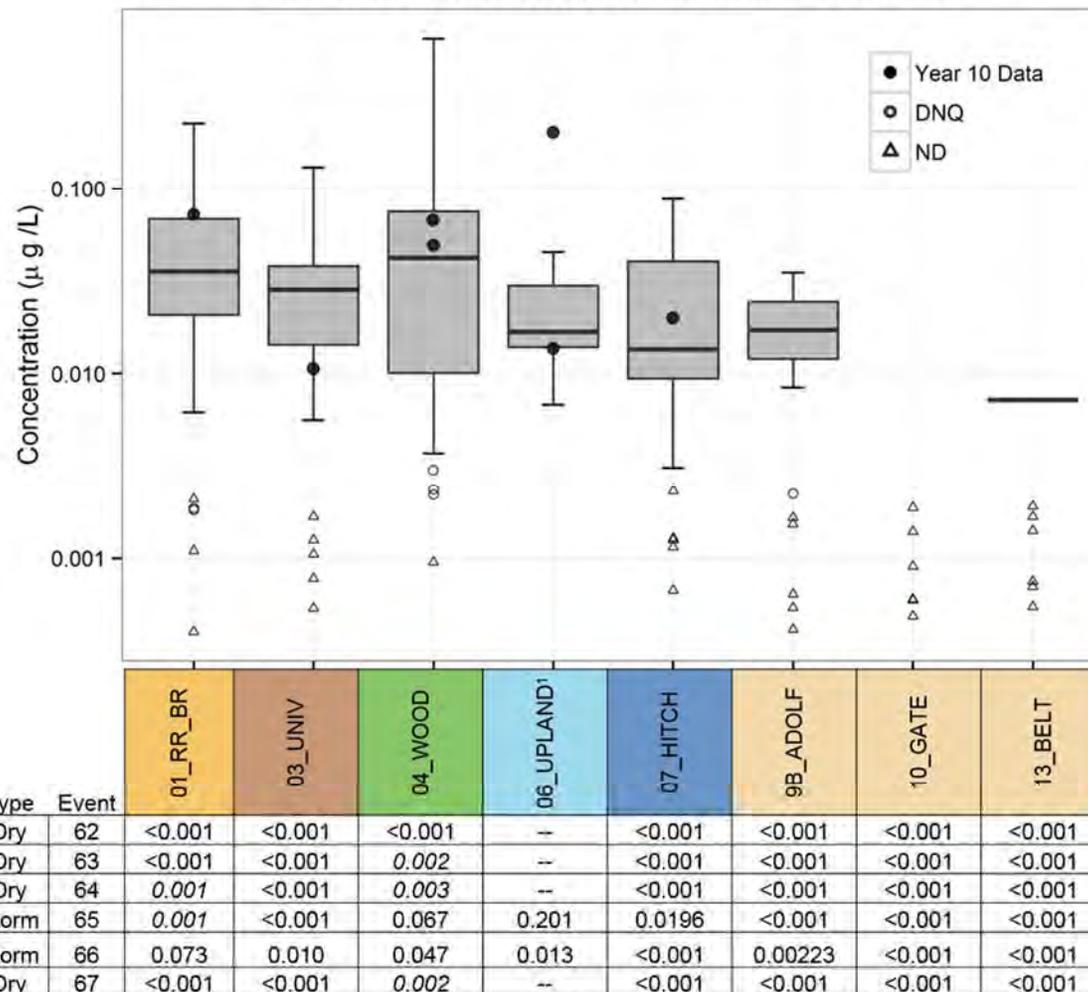
4,4'-DDD in Receiving Water Sites: 2008-2018

1. Access to 06_SOMIS was revoked during Year 8 and was replaced by 06_UPLAND in Year 9. All collected data prior to event 56 were obtained from 06_SOMIS. This footnote applies to all boxplots with 06_UPLAND.

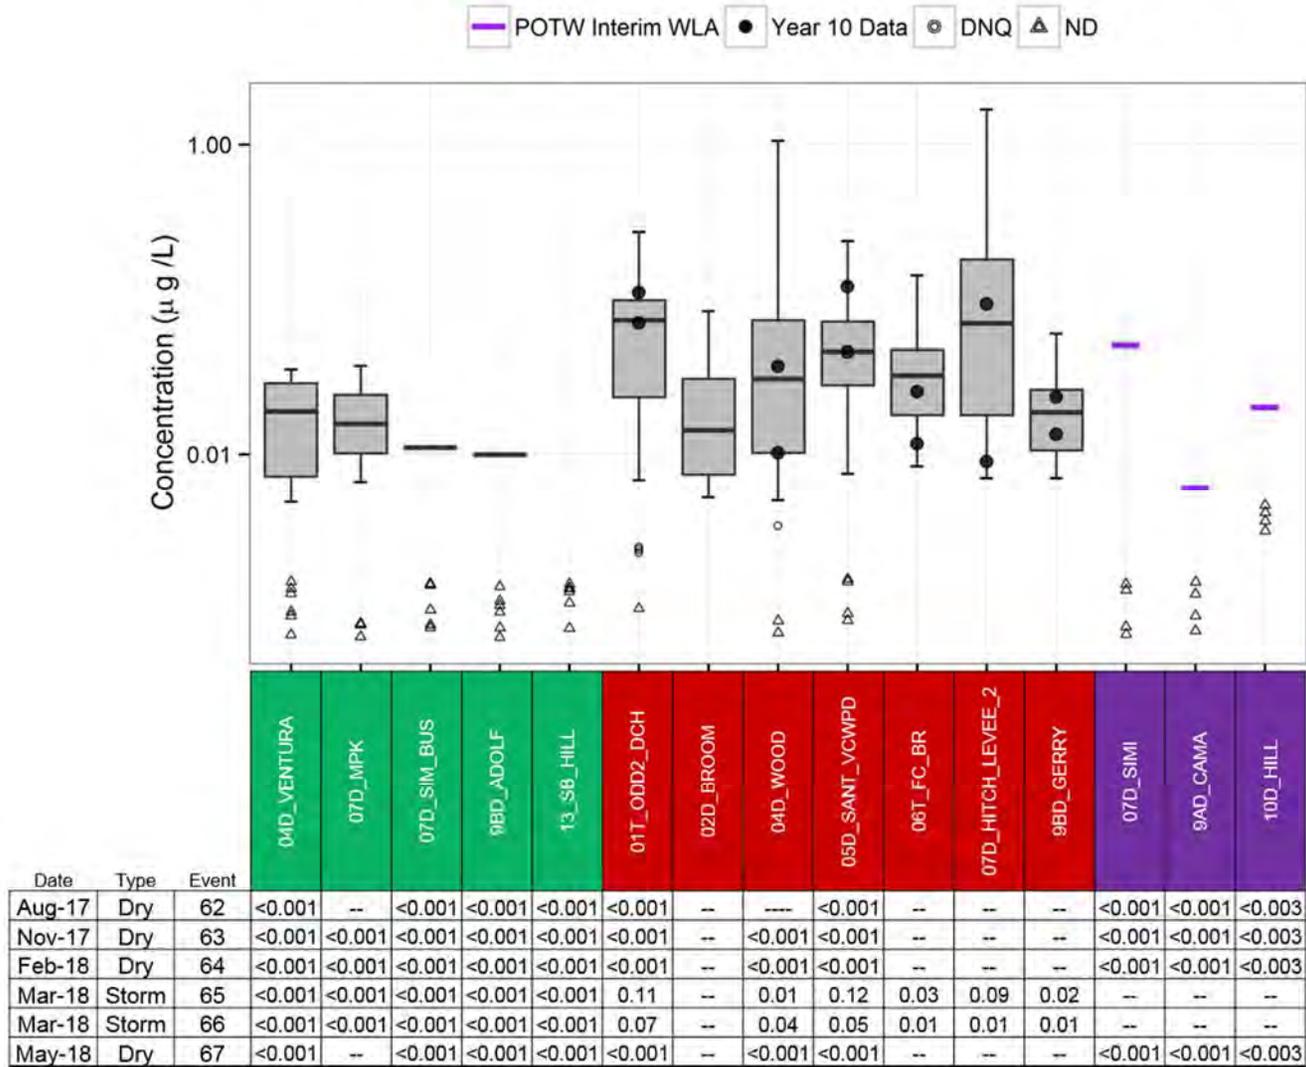
Figure 11. 4,4'-DDD Water Column Concentrations in Urban, Ag, and POTW Sites: 2008-2018

4,4'-DDD in Water from Urban, Ag, & POTW Sites: 2008-2018

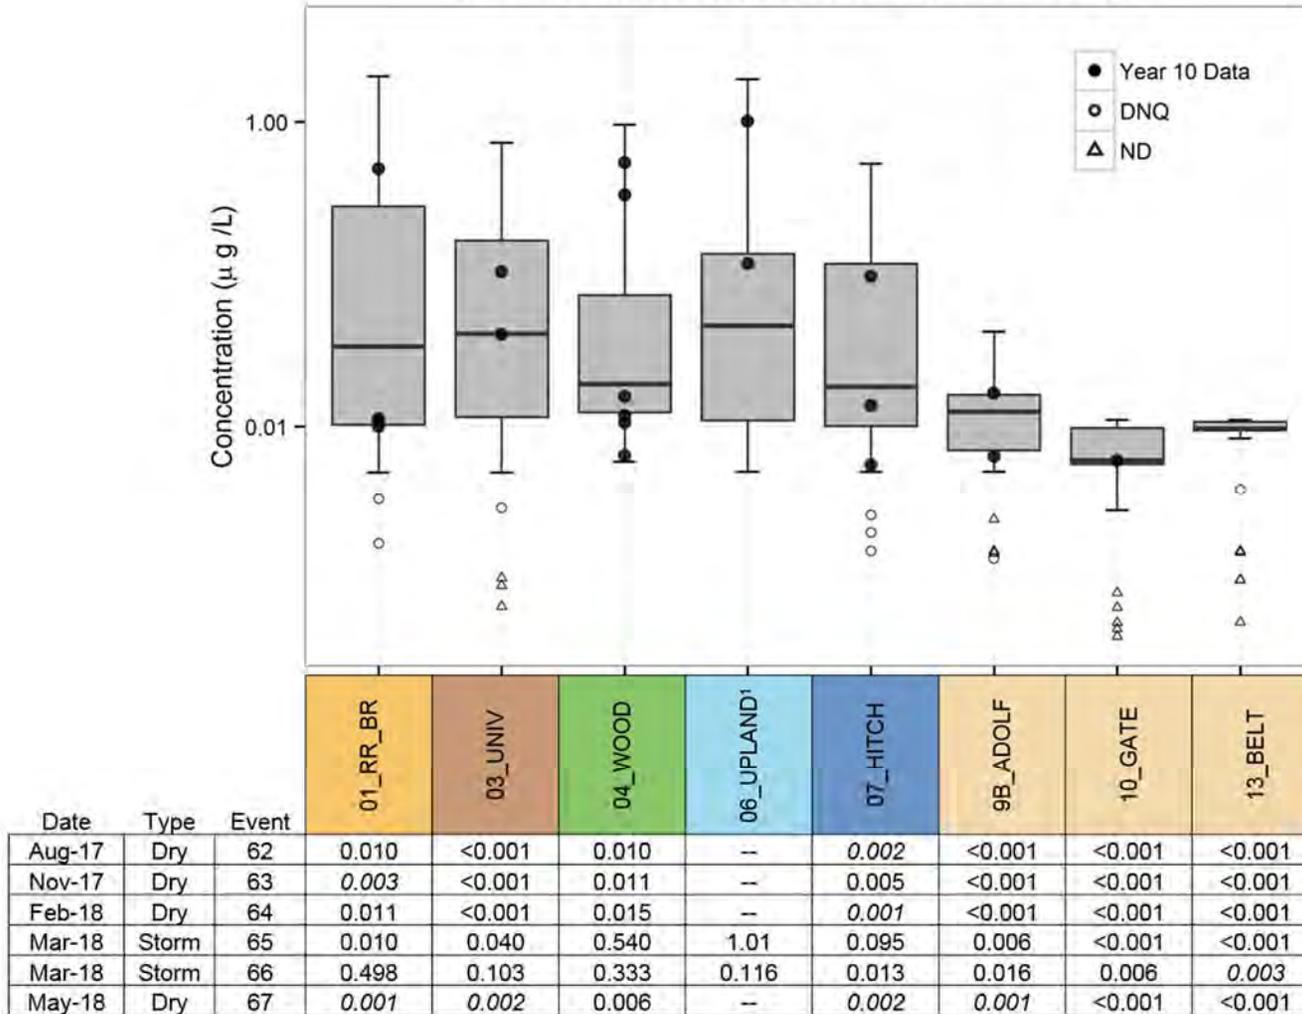
Figure 12. 4,4'-DDE Water Column Concentrations in Receiving Water Sites: 2008-2018

4,4'-DDE in Receiving Water Sites: 2008-2018

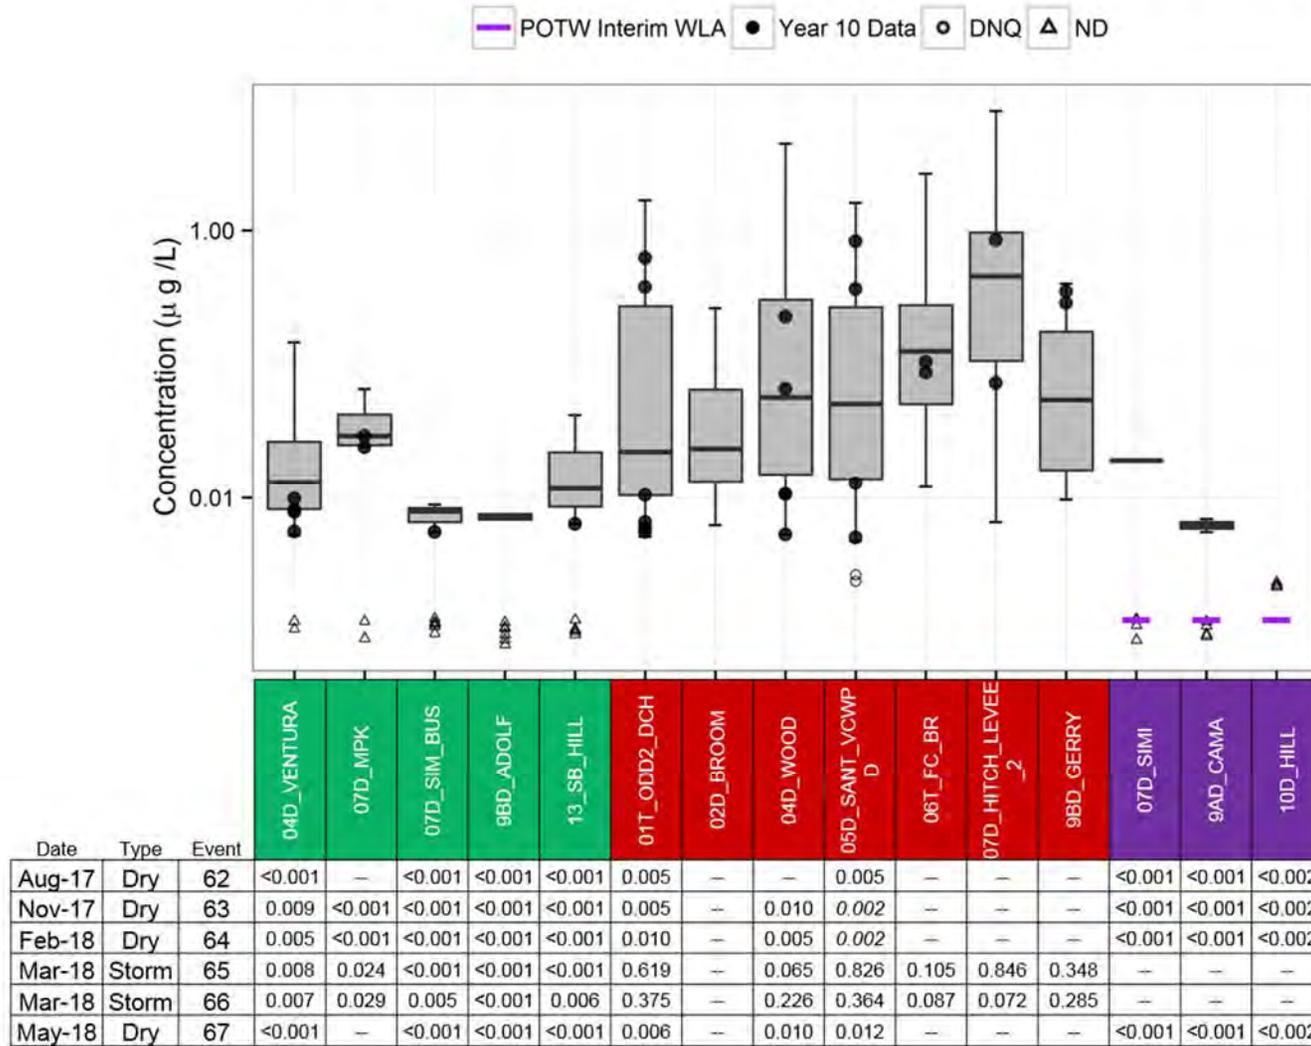
Figure 13. 4,4'-DDE Water Column Concentrations in Urban, Ag, and POTW Sites: 2008-2018

4,4'-DDE in Water from Urban, Ag, & POTW Sites: 2008-2018

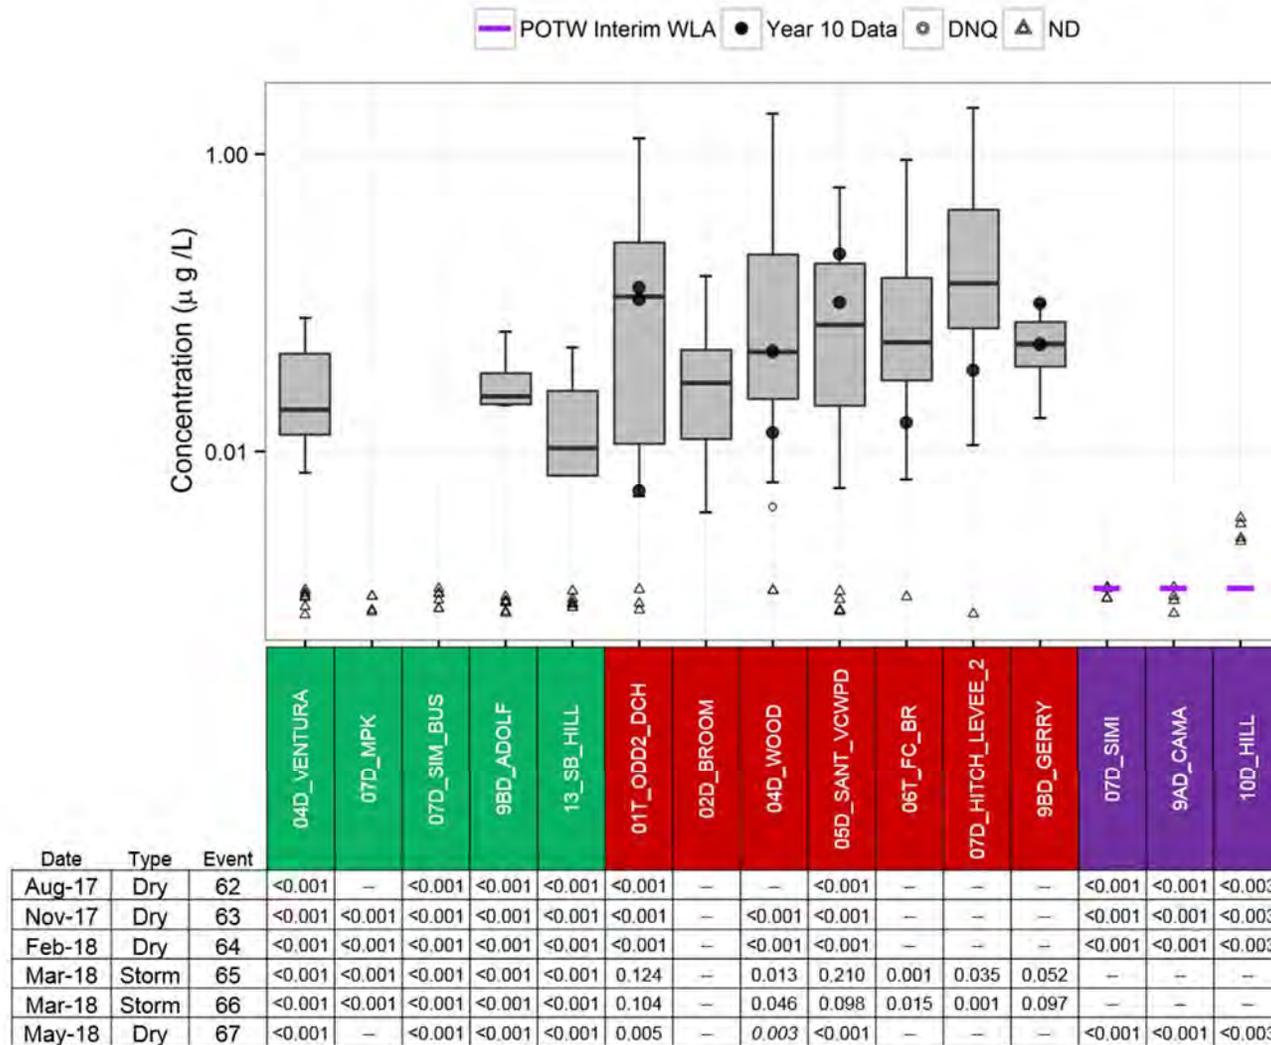
Figure 15. 4,4'-DDT Water Column Concentrations in Urban, Ag, and POTW Sites: 2008-2018

4,4'-DDT in Water from Urban, Ag, & POTW Sites: 2008-2018

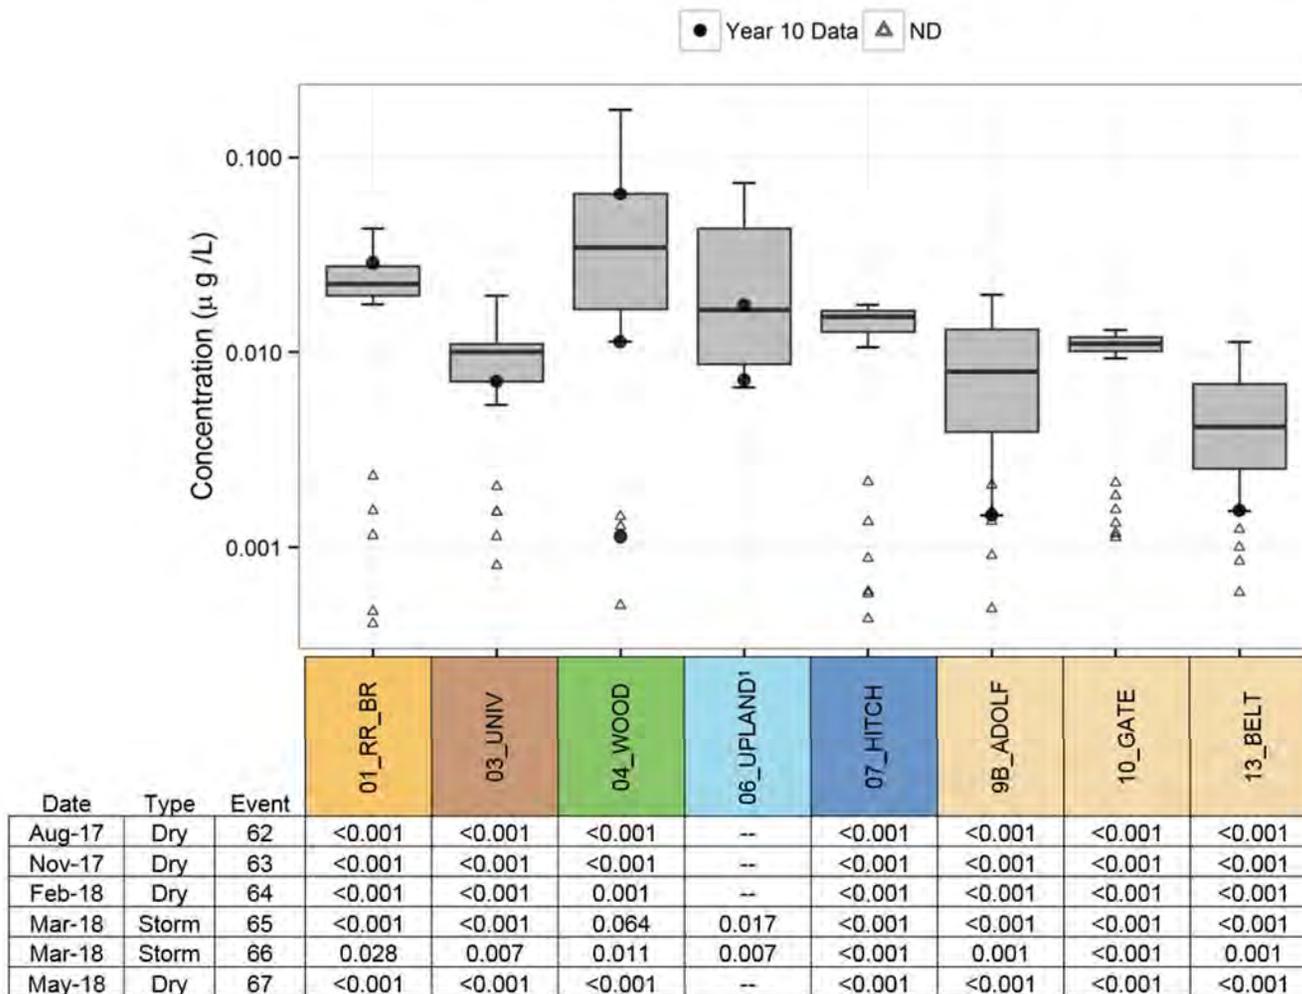
Figure 16. Total Chlordane Water Column Concentrations in Receiving Water Sites: 2008-2018

Total Chlordane in Receiving Water Sites: 2008-2018
