*Ventura Countywide
Stormwater Quality
Management Program*

Ventura Countywide Stormwater Quality
Management Program Annual Report

Attachment E – TMDL Reports (3/3)

TOTAL MAXIMUM DAILY LOAD FOR ALGAE, EUTROPHIC CONDITIONS, AND NUTRIENTS IN VENTURA RIVER, INCLUDING THE ESTUARY, AND ITS TRIBUTARIES (VR ALGAE TMDL)

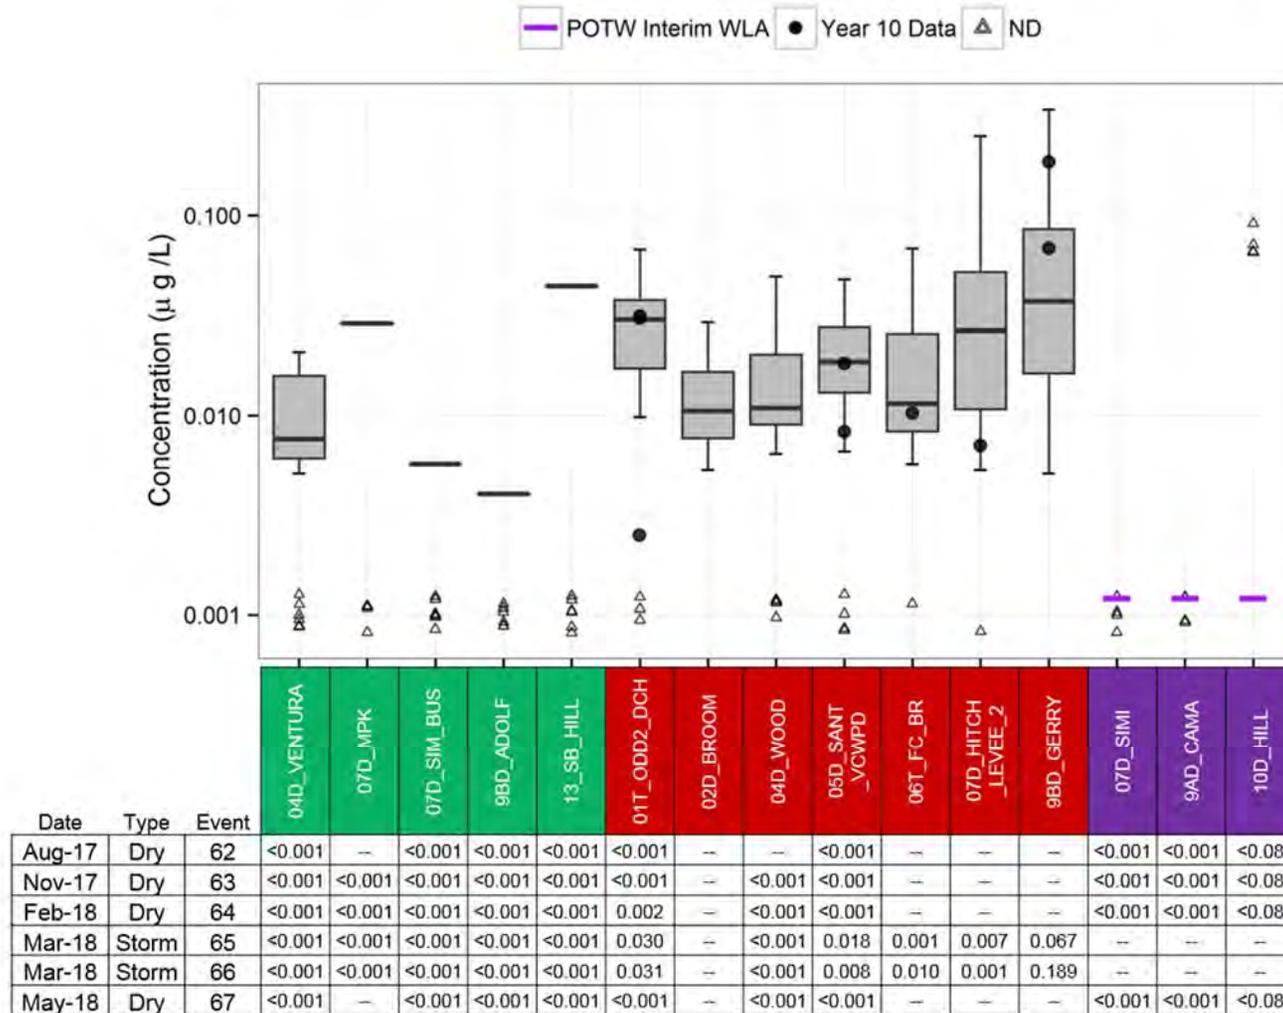
Figure 17. Total Chlordane Water Column Concentrations in Urban, Ag, and POTW Sites: 2008-2018

Total Chlordane in Water from Urban, Ag, & POTW Sites: 2008-2018

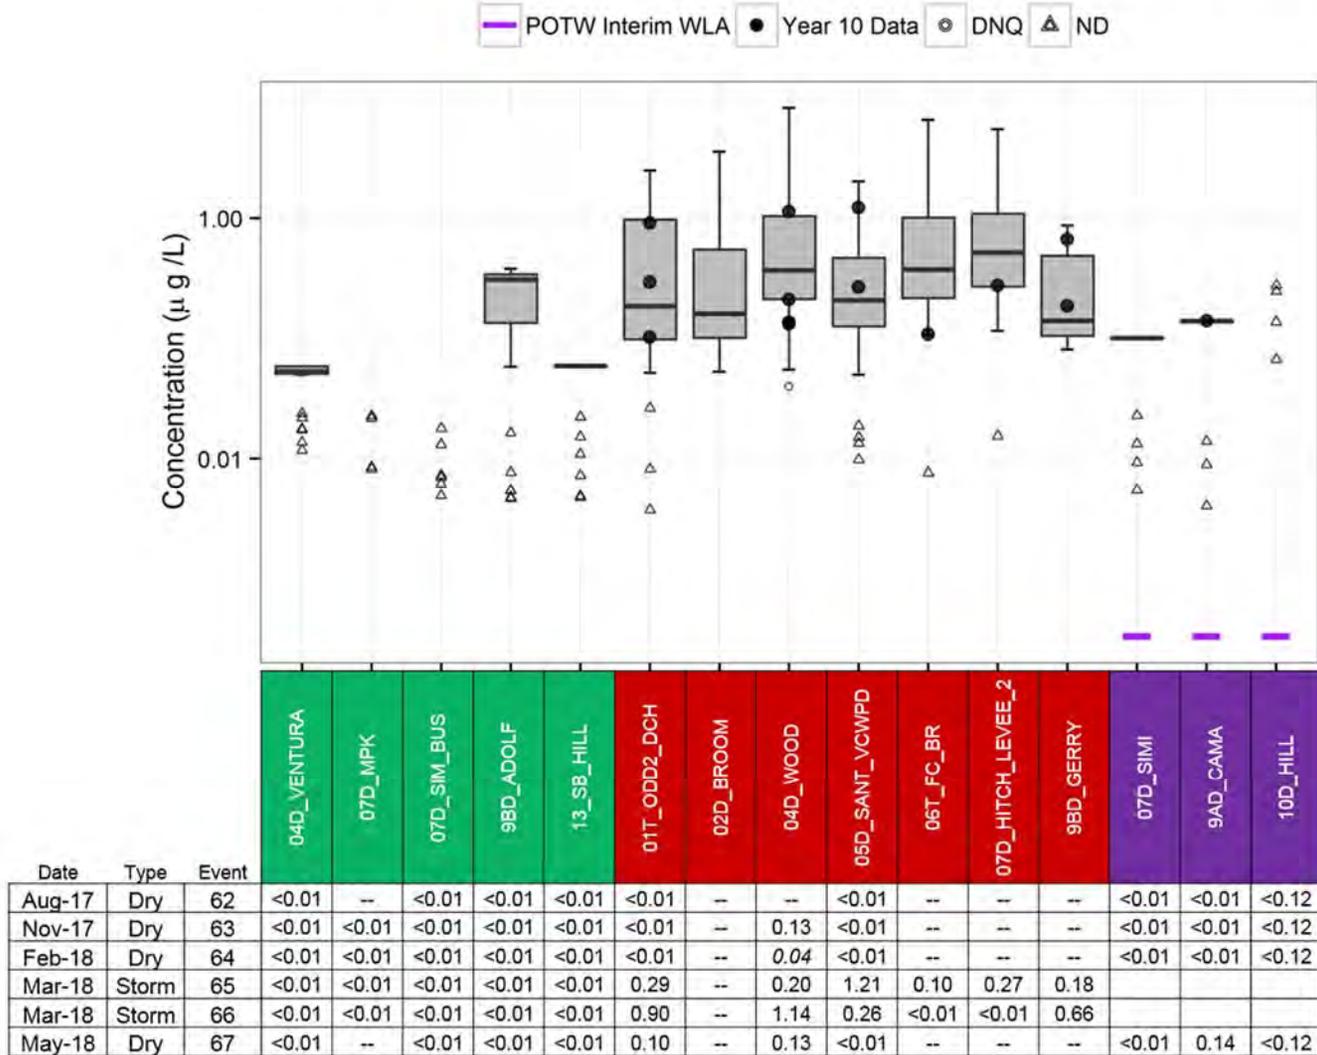
Figure 19. Toxaphene Water Column Concentrations in Urban, Ag, and POTW Sites: 2008-2018

Toxaphene in Water from Urban, Ag, & POTW Sites: 2008-2018

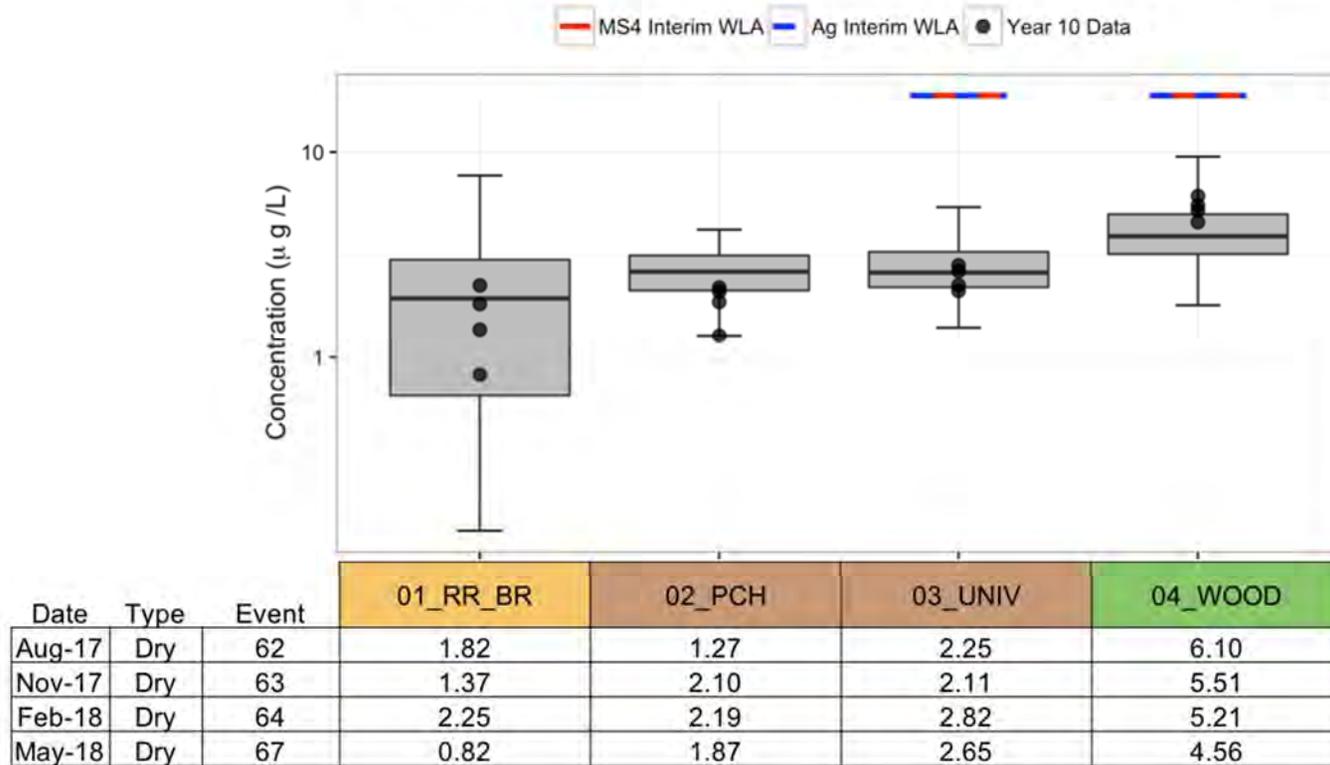
Figure 25. Total Copper Dry Weather Concentrations in Receiving Water Sites: 2008-2018

Total Copper in Receiving Water Sites: 2008-2018 Dry Weather

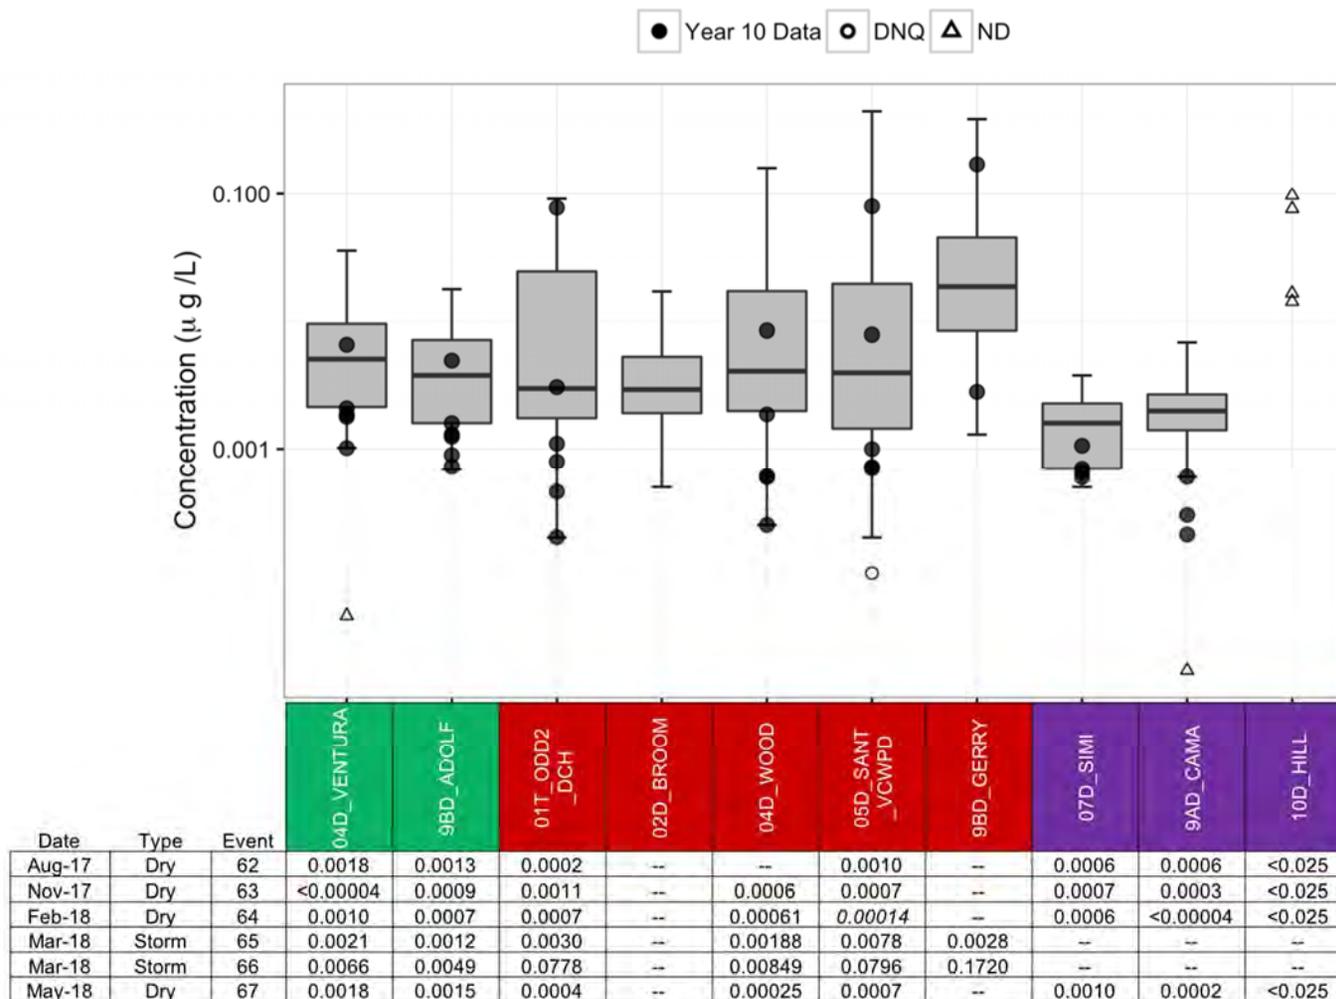
Figure 32. Total Mercury Concentrations in Urban and Ag Sites: 2008-2018

Total Mercury in Urban, Ag, & POTW Sites: 2008-2018
