*Ventura Countywide  
Stormwater Quality  
Management Program*

Ventura Countywide Stormwater Quality  
Management Program Annual Report

Attachment E - TMDL Reports Volume II

# TOTAL MAXIMUM DAILY LOAD FOR ALGAE, EUTROPHIC CONDITIONS, AND NUTRIENTS IN VENTURA RIVER, INCLUDING THE ESTUARY, AND ITS TRIBUTARIES (VR ALGAE TMDL)

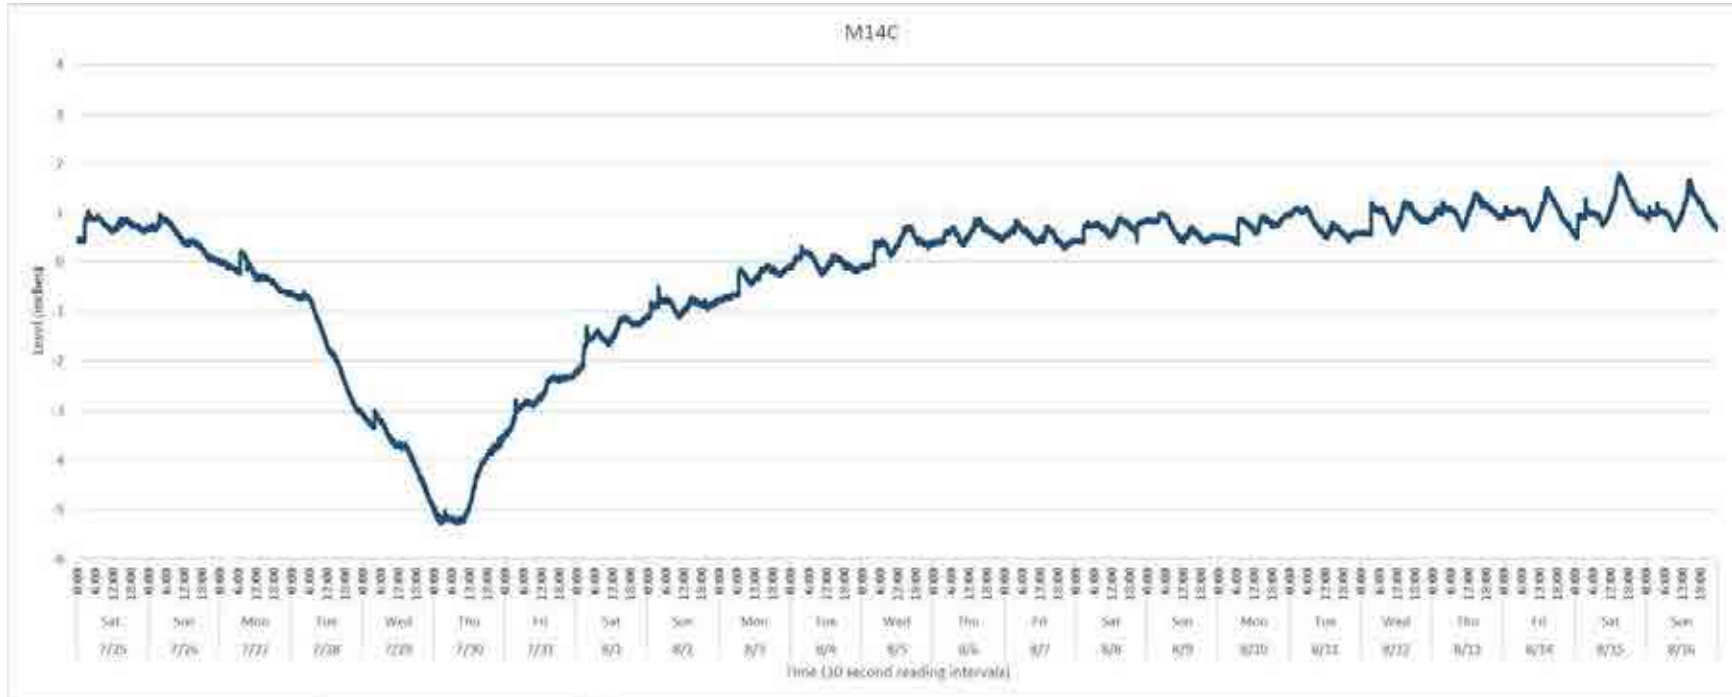
Figure E-5. Level logger data plot for outfall M14C. \*Data indicates the level logger malfunctioned during deployment.

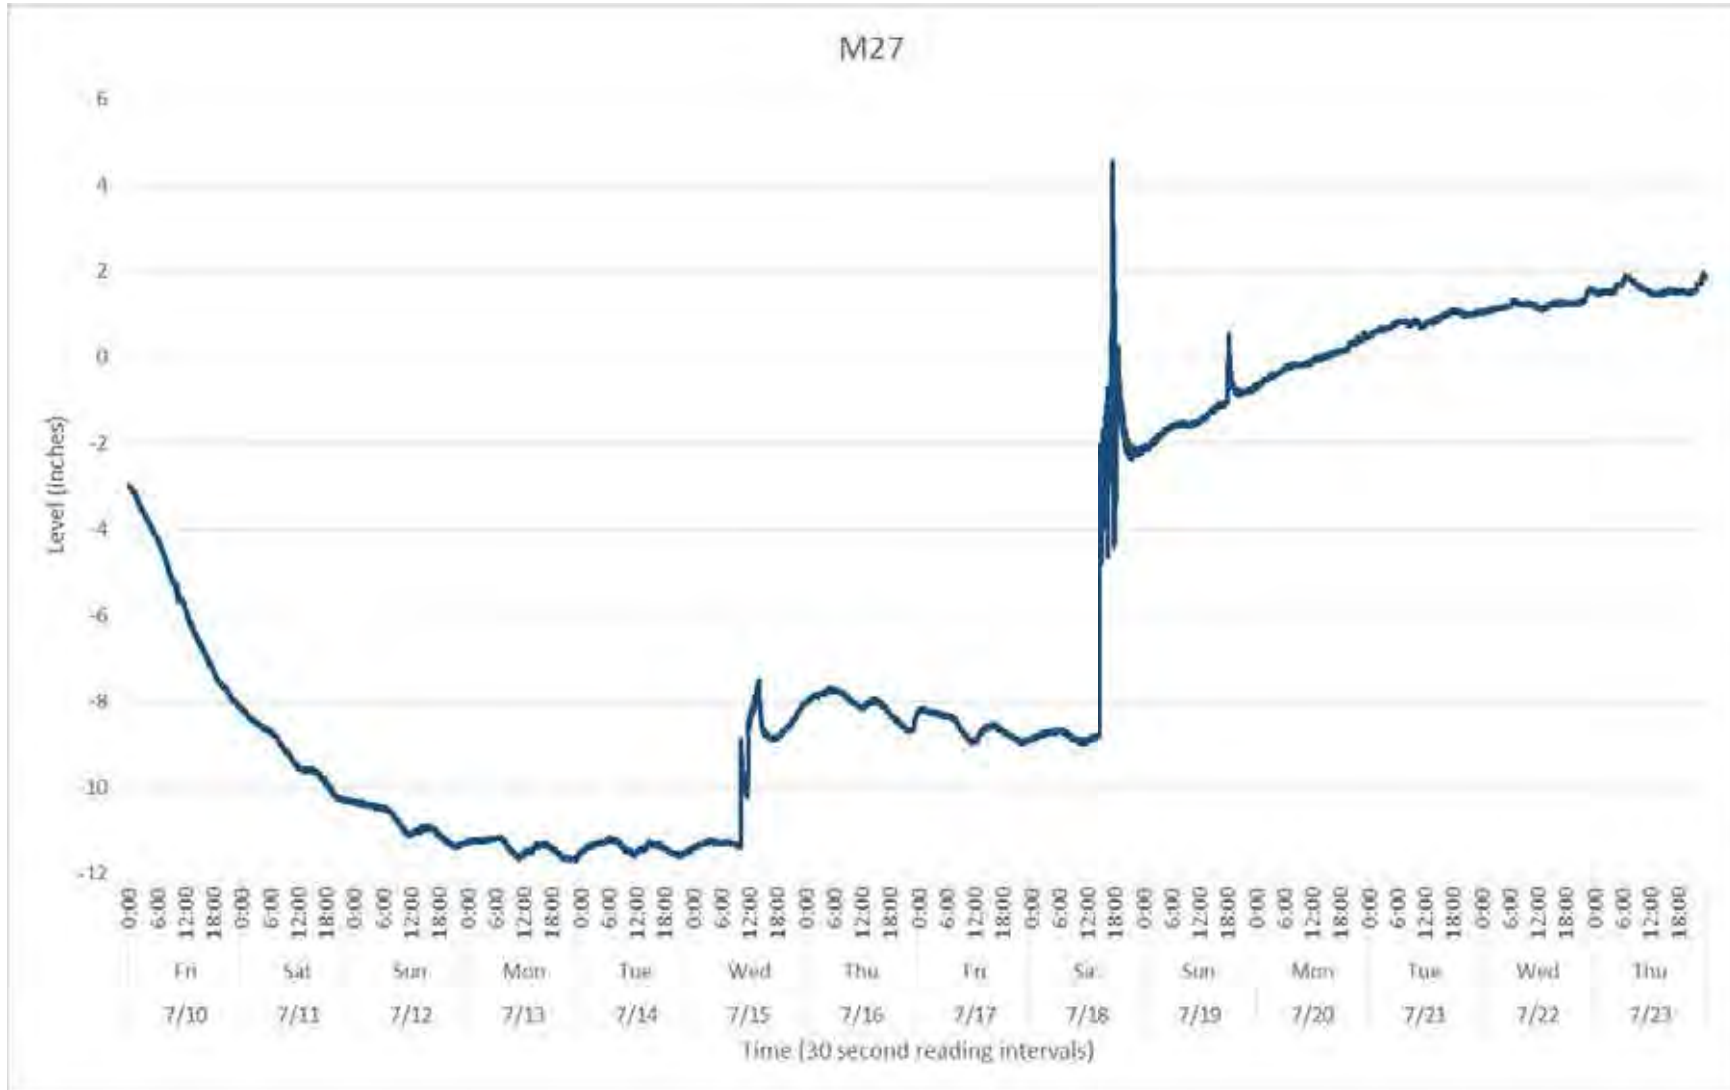
Figure E-8. Level logger data plot for outfall M27. \*Data indicates the level logger malfunctioned during deployment.
