*Ventura Countywide  
Stormwater Quality  
Management Program*

2017-2018  
Permit Year

# Ventura Countywide Stormwater Quality Management Program Annual Report

Ventura County Watershed Protection District

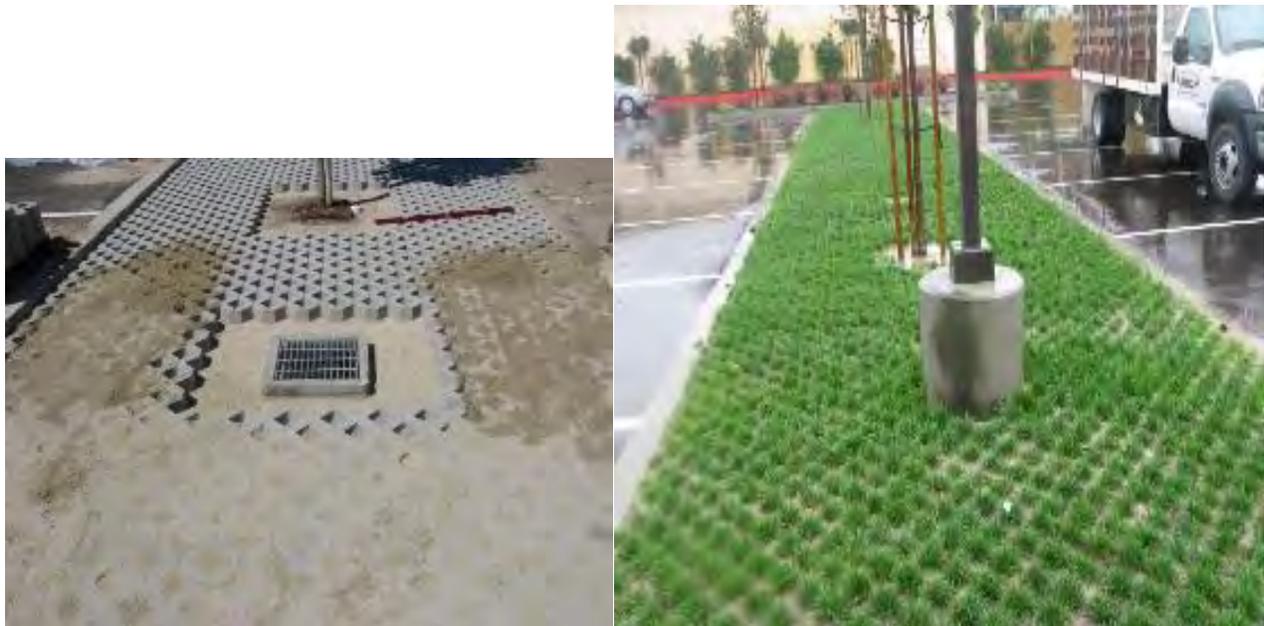
*Before and after pictures of infiltration area of parking lot during construction.*

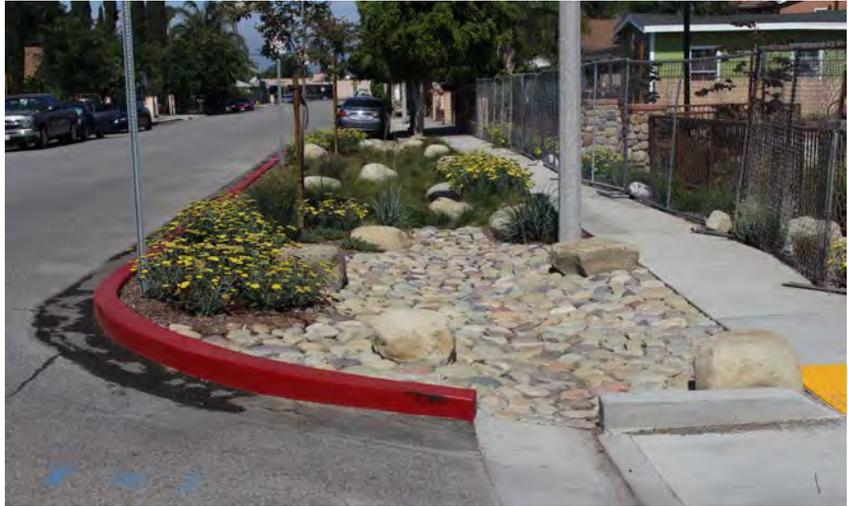
*Low Impact Development infiltration BMP*

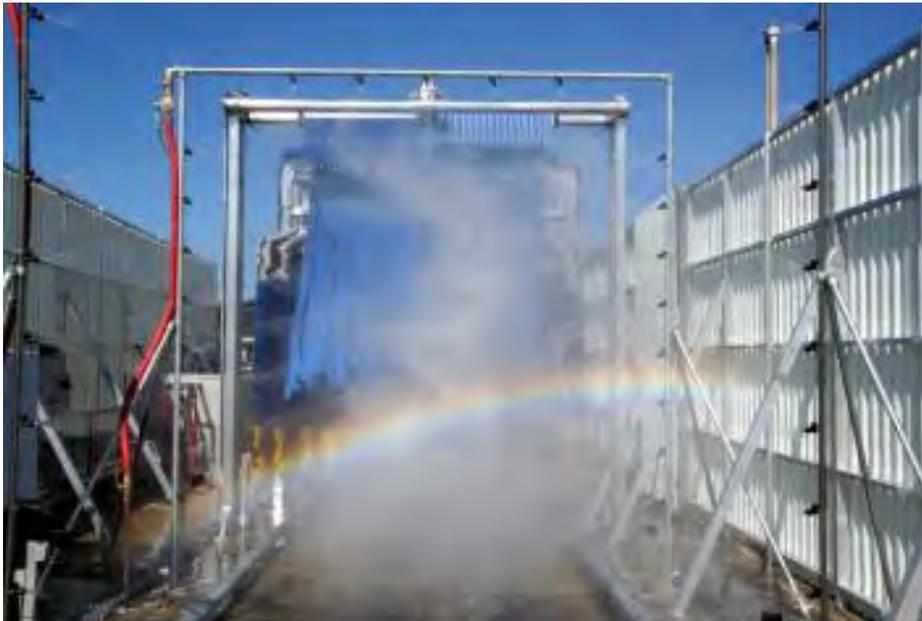
*Thousand Oaks' car wash facility drains to wastewater treatment plant*

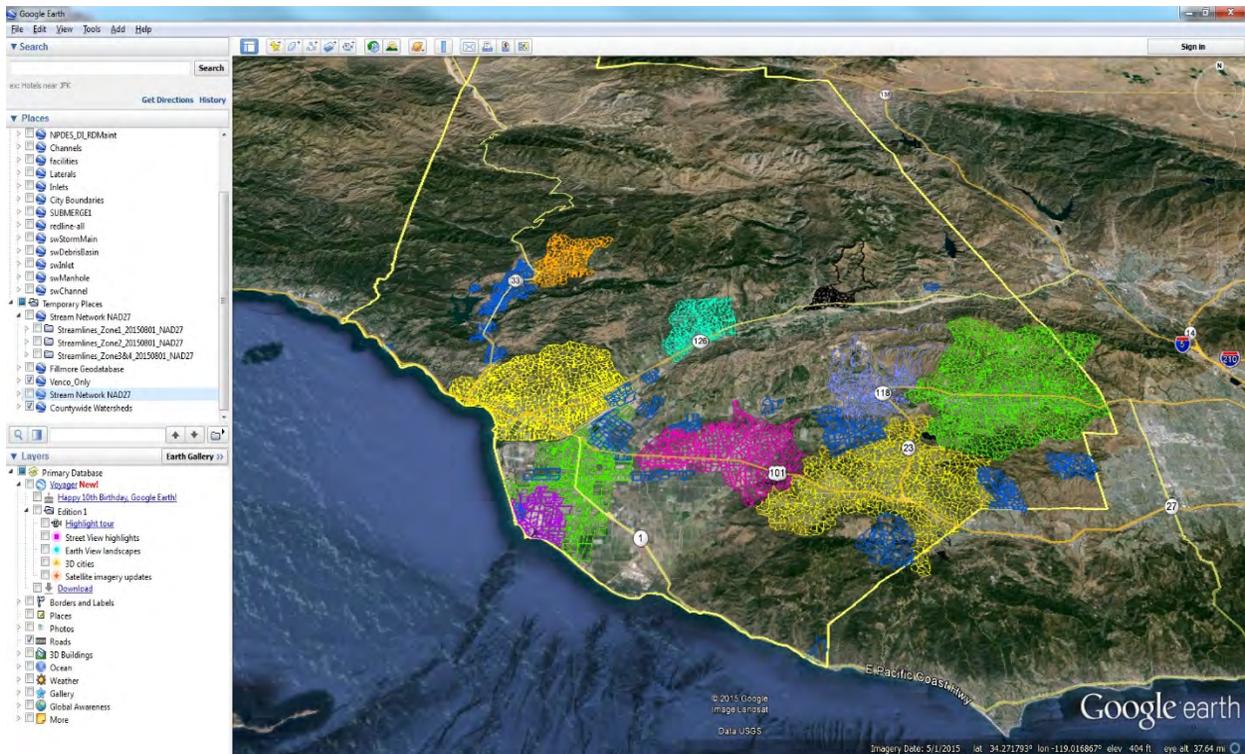
Screen shot of Countywide Unified Storm Drain Atlas with all storm drain information in a single database.

The Program has completed its Ventura Countywide Unified Storm Drain Mapping project. This project involved the creation of five new Storm Drain System Geodatabases and sub watershed boundaries for the five small cities of Fillmore, Moorpark, Ojai, Port Hueneme, and Santa Paula who did not have this mapped in Geodatabase format. The new storm drain geodatabases are consistent with existing Storm Drain System Geodatabases for Permittees Thousand Oaks, Camarillo, Simi Valley, Oxnard, Ventura, and the County. A single Geodatabase now contains all available storm drain information from all of the Permittees. This information is also available in Google Earth KMZ files downloadable from [vcstormwater.org](http://vcstormwater.org). This project also included a Countywide GIS analysis to identify infiltration constrains per 2011 Technical Guidance Manual and mapping of the natural stream network. In addition, a user-friendly computer program was created which allows for easy updating to the unified Geodatabase and KMZ files. This allows the Permittees to share updates to their storm drain system with all of the other Permittees ensuring all have the latest and greatest version of the unified storm drain information.

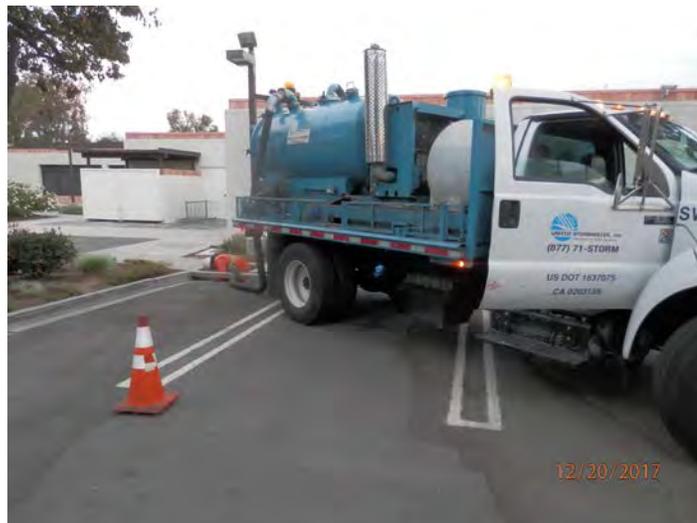
*Catch Basin Cleaning Using a Vacuum Truck*

Inspections include the visual observation of each catch basin and open channel to determine if the device or conveyance has accumulated trash, sediment, or debris requiring removal. All debris removed (including natural debris such as leaves from street trees) is disposed of properly and therefore represents a removal of pollutants that would have been washed downstream to a receiving water. For catch basins, “as-needed cleaning” occurs whenever trash, sediment, or debris accumulation is found to be at least 25% of capacity. Watershed Protection District cleans and maintains their flood control facilities, but does not operate any catch basins that receive runoff directly from streets or roads.

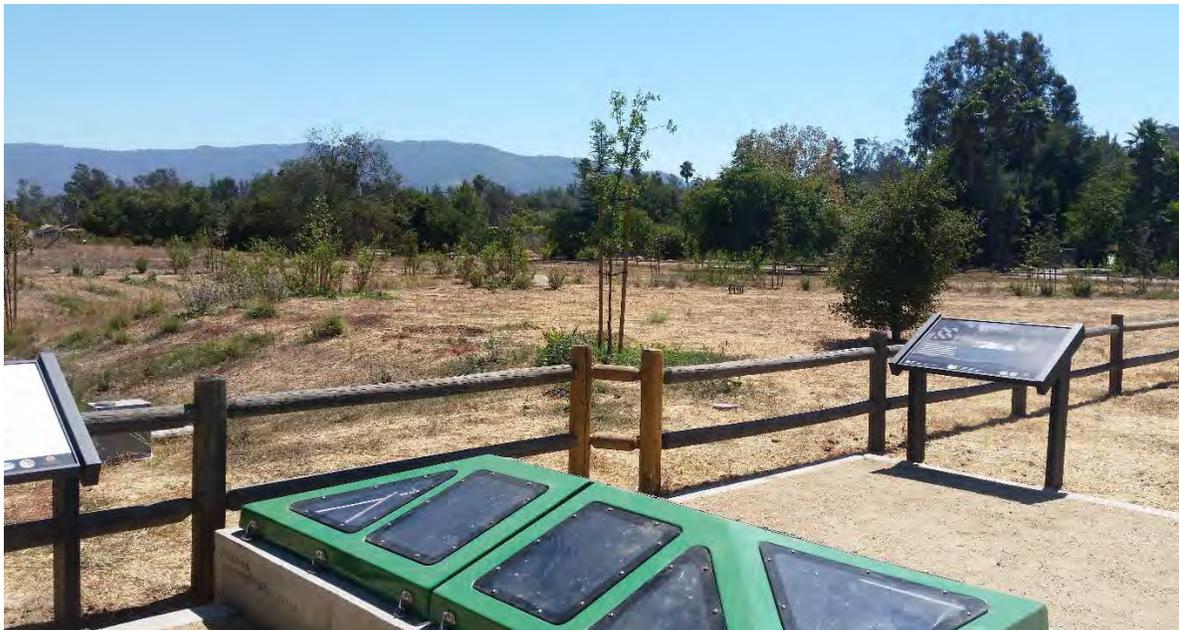
2. Meiners Oaks Urban Low Impact Development Retrofit project. Construction of bioswale was completed in February 2016. The project captures nuisance flows and stormwater runoff from 40% urbanized area (or over 36 acres) of Meiners Oaks community to meet Ventura River Algae TMDL compliance. Total project cost including monitoring and educational outreach was \$0.95M.

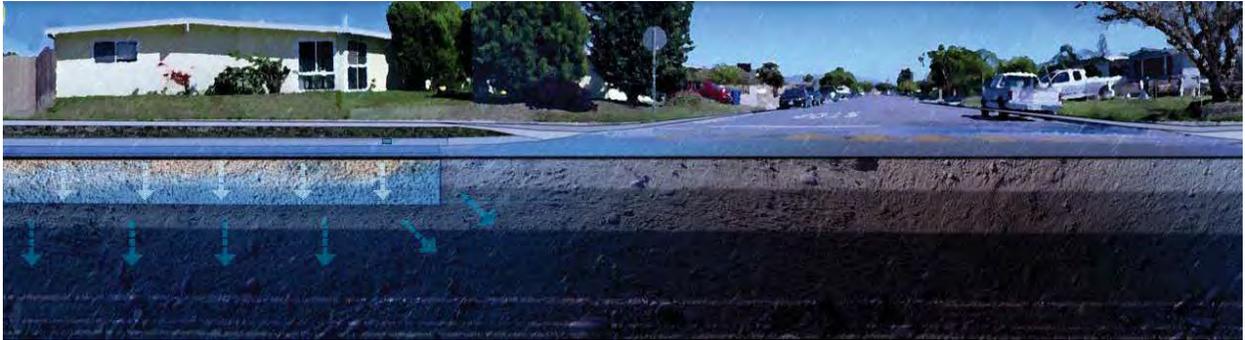
3. El Rio Retrofit for Groundwater Recharge. Construction was completed in March 2016. The project captures 100% nuisance flows and the first flush stormwater discharges from 46 acres of residential community of El Rio for infiltration and groundwater recharge. Total project cost is \$1.3M.
