*Ventura Countywide  
Stormwater Quality  
Management Program*

Ventura Countywide Stormwater Quality  
Management Program Annual Report

Attachment E - TMDL Reports Volume II

# TOTAL MAXIMUM DAILY LOAD FOR ALGAE, EUTROPHIC CONDITIONS, AND NUTRIENTS IN VENTURA RIVER, INCLUDING THE ESTUARY, AND ITS TRIBUTARIES (VR ALGAE TMDL)

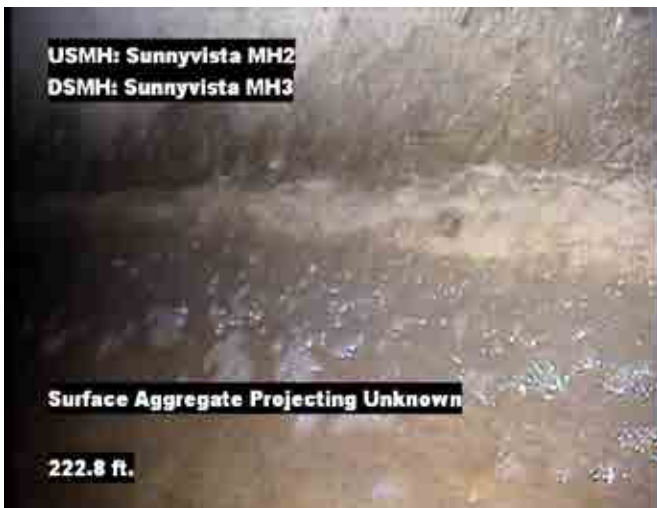
Distance: 222.8 ft.      Grade: 3  
 Condition: Surface Aggregate Projecting Unknown  
 Remarks: N/A

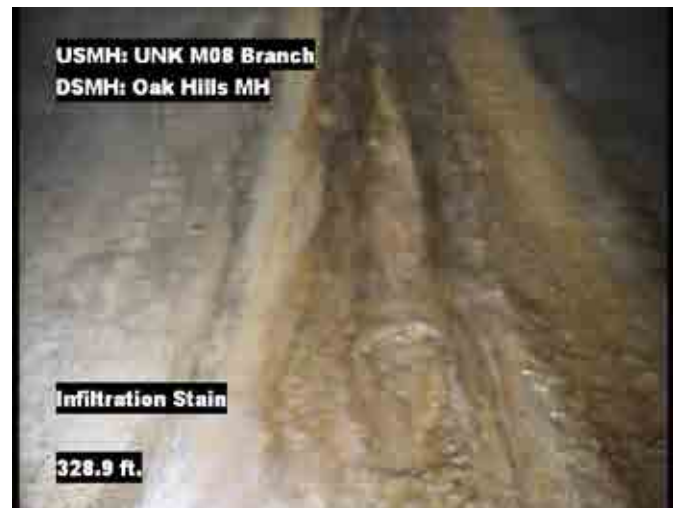
Distance: 328.9 ft. Grade: 0  
Condition: Infiltration Stain  
Remarks: N/A

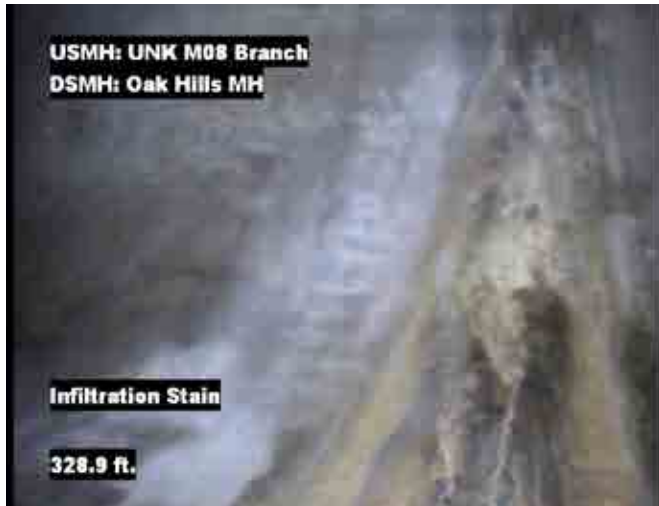
Distance: 328.9 ft.      Grade: 0  
 Condition: Infiltration Stain  
 Remarks: N/A

1) ~328.9 FT UPSTREAM OF  
OAK HILLS MIDDLE IS AREA  
OF WATER INFILTRATING  
STAINS (GEORGE SAYS AS NOT  
SIMILAR TO INFILTRATION  
IN SOURCE CLM)

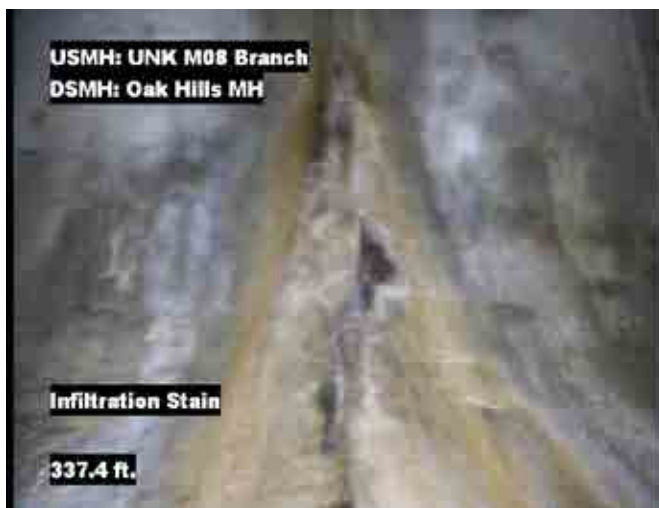
Distance: 337.4 ft.      Grade: 0  
 Condition: Infiltration Stain  
 Remarks: N/A

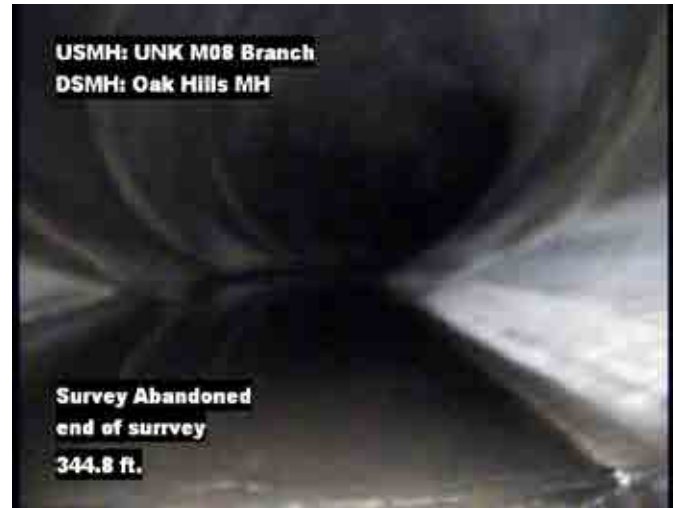
Distance: 344.8 ft.      Grade: 0  
 Condition: Survey Abandoned  
 Remarks: end of survey
